CONTINENTAL MOTORS® AIRCRAFT ENGINE SERVICE BULLETIN

SB95-7A

SUBJECT: MANIFOLD VALVE COVER INSPECTION

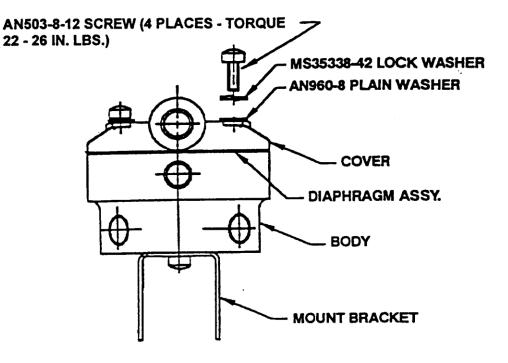
UPRIGHT VALVES FIGURE 1

- e. Place a suitable container under the induction system drain(s).
- f. While additional personnel observe the fuel manifold valve, (and all other fuel system components) engage the aircraft fuel boost pump for 5 seconds and verify fuel flow indication on the aircraft fuel flow gage.
- g. Inspect all fuel system components and lines for leaks.
- h. Repair fuel leaks prior to further flight. If fuel leakage is noted at the manifold valve cover to body mating surfaces, perform the following rework procedure.

- 1. UPRIGHT VALVES See Figure 1.
 - a. Remove manifold valve cover safety wire.
 - b. Remove one screw and discard.
 - c. Install one set of attaching hardware as indicated in Figure 1. Torque to 22 to 26 inch pounds and the latest revision of M-0, Standard Practice Maintenance Manual.

- d. Repeat steps b and c replacing the attaching hardware in a crisscross pattern until all four sets have been replaced.
- e. Safety wire using approved practices outlined in the latest revision of M-0, Standard Practice Maintenance Manual.
