HARRY DIAMOND LABS ADELPHI MD
STRUCTURAL FIRING TESTS OF THE M735 PROXIMITY FUZE.(U)
MAY 79 J M MILLER, S A BORING

HDL-TM-79-6

REPORT DOCUMENTATION PAGE		READ INSTRUCTIONS BEFORE COMPLETING FORM
1. REPORT NUMBER 14 HDL-TM-79-6	2. GOVT ACCESSION NO.	3. RECIPIENT'S CATALOG NUMBER
4. TITLE (and Subtitle) 6 Structural Firing Tests of the M735 Proximity Fuze	5. TYPE OF REPORT & PERIOD COVERED Technical Memorandum

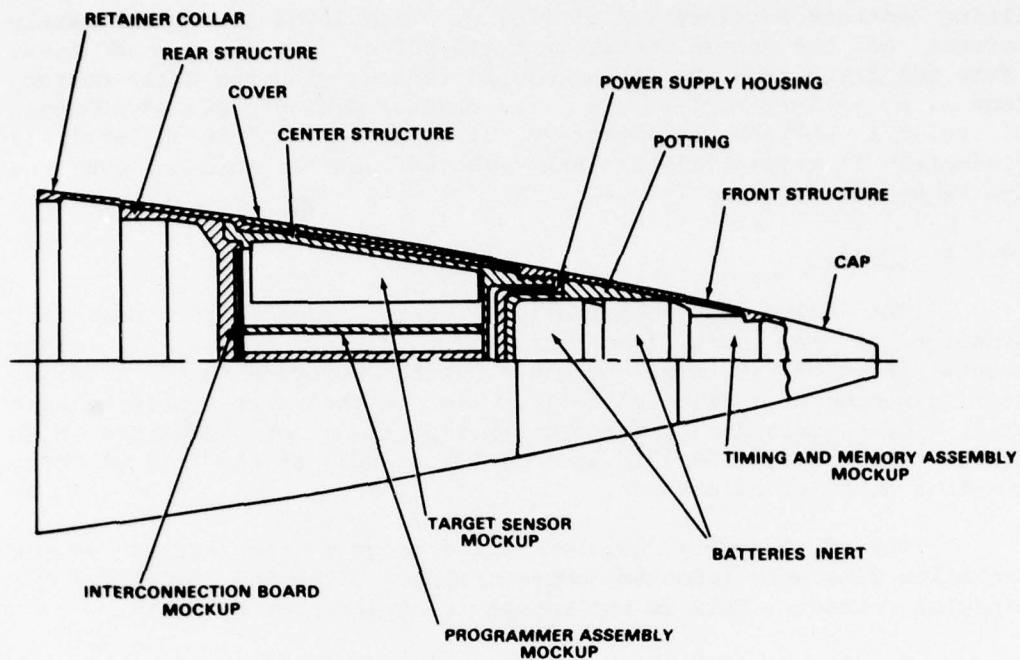
Figure 7. Structural mockup fuze, Group 1.

The following observations were made after post-test examination of the fuze from the first firing test. All major structural parts of the fuze survived, with no evidence of yielding. However, a number of fasteners failed, as did the power supply housing potting. The programmer boards also showed signs of localized high stresses. The observed individual failures as well as the failure modes follow in a detailed discussion.

The four screws which attach the target sensor assemblies to the center structure failed in shear. This failure was attributed to the potential differential axial deflection of the rf housings and center structure. In particular, the thin-walled center structure is not nearly as stiff as the rf housings in the axial direction. In addition, this structure must support a much larger inertial load, including the total mass of the nose section. As a result, the center structure axial strain rate is larger than that of the rf housings, thereby causing relative motion of the center structure with respect to the rf housings at gun launch. If the rf mounting screw clearance holes in the center structure are not large enough to accommodate this motion, the screw can fail.

The set screws which provide lateral support to the center of the programmer assembly failed (one was fractured and one was severely bent). This failure was attributed to the potential differential deflection of the rf housings and rear assembly, in particular the rear structure. Since the rear structure is inherently more compliant and more heavily loaded than the rf housings, the interface between the set screw and programmer assembly must be able to accommodate relative axial motion. If this interface does not provide a relatively smooth surface, the set screw can be pulled down by the rear assembly, thus resulting in screw failure. In this instance the set screws were prevented from moving by the protrusion of the tie bolt on the programmer assembly.

The forward assembly potting fractured at the forward lip of the power supply housing. This failure was apparently caused by the lack of adequate structural support for that portion of the potting which extended above the housing lip.

The two tie bolts which fasten the programmer assembly to the mounting blocks failed: both were severely bent and one was fractured. Due to the nature of the failure, and the fact that these bolts are not under load during setback acceleration, the failure was attributed to compression release acceleration. This acceleration results when the projectile's axial acceleration is suddenly unloaded at muzzle exit. This sudden load release produces a rebound effect which essentially results in a tensile wave traveling through the projectile. In this instance, the programmer boards are driven forward with respect to the rear structure. Relative motion of the board with respect to the rear structure is restrained by the tie bolts. In addition, the rear structure rebounds forward at its center, resulting in a slap to the bottom of the programmer boards which also loads the tie bolts. It was apparent from this failure that the tie bolts were not adequate.

The programmer boards exhibited localized delamination and thread engraving on the upper surface of the mounting holes. This damage also appeared to have been caused by compression release acceleration. The programmer boards also exhibited very slight localized delamination in the foot area. This localized failure was caused by setback acceleration loading, which produces highly localized stress in this area of the board. In particular, the programmer board support in this area was marginal due to cut-outs of the interconnect board in the mounting block area.

- The programmer center tie bolt was replaced with a threaded stud and nuts. The threaded stud length was such that it did not protrude beyond the outer surface of the nuts. The nuts provide a relatively smooth flat surface for the lateral support set screws, thus allowing axial movement of the programmer assembly nut with respect to the stud and preventing set screw failure.

- The power supply housing potting extension above the forward lip was eliminated to prevent potting failure.

- The programmer/mounting block tie bolts were replaced with high strength studs to prevent stud failure and programmer board delamination/engraving.

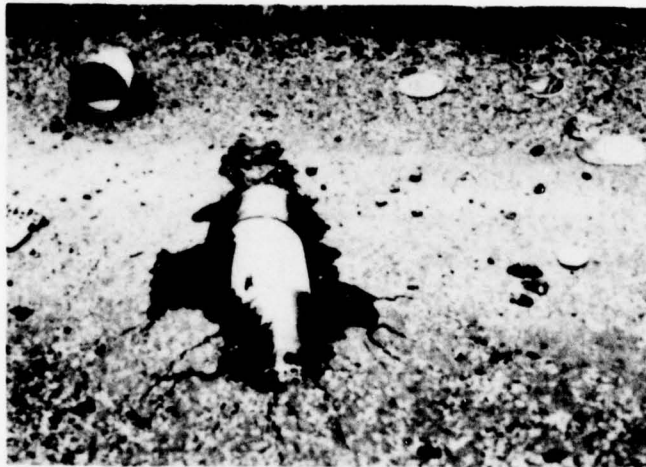
Figure 14. Group 5 structural fuze, hard impact.

Fuze 2 was fired vertically on 21 May 1976. The round went unstable and landed sideways on an asphalt road behind and to the left of the gun. The impact is shown in figure 14. The spoiler plate was never found, but the impression left on the road indicates that it was attached at impact (fig. 15). It was determined that the smaller spoiler plate was ineffective at the higher velocities produced by the gun and charge. Firing was terminated for the day. It was decided that fuzes 1 and 3 be fired down-range on PXR 6165 parachute recovery rounds at YPG.
