ITA COSUF Workshop, 28th – 29th October 2015

# BAB A7 Elbe Tunnel

LSBG  
Landesbetrieb Straßen,  
Brücken und Gewässer  
Hamburg

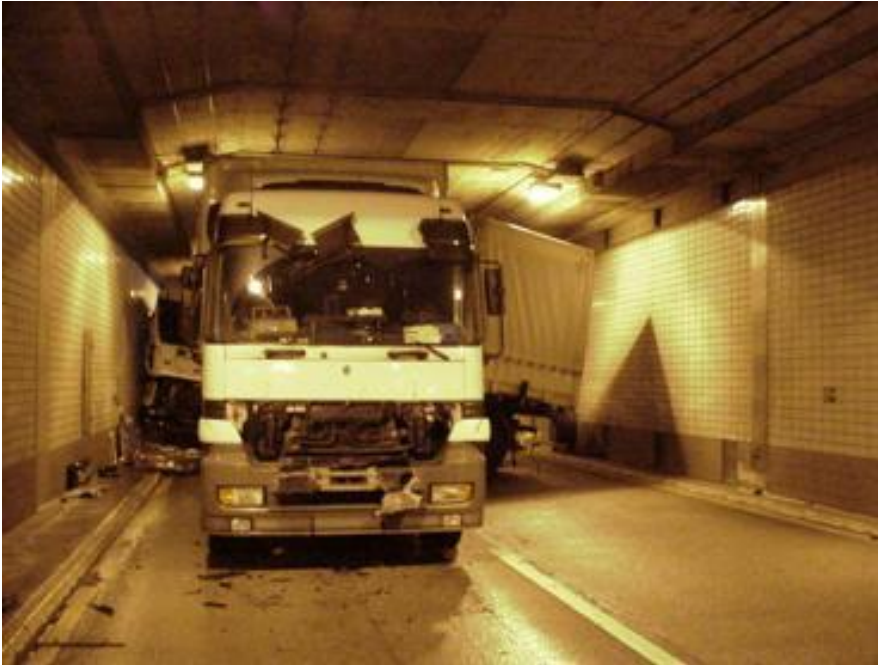
blocking of tunnel tube 1

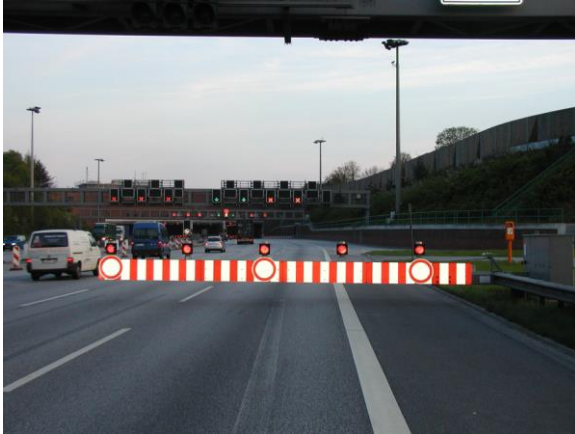
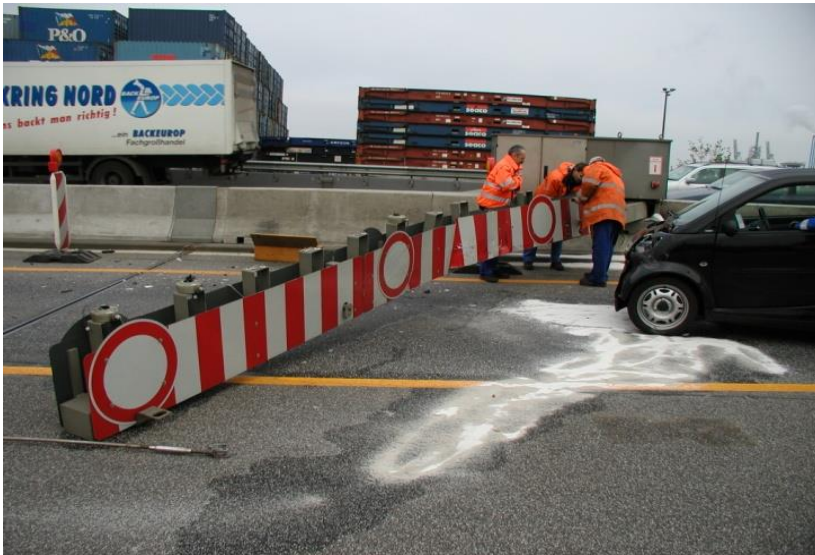
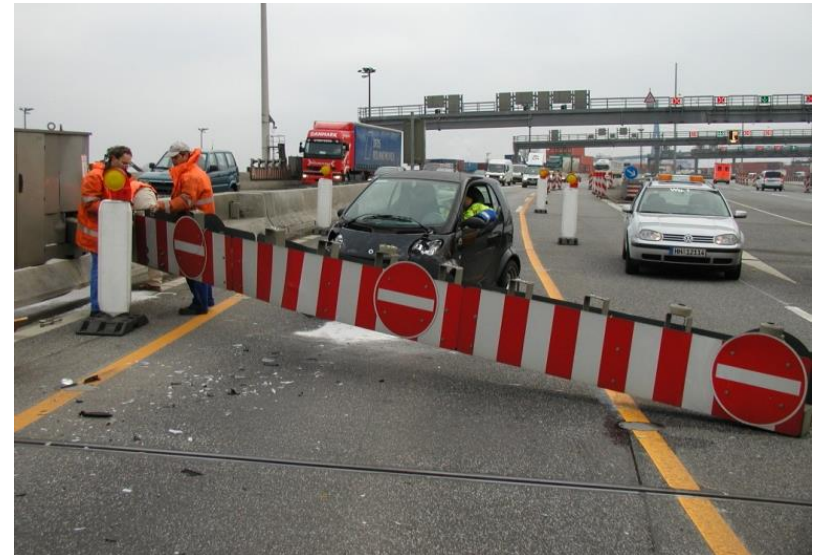
- barriers are used for lane closures
- although comprehensive signalisation before the barriers, crashes occur regularly
- caused by exhausted / drunken drivers

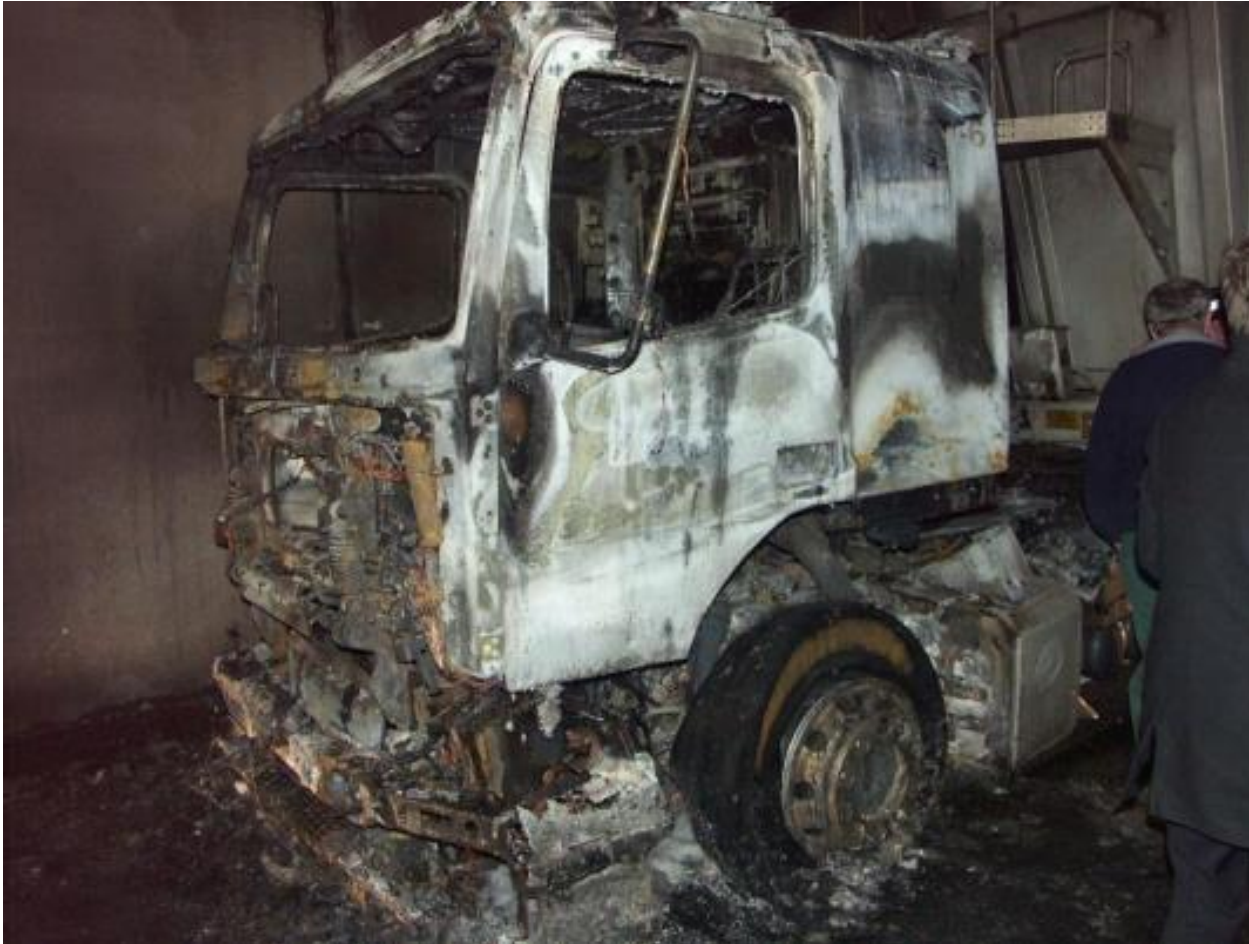
- lorry caught fire in the middle of tunnel tube 4
- cause of fire:  
self-ignition in engine compartment,  
probably because of leaking engine oil
- detection: visibility alarm in control center, while operator was checking -> heat sensor cable set off the programme for „Catastrophy“
- instant response of the fire fighters  
(3 minutes after alert in tunnel tube)
- the fire could be controlled and extinguished within 30 minutes

- fortunately no one injured
- evacuation process relatively slow:
  - poor performance of old loudspeaker system
  - people felt save despite smoke in front of them (presence of fire fighters and well performing smoke extraction)

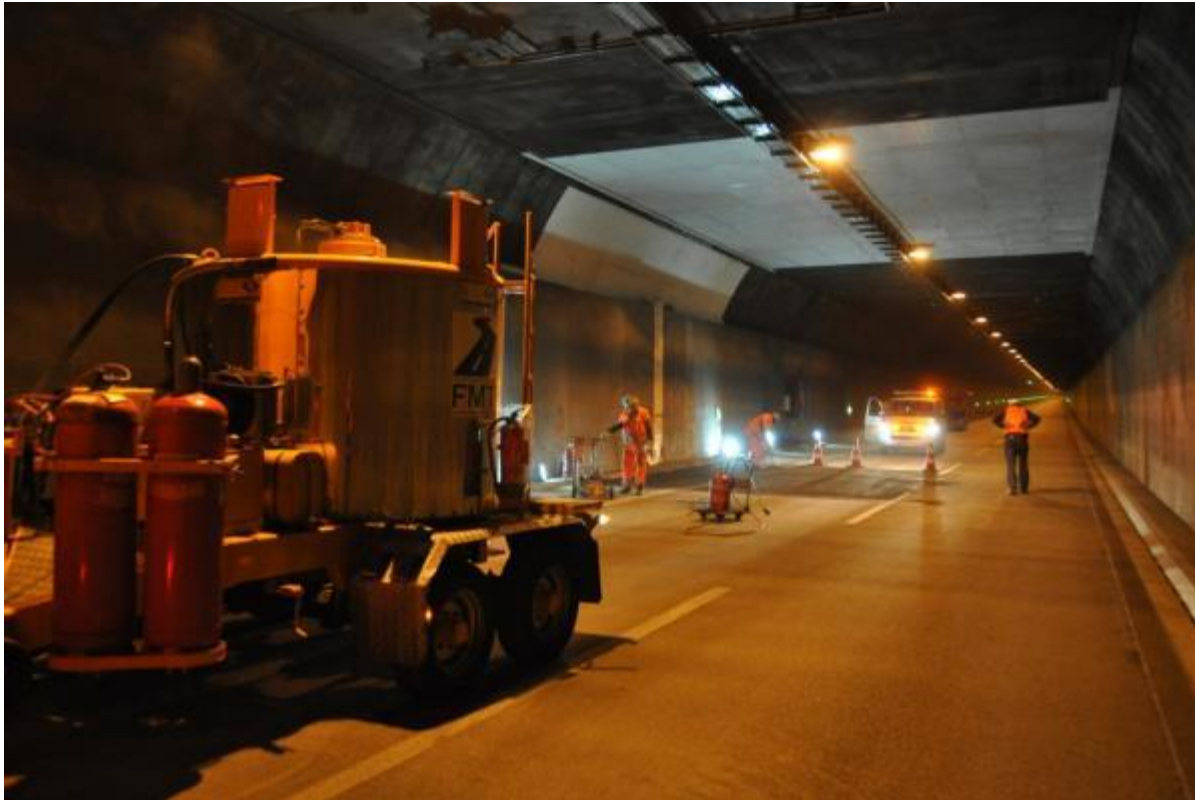
- 50 m<sup>2</sup> of asphalt and fire protection cladding had to be replaced
- replacement of cabling in the affected section
- concrete walls intact, only joints had to be replaced

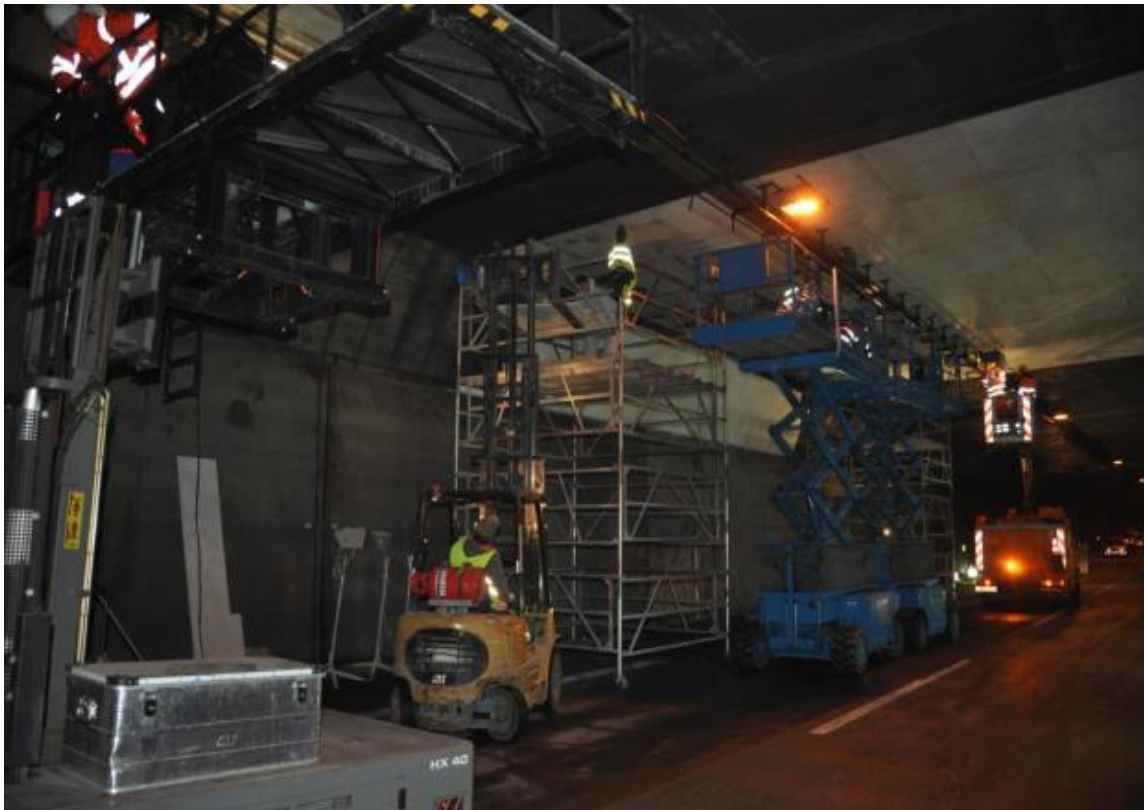
- after 10 days of reconstruction and testing the tunnel tube could be re-opened
- because of the refurbishment program in the old tubes, spare parts + contractors were quickly available

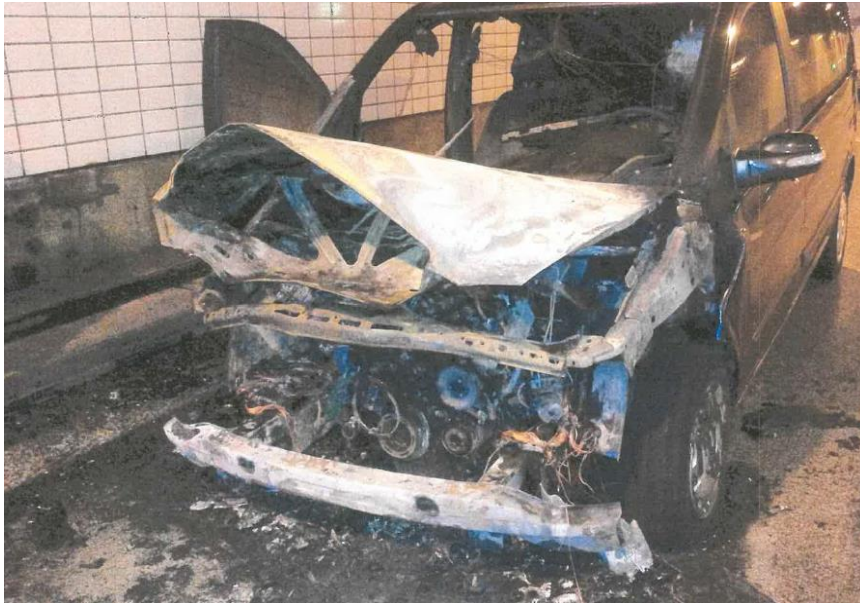
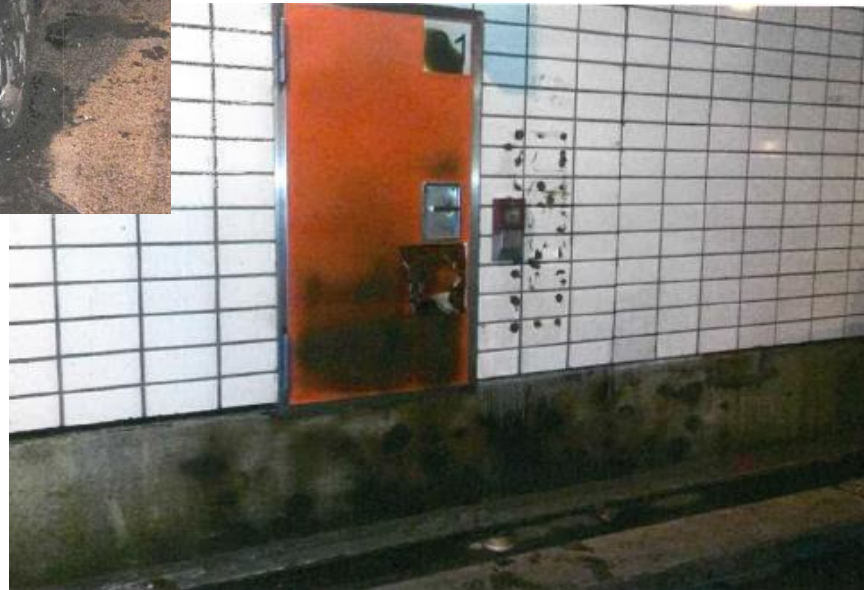
- no serious damage to safety facilities
- asphalt had to be replaced
- tube could be opened after a few hours (one lane)

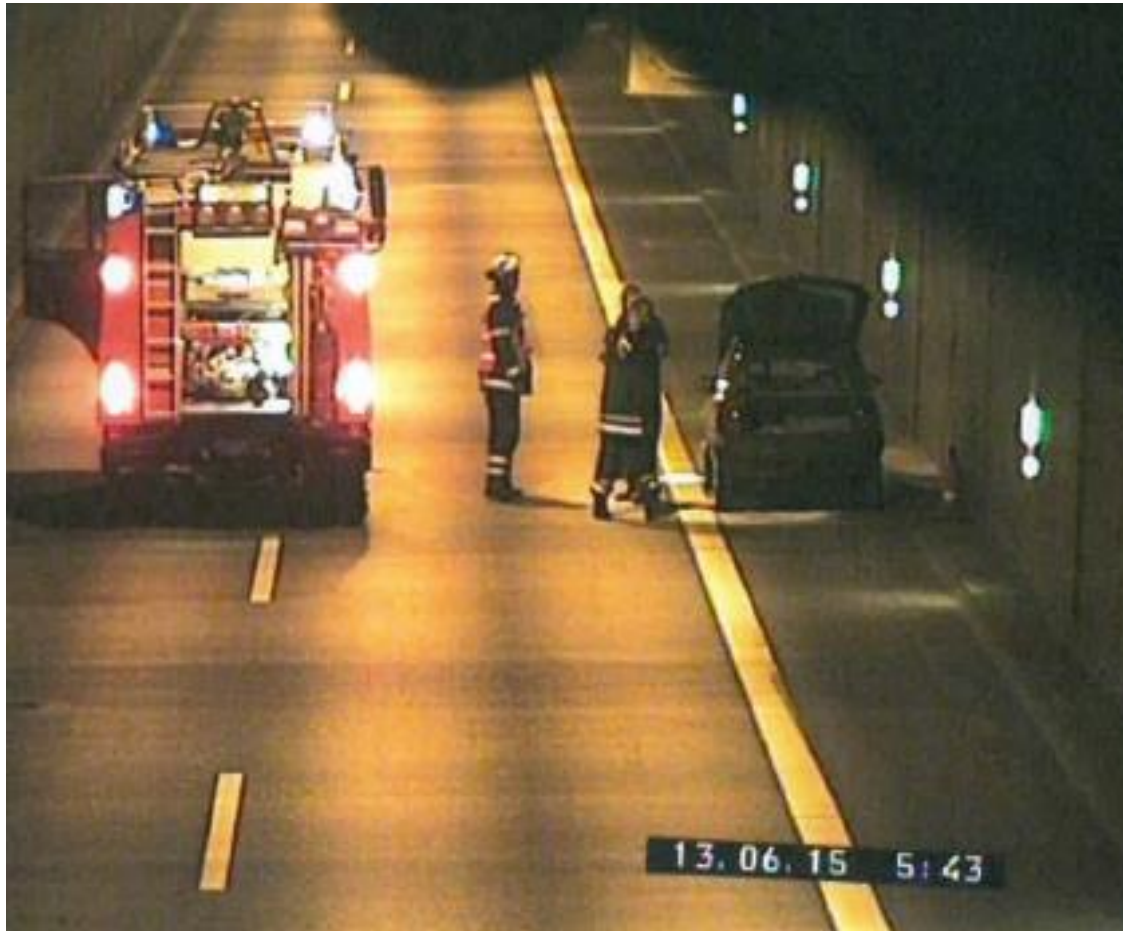
- a car caught fire in tube 4
- the driver stopped the car and used the emergency phone
- advised by the operator the driver used the fire extinguisher and was able to extinguish the fire by himself

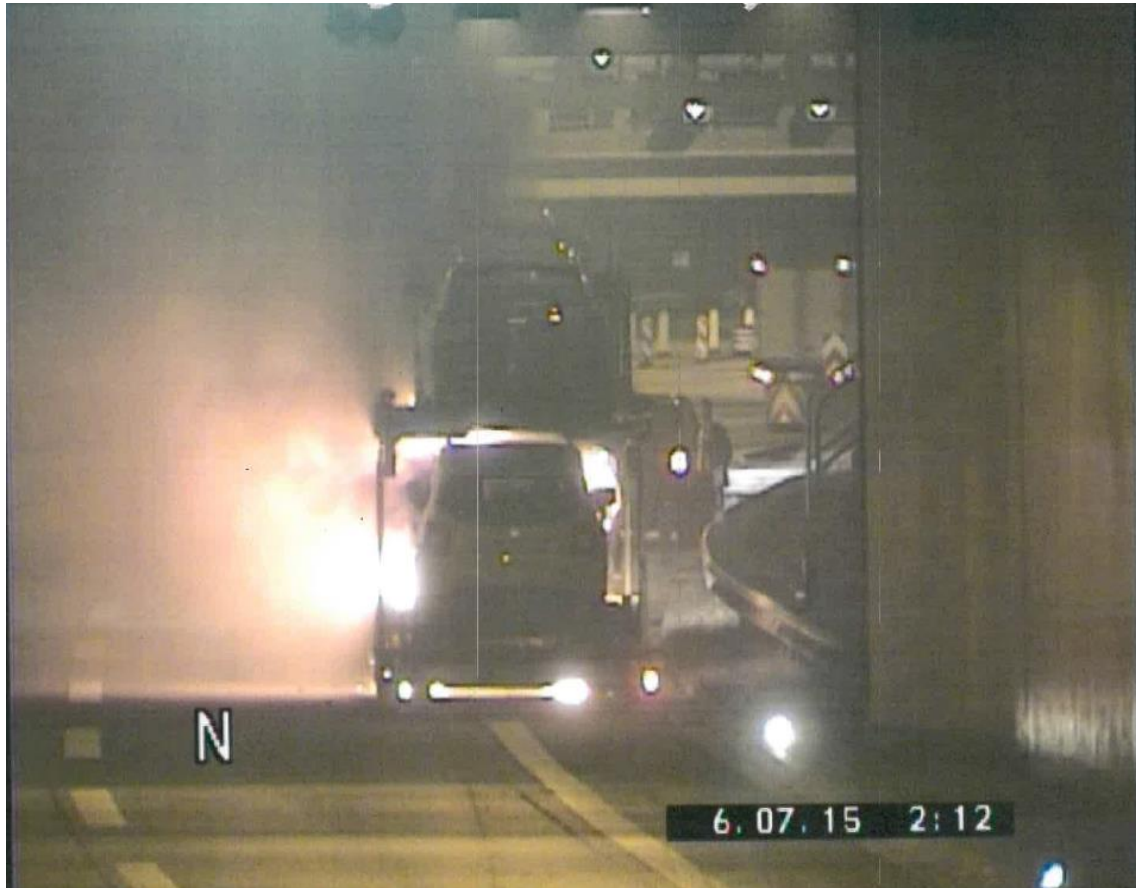
- the tyre of a trailer of a car transporter caught fire in tube 1
- being aware that his trailer is burning, the driver went ahead and stopped outside the tunnel
- then a car on the trailer also caught fire

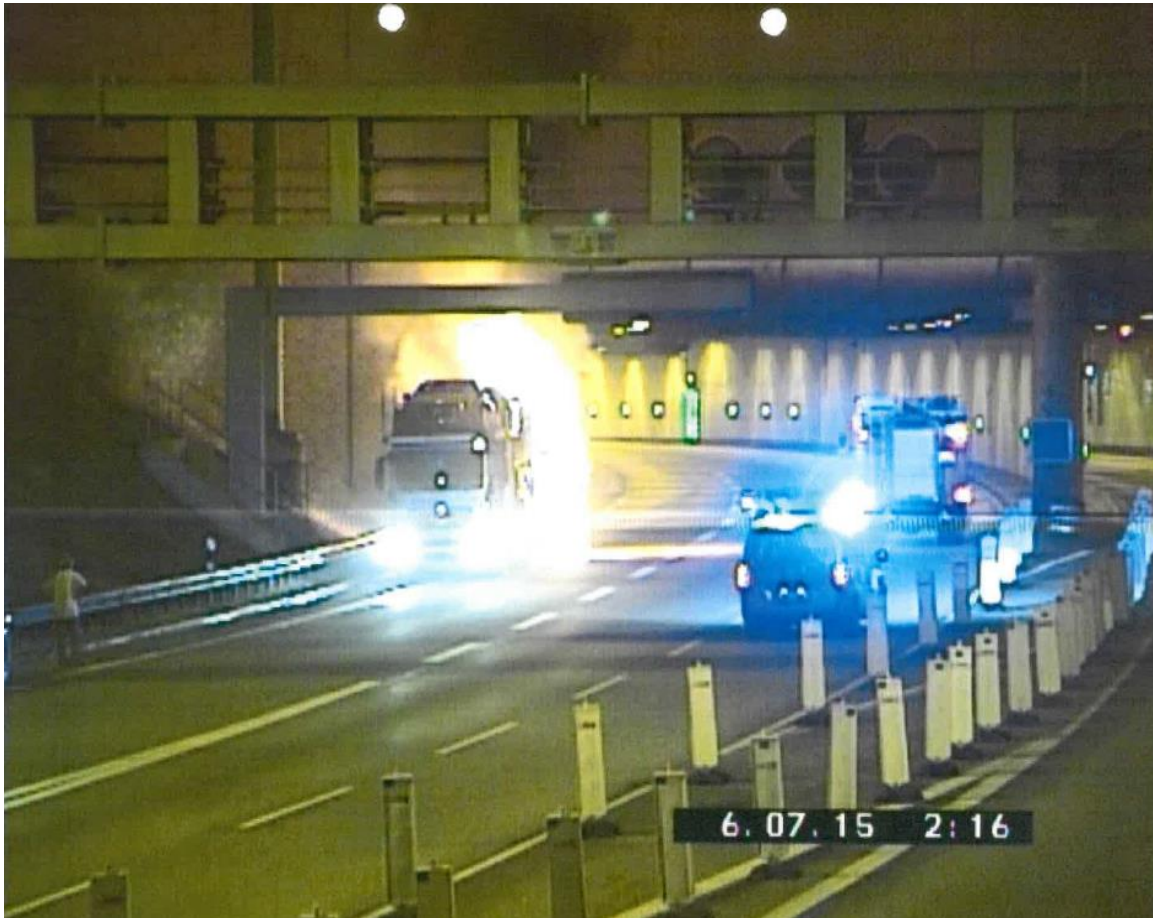
- after 5 minutes fire fighters and police arrived at the scene

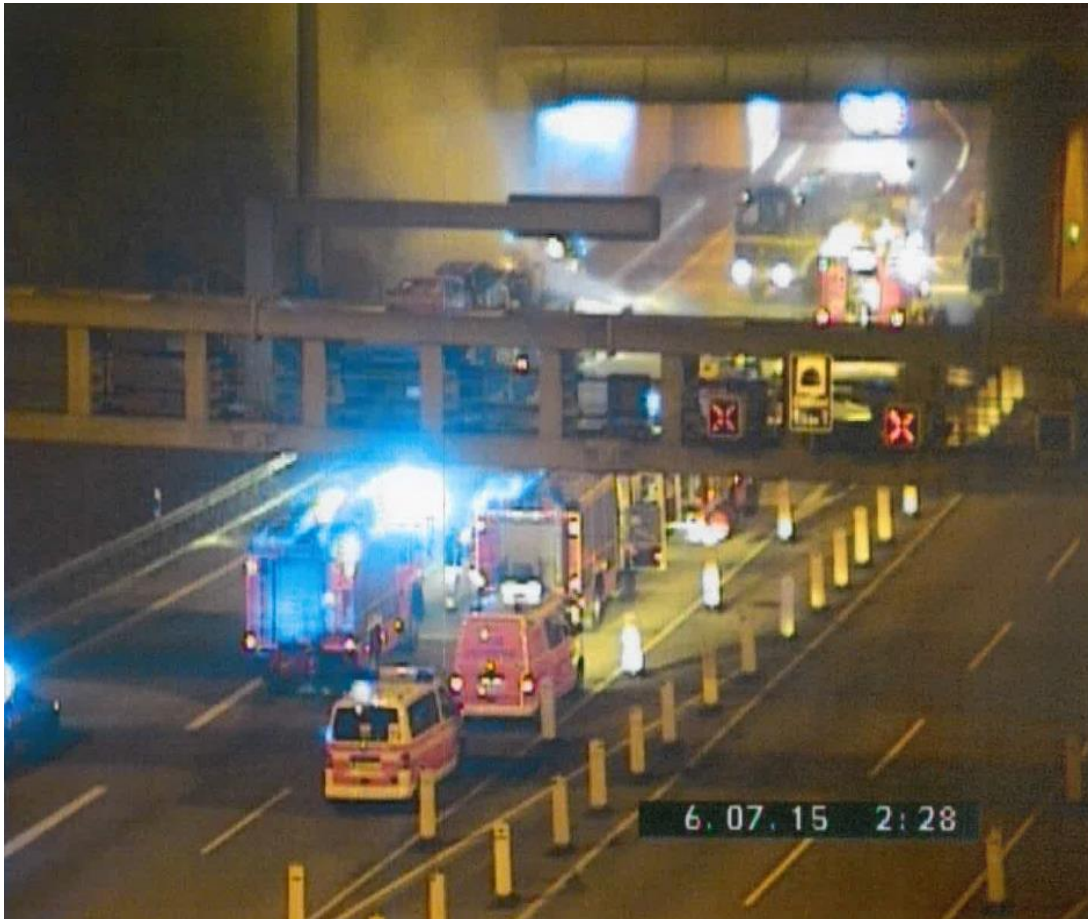
- additional forces at the scene
- 35 minutes after alert the fire was extinguished
