Control Panel Message Document (CPMD)

HP Color LaserJet Enterprise M855, flow MFP M880

This document provides error-code troubleshooting information

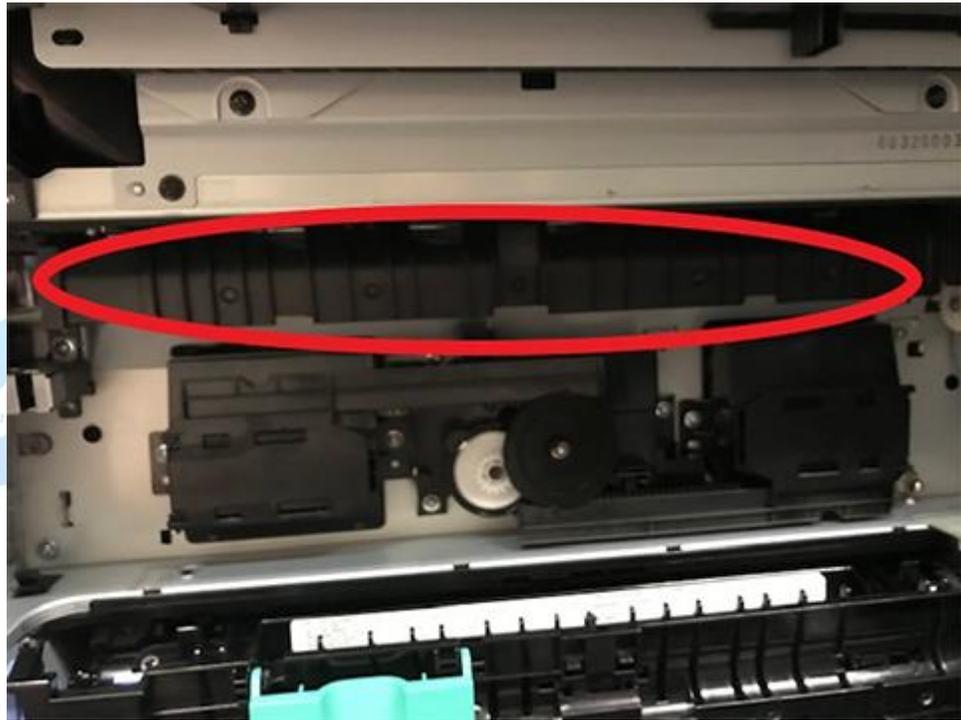
1. Open the right door and clear the paper that is stuck inside the printer.
2. Check the printer engine for a missing cover. Show in the following image.

Missing cover

3. If this cover is missing, escalate to the GBU to try to get a replacement from a parts engine.
4. If the cover is present, close the door to allow the printer to attempt to clear the jam.
5. If the error persists, check the entire printer for any paper present in the paper path and remove it.

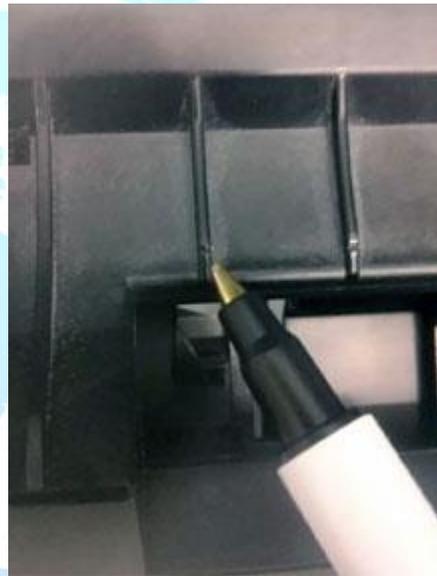
Part number: RM1-9644-000CN

- c. If this damage is seen on the ribs, replace the MP paper pickup assembly that contains the affected rib or ribs.

Close-up of small cracks or nicks on two ribs

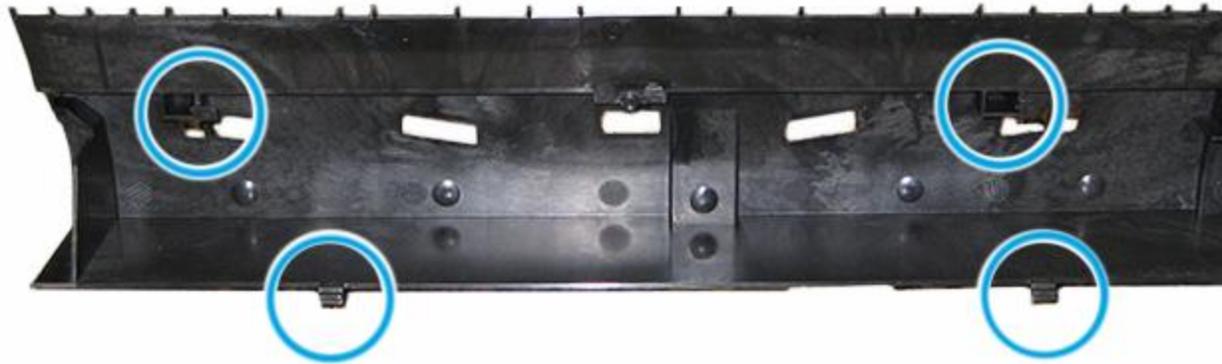
- With the exit guide removed, check the tabs on the guide. If any of these tabs are broken, elevate the issue using the Standard Support Process.

Exit guide tabs

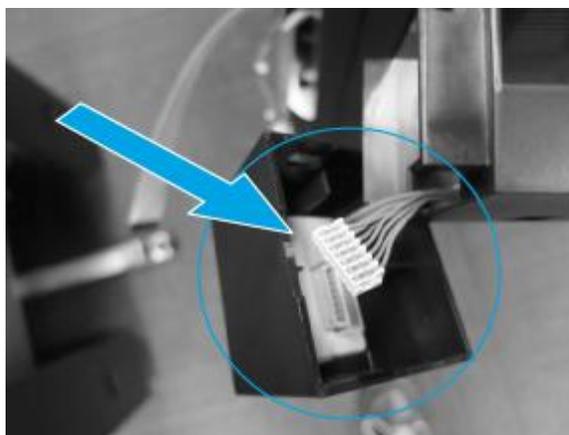
Connector disconnected

- a. Push in on the tab to release the connector housing.
- b. Check to ensure that the connector is not loose or disconnected.

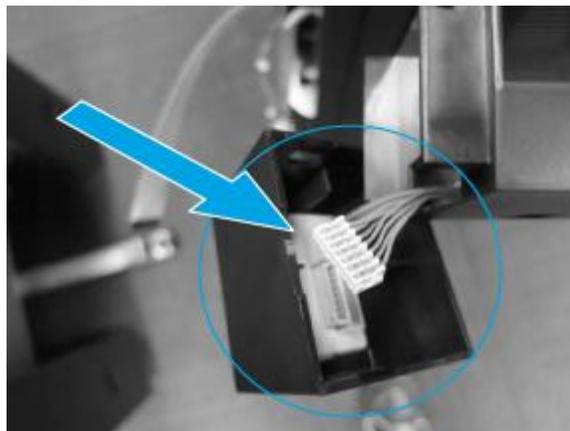
Connector disconnected

- b. Check to ensure that the connector is not loose or disconnected.

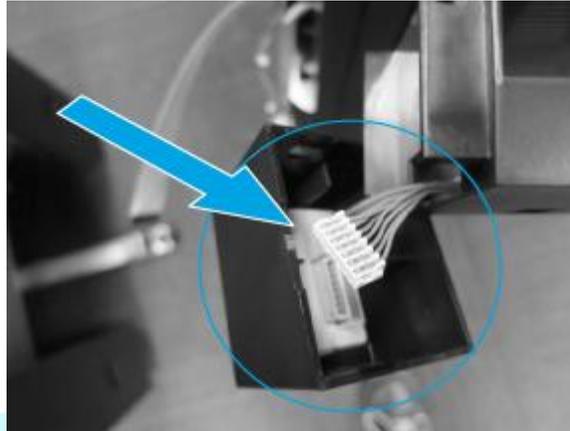
Connector disconnected

- b. Check to ensure that the connector is not loose or disconnected.

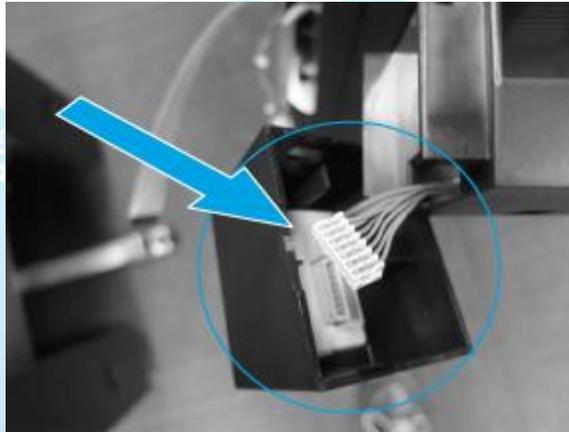
Connector disconnected

- c. Ensure that the connector is not loose or disconnected.

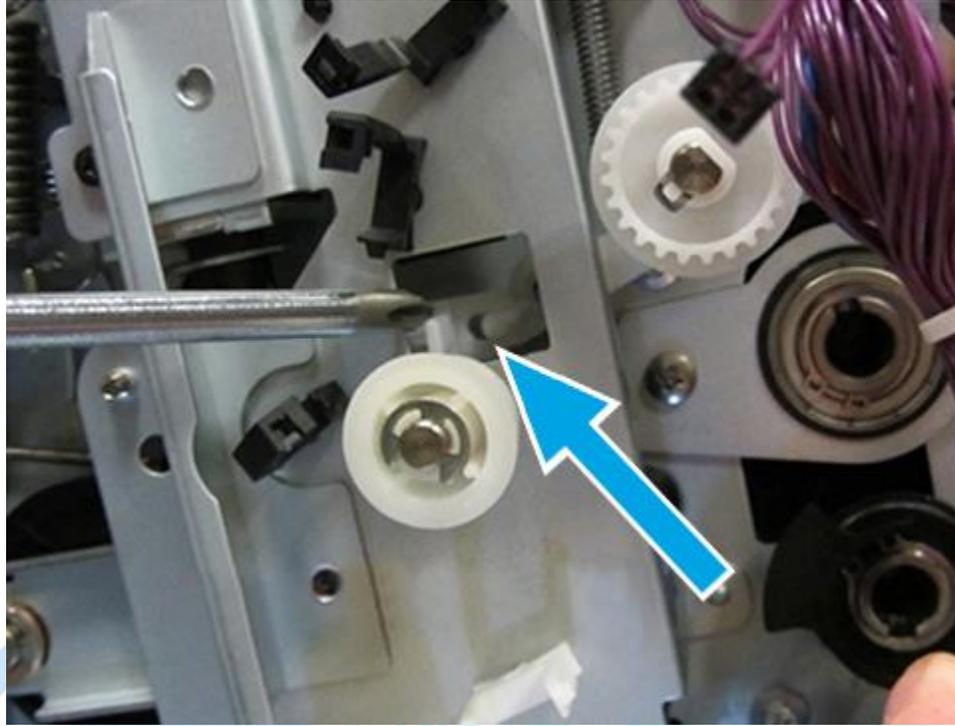
Tension spring loose and white arm in incorrect position

- f. If the pin is not in the correct position, rotate the arm clockwise so that the arm pin is between the plastic fork, then reattach the tension spring.

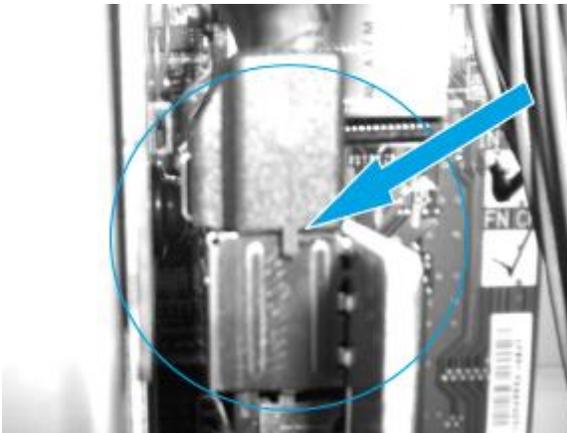
USB not connected correctly

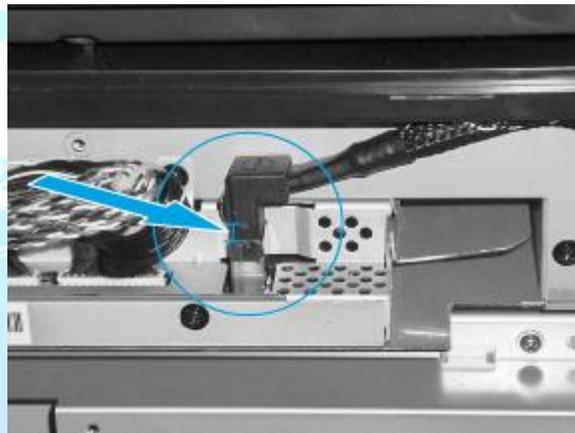
SCB USB not connected correctly

8. Check the USB connection on the engine and the SCB (a loose or poorly seated connection can cause this error).

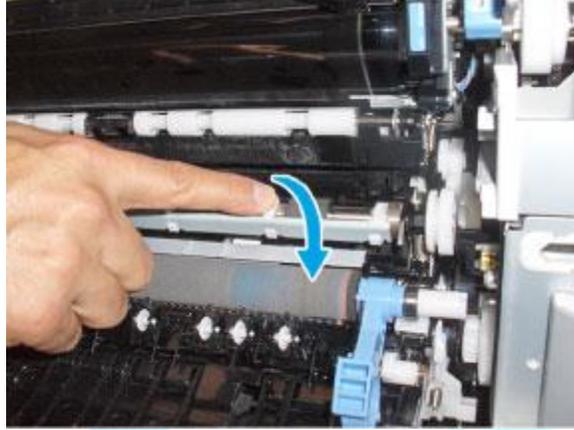
Pull down the deskew shutter to check the spring operation

5. If the spring is damaged, then replace the secondary transfer unit assembly.
