46<sup>TH</sup> TURBOMACHINERY & 33<sup>RD</sup> PUMP SYMPOSIA  
HOUSTON, TEXAS | DECEMBER 11-14, 2017  
GEORGE R. BROWN CONVENTION CENTER

## Bearing wear in electric motors and rotating equipment under the aspect of VSD converter operation

### Hans Tischmacher, Ph.D.

Senior Engineer  
Siemens AG  
Nuremberg, Germany

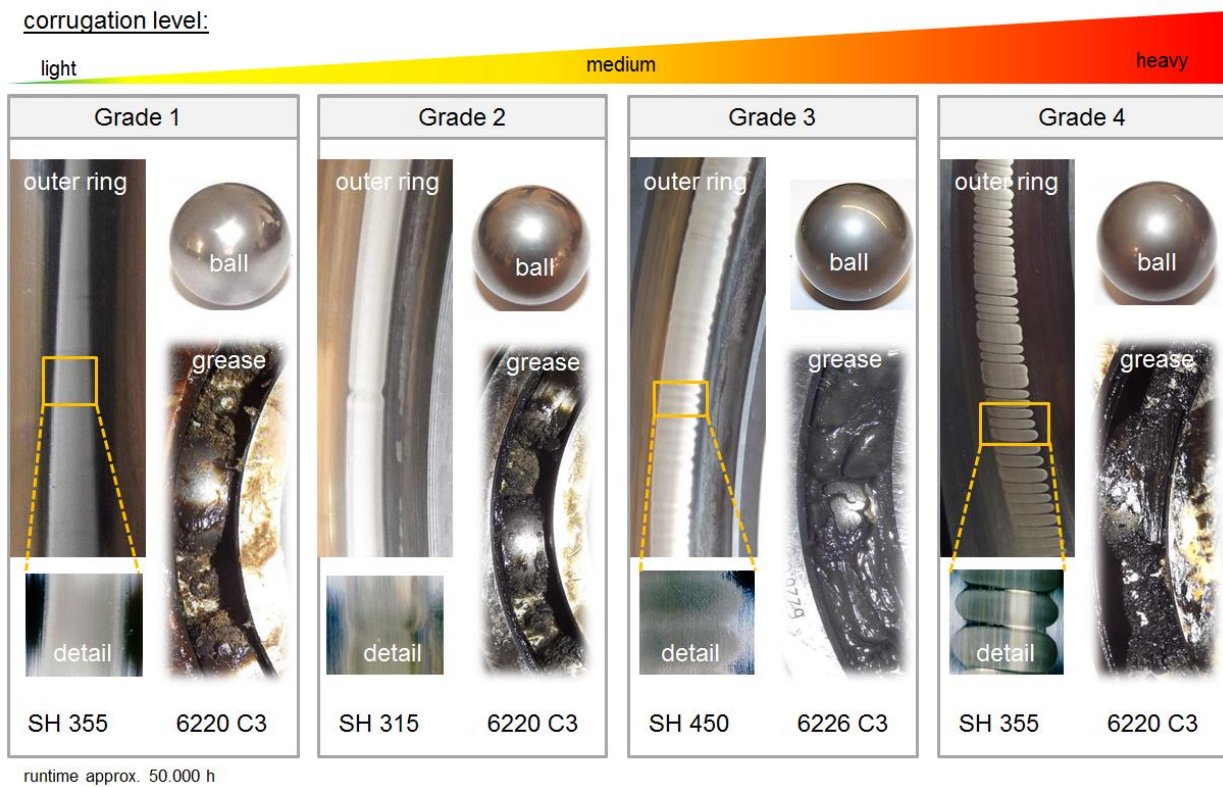
**Figure 2** Different grades of bearing damages

Figure 2 shows different shapes of roller bearing damages in various grades. This is based on macroscopic images of the outer raceway, the balls and the lubricants of different roller bearings, which have been operated approximately 50,000 h in motors of different shaft heights. Starting from the arising, initially slight ripple formation (Grade 1), the transition to the strong or heavy ripple formation (Grade 4) is shown in three steps. Grade 1 still shows, similar to the frosted surface depicted in Figure 1, a sequence of a multitude of small melting craters (see SEM image, Figure 1 b). Here, the frosting is an optical impression which can be attributed to a change in light scattering, induced by the summation of the melt craters. In the case of the damage of Grade 1, the first indications (shades) of an emerging crosswise ripple formation visible. In this phase, the lubricant already shows the typical black discolorations, which become perceptible with increasing degree of damage. From Grade 2 to Grade 4 an increasing crosswise ripple formation (fluting) becomes visible. Likewise, the black coloration of the grease clearly indicates the influence of an electrical bearing load.

Broadband measurements as shown above, have only little significance with regard to early detection of damages. Frequency-selective methods facilitate – besides localizing of the damage location – also the classification of the extent of damage. Especially the envelope curve technique is due to its very good signal-to-noise ratio an effective means to evaluate the mechanical bearing status during real plant operation. On the basis of empirical values out of a multitude of measurements on site, it is possible to define areas for the maximum amplitude of the spectral components of the vibration acceleration  $\hat{a}_{\text{Spek}}$ , which correspond to the levels of damage from ripple formation depicted in Figure 2. These values are summarized in the following table.

The precise evaluation of the mechanical bearing status is only possible by frequency-selective analysis methods. Particularly the early detection of corrugation can be achieved by applying the so-called envelope curve analysis on the basis of vibration acceleration values at the bearing location to be considered. All broadband values reveal alterations of the bearing status only very much delayed. The assessment of the current bearing condition can be performed by comparing the measuring values with those limit values given in Table 3 whether appropriate correlation to the actual damage level according to the possible grades of corrugations presented in Figure 2.

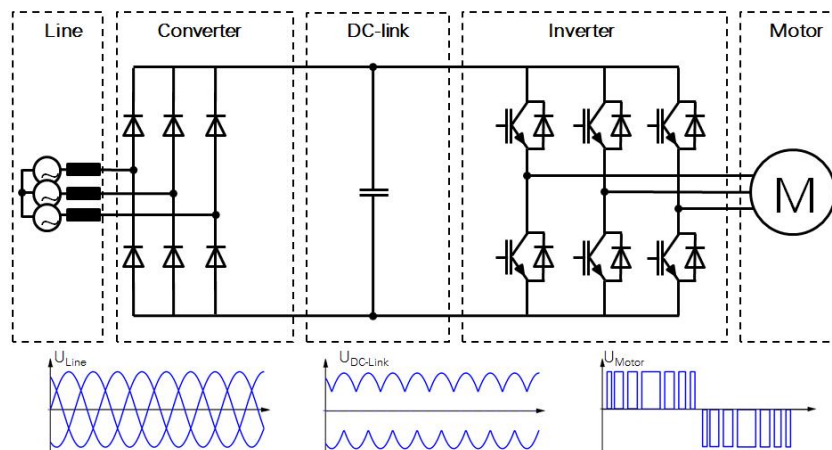
**Figure 3** Schematic diagram of a voltage source inverter (VSI)

The converter transforms the input voltage from the supply, which is, as a first approximation, constant in amplitude and frequency, into a variable voltage in frequency and amplitude. For that purpose, a rectifier unit is feeding a DC voltage link, in which DC link capacitors act as voltage smoothers and energy storage. The subsequent inverter transforms the DC link voltage with the procedure of pulse-width modulation into a variable AC voltage. In this way, the connected electrical motor can be controlled in terms of speed and torque.

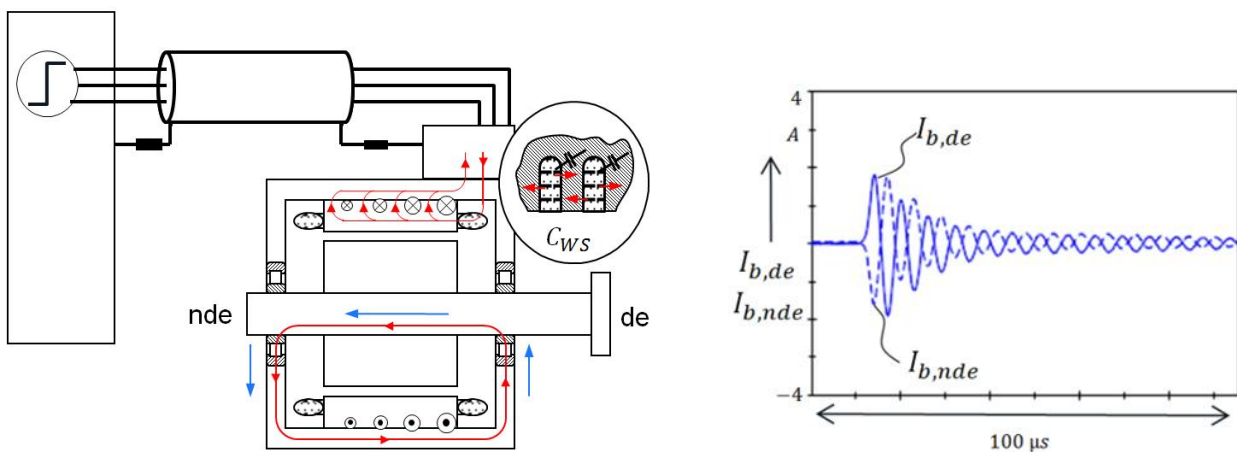
Figure 8 To the formation of circulating currents

In contrast to the EDM bearing currents, the circular currents, depicted in the left part of the equivalent circuit diagram in Figure 5 has a crucial influence – in form of the parasitic capacity between winding and stator lamination  $C_{ws}$ . The high-frequency common mode current which is flowing off via the slot insulation, induces a circular magnetic flux, which encircles the shaft of the motor. The voltage induced by that flux into the shaft of the motor causes a high-frequency circular current, which closes over: laminated core – bearing shield – motor bearing – shaft. In contrast to the classical circular bearing current according to [11], which leads to a circular current with motor fundamental frequency due to magnetic unbalances. The circular current caused by converter operation features has a significantly higher frequency. The circumstances are schematically shown in Figure 8 at the left. On the right-hand side, one can find a detailed magnification of the current time plots, measured at both motor bearings. Both current courses show a phase displacement of  $180^\circ$  at identical amplitude and thus they represent a circular current.

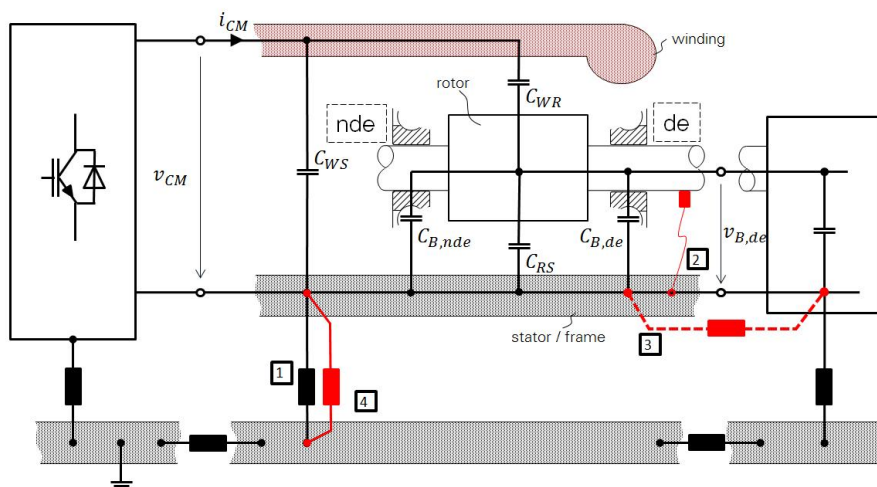
Figure 10 A motor integrated in a drive system

The current flowing from the winding through the capacity  $C_{WS}$  - illustrated in Figure 5 - to the stator core lamination is routed back via the enclosing grounding system to the source – the DC link of the converter. In case, the grounding conditions at the motor are designed in such a way, that a path of low impedance is leading to the shaft of the motor, currents of considerable amplitude can flow via the connection motor shaft → coupling → load. In this way, they can potentially damage electrically passive plant component that are connected to the motor. Thus, the amplitude of the current from rotor to ground is strongly dependent on the quality of the enclosing grounding system. In Figure 10, the conditions are illustrated that are originated by the extension of the HF equivalent circuit diagram depicted in Figure 5. Here, the capacities of the motor, the load and the impedances of the enclosing grounding system can be identified.

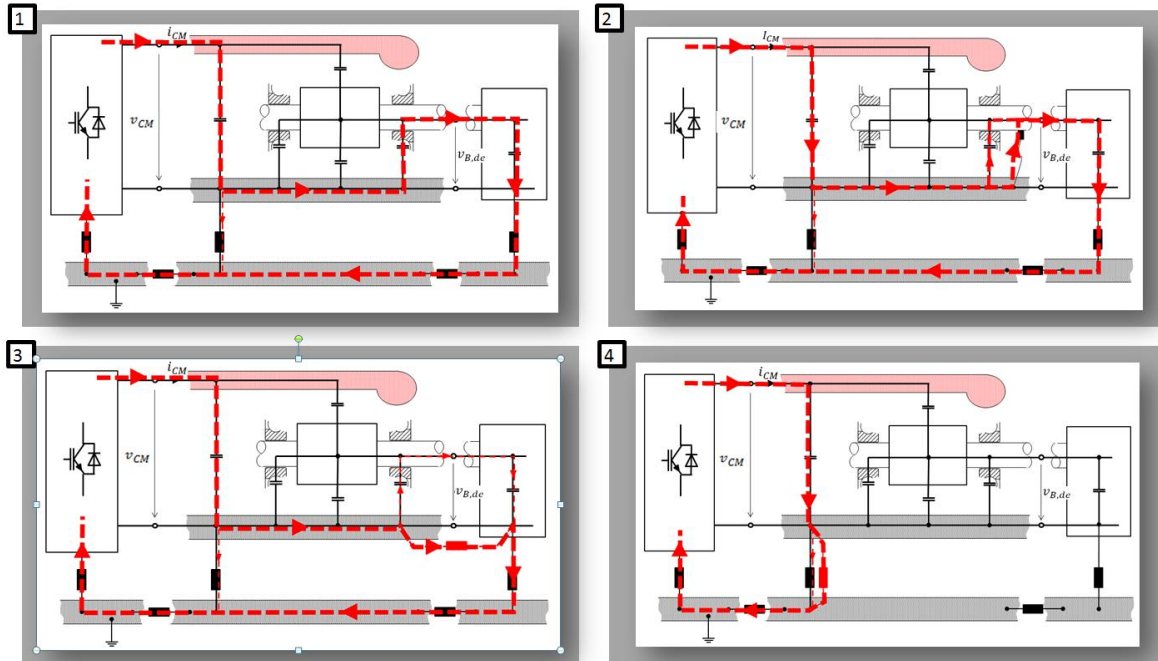
Figure 11 Possible rotor-ground current paths

With regards to the possible rotor–ground current paths and their quality, the four cases depicted in Figure 11 have to be discriminated:

- (1) insufficient HF grounding of the motor (high impedance) and good HF-connection of the load (low impedance)  
→ current rotor–ground ↑↑, bearing NDE bearing ↑↑, current via the load ↑↑
- (2) like (1), but with additional grounding brush on the NDE side  
→ → current rotor–ground ↑↑, bearing NDE bearing ↓, current via the load ↑↑
- (3) like (1), but with additional equipotential bonding between motor and load  
→ → current rotor–ground ↓, bearing NDE bearing ↓, current via the load ↓
- (4) good HF grounding of the motor (low impedance) and good HF connection of the load (low impedance)  
→ current rotor–ground ↓↓, bearing NDE bearing ↓↓, current via the load ↓↓

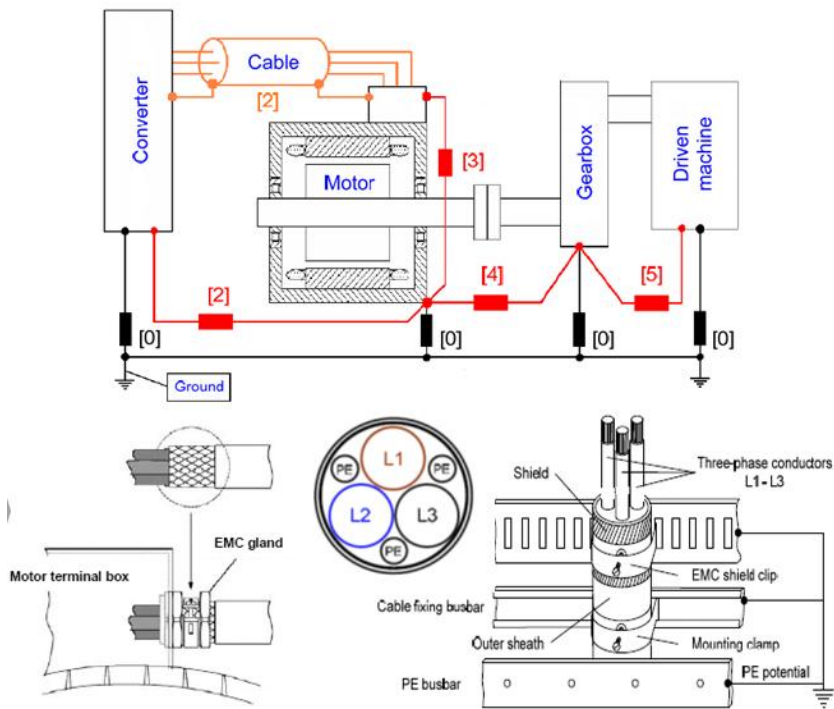
Figure 12 Possible measures to reduce rotor-ground currents

One of the most important measures to reduce rotor–ground currents is the improvement of the impedance conditions [12]. The feasible measures are schematically shown in Figure 12. Summarized, these are:

- ⊕ HF grounding of the components (4)
- ⊕ Use symmetrically shielded motor connecting cables (4)
- ⊕ Potential bonding in the system (3)
- ⊕ Connection through the largest possible surface area (4)

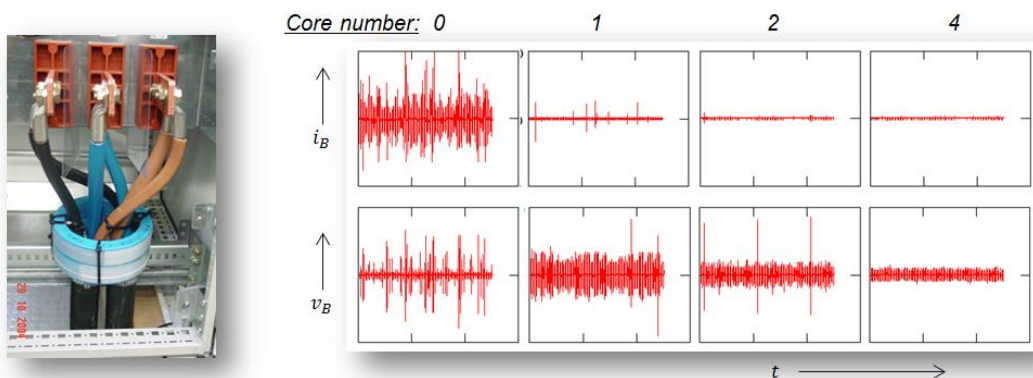
Figure 13 Application of nanocrystalline iron cores at the converter output

Besides the improvement of the impedance conditions, another alternative would be, to install additional common mode inductivities (chokes), in order to reduce the excitation, i.e. the common mode current. [13, 14]. The attachment of nanocrystalline iron cores at the output of the inverter has proven to be a viable solution. For that, the iron cores have to be installed in all three phases (without ground), as shown in Figure 13- at the left. The effectiveness of these additional inductivities is exemplified in the form of measured curves of bearing currents and voltages in Figure 13- on the right side. One can see that the bearing currents are significantly reduced with increasing number of iron cores. The optimum number of iron cores is depending on the selected type of cable, the cable length and the motor power. The effectiveness of the iron cores is limited to high frequencies, i.e. low-frequency components in the common mode current will result in a magnetic saturation of the iron cores. These low-frequency components can arise e.g. from unsymmetrical motor cables or single conductor arrangements. Magnetic saturation can result in an almost complete neutralization of the effectiveness in the high-frequency range. With respect to the previously described EDM currents, the iron cores are not effective at all.

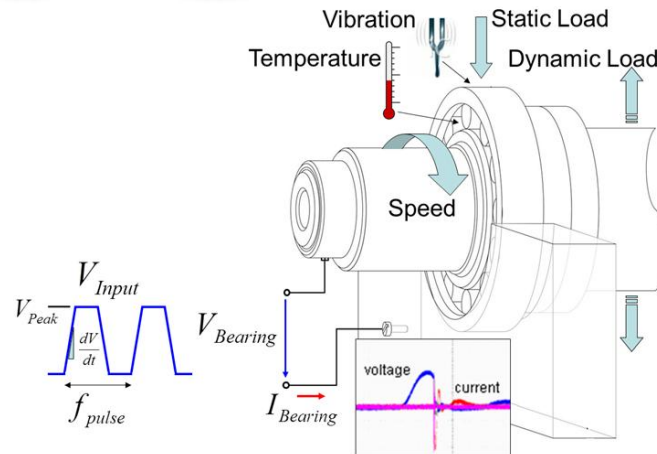
Figure 17 Bearing current test stand according to [8, 10]

The bearing test stand shown in [8, 10] allows parameter tests to be performed with various relevant bearing types and sizes. In addition to the electrical operating parameters – such as bearing voltage and current – there are especially the mechanical parameters that can be changed separately. The range of the parameter settings is based on the field- and system test experience. Speed, temperature, load and vibration level at the test bearing can be adjusted – the last two regarding amplitude and frequency. An open-loop and closed-loop measuring control system allows closed-loop controlled operation where all of the relevant data can be simultaneously acquired. A schematic diagram of this test stand is shown in Figure 17. The test bearing is connected to the drive unit through the shaft and an insulated coupling. This allows any speed points and profiles to be set. A defined, steady-state radial load can be applied to the bearing system using a loading bearing. Dynamic load components are introduced into the system using an unbalance disk as well as an inertial shaker. The bearing temperature is kept at a constant value using heating cartridges.
