Evaluation of the Debris Throw from the 1992 Explosion in the Steingletscher Installation in Switzerland

Peter O. Kummer
dipl. Ing. HTL/SIA, EUR ING
BIENZ, KUMMER & PARTNER LTD, Langägertenstrasse 6
CH-8125 ZOLLIKERBERG, SWITZERLAND
Tel: int 41 1 391 27 37 FAX: int 41 1 391 27 50

On 2 November 1992 a detonation with an approximate force of 225 tons of TNT happened in the Steingletscher ammunition and explosives storage installation in Switzerland. Six people lost their lives in this accident. The installation was destroyed completely, the rock cover above the underground chamber broke off and rock as well as concrete pieces were thrown over a wide range into the surroundings.

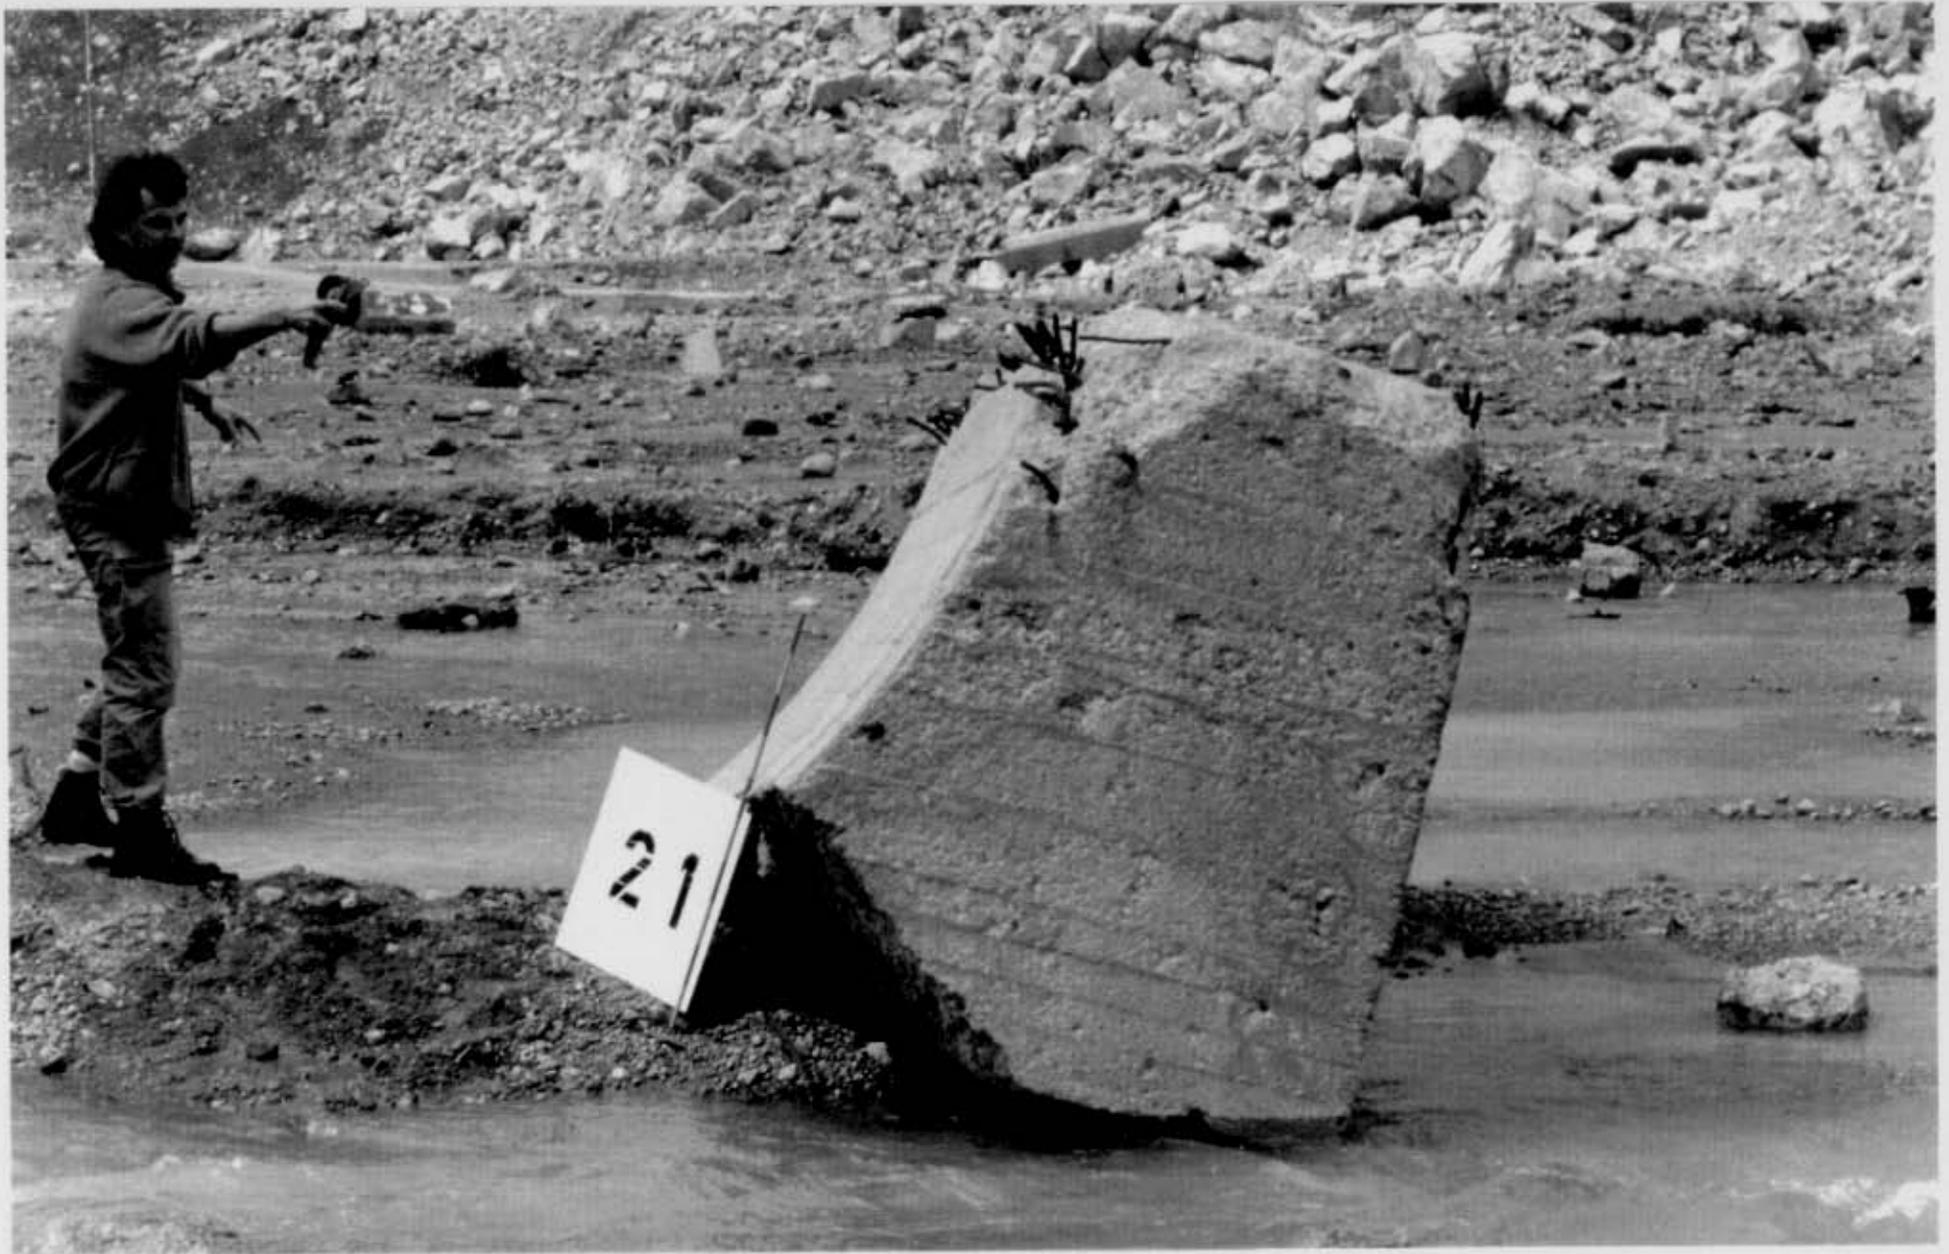
Figure 7

**Concrete Block from Entrance Building
Weight 15 tons, 370 m from Original Place**

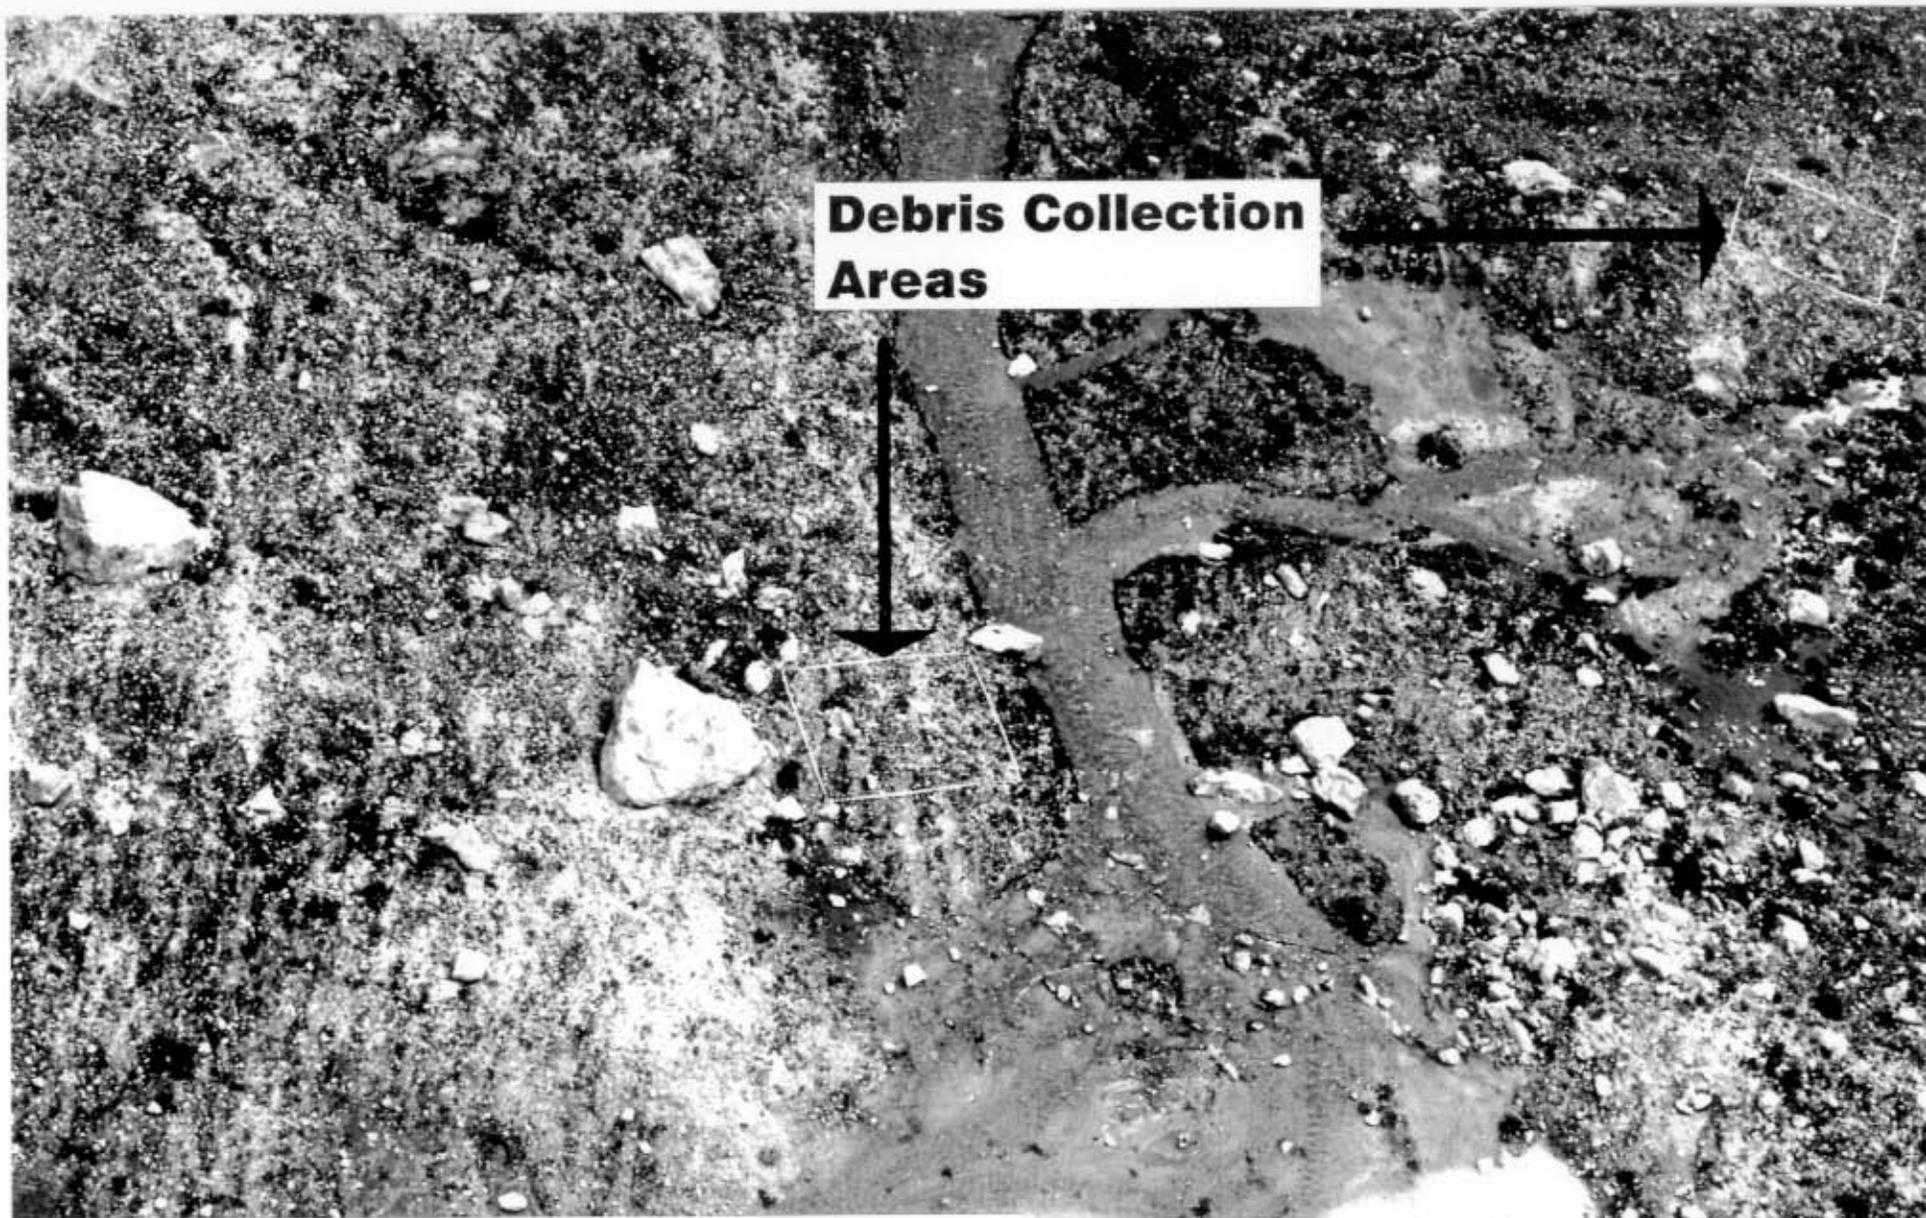
1. First of all, suitable debris areas showing a characteristic debris distribution had to be selected. This was quite a difficult task as "new" debris had to be found in a desert of stones. In the end however, it was easier than expected as the shape of the crater debris, the vegetation under them at the place where they were found and the "clean" debris surface - without any lichens on it - made a distinction possible. Figure 8 shows two of the chosen fields.

Debris Collection Areas
Foreground Debris No 21 (Figure 9)

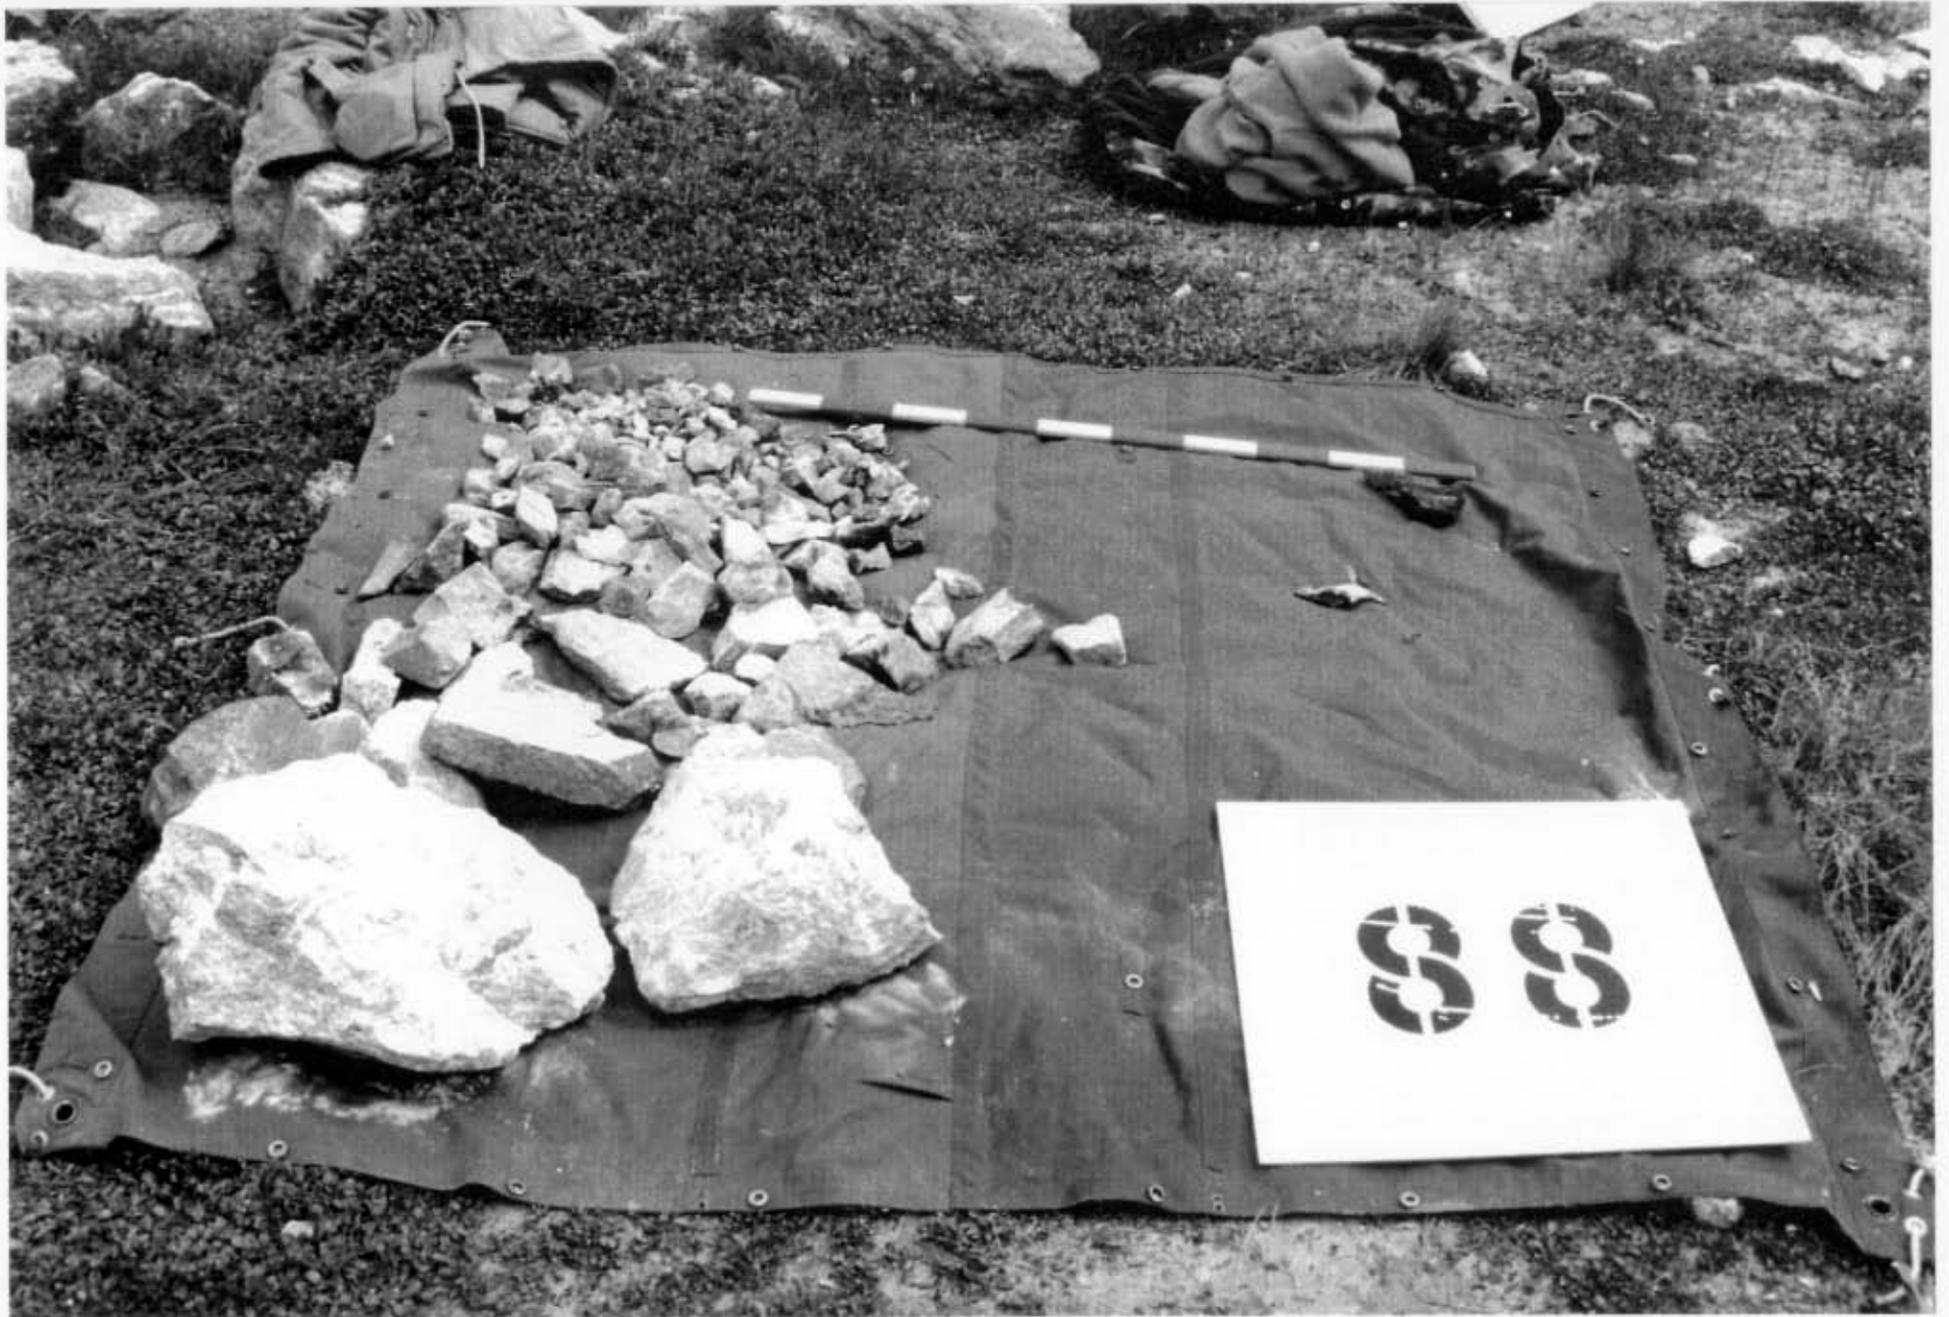
3. At last, all debris were collected, sorted out for different materials (rock, concrete, metal parts etc.) and according to their size. Figure 10 shows an example. The debris were counted and weighted. Back in the office, for each debris field a data sheet showing all details was elaborated and, as a first step of the evaluation, the debris density in kg/m² was defined (fig. 11). Figure 12 gives an overview of the data of all debris fields.

Debris from a "Collection Area"
