Baseline Ecological Assessment of Artificial Reef, High Island A-389-A: Pre- and Post-partial Structure Removal

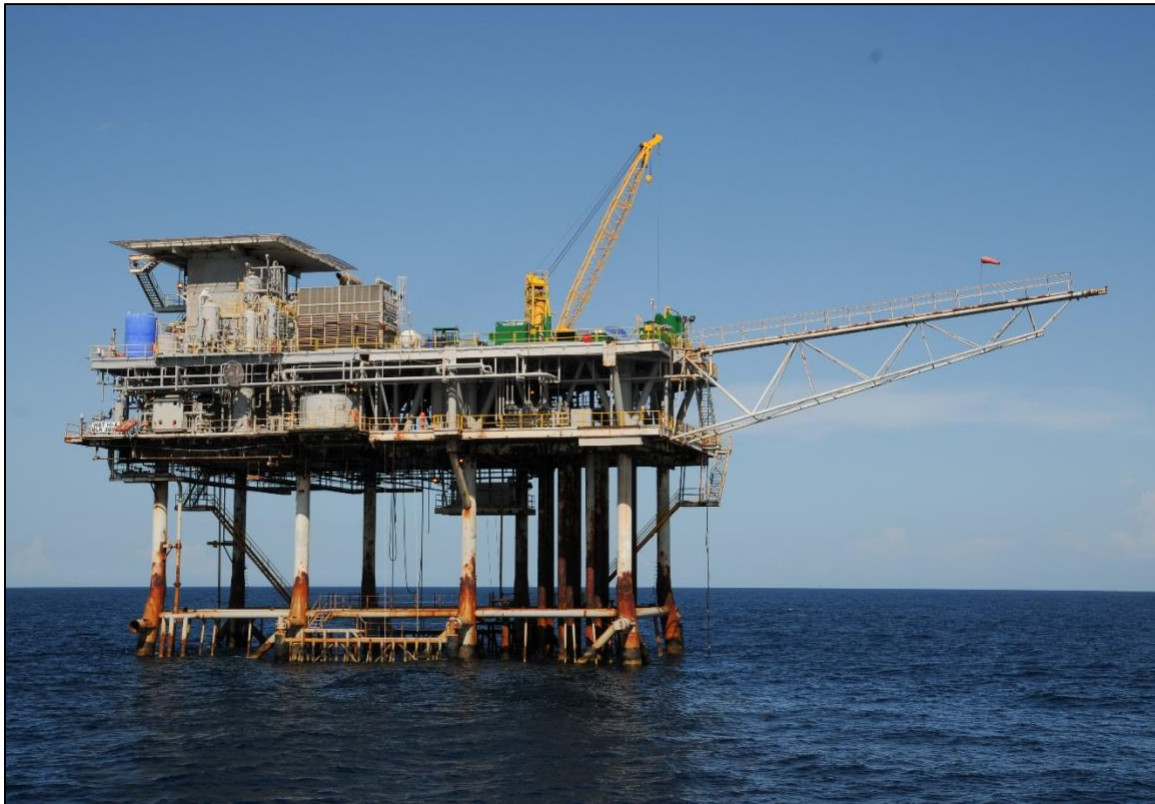
Figure 1.1. HI-A-389-A, an oil and gas production platform located in the northwestern Gulf of Mexico. Photo: G.P. Schmah/NOAA

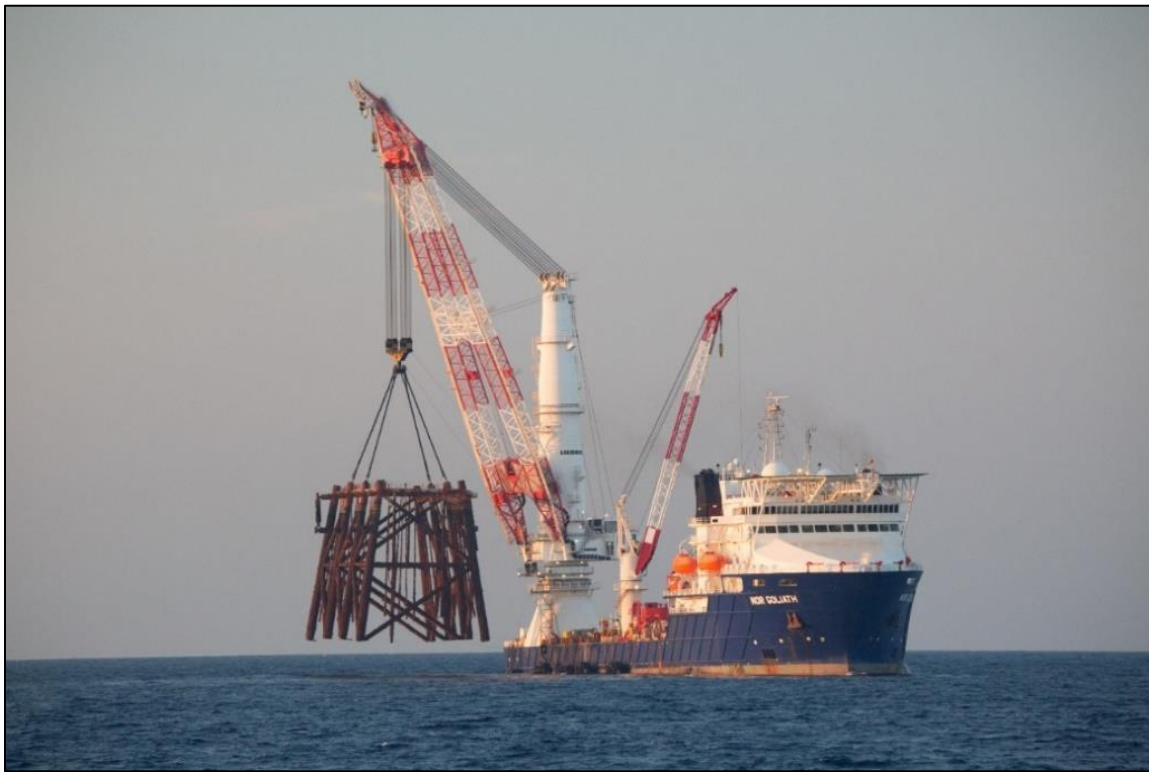
Figure 1.4. Dynamic positioning vessel *Nor Goliath* lifting the top section of the platform's underwater structure in July 2018. Photo: G.P. Schmahl/NOAA

In 2014, W&T Offshore, Inc. negotiated with FGBNMS for the platform to be partially removed and established as a component of the Texas Parks & Wildlife Department (TPWD) Artificial Reef Program. The decommissioning process requires plugging and abandonment of the wells prior to the partial removal process, which involves the removal of the working deck, as well as the top sections of the platform jacket and well conductors. The artificial reef would be held under the liability of TPWD, while liability for pipelines and wells would remain with the respective owners. Significant interest by the public and the Sanctuary Advisory Council led to the sanctuary's willingness to accept this decommissioned platform within EFGB boundaries. Removal of the deck (where oil and gas production occurred) and the top portion of the platform was completed on July 25, 2018 (Figures 1.4 and 1.5). The materials were taken to shore for recycling or reuse.

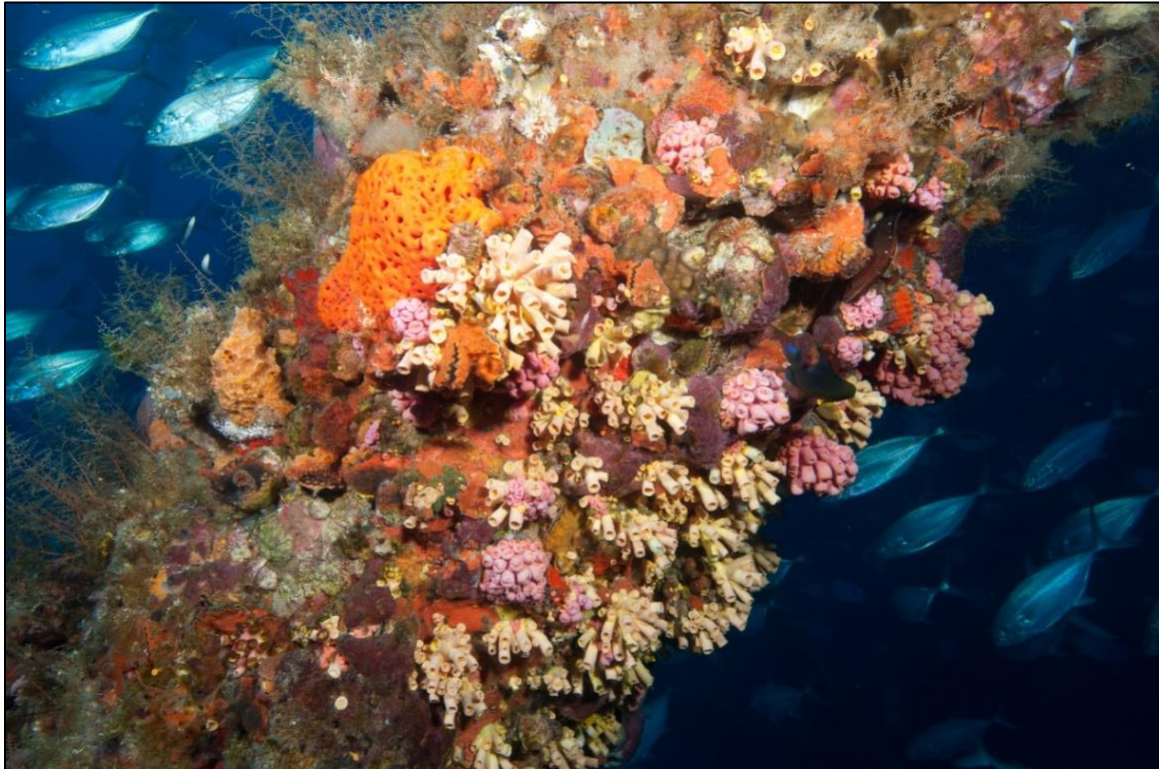
Figure 1.6. Sponges, orange cup coral, and bivalves cover one of the vertical HI-A-389-A platform pilings while a school of blue runner (*Caranx crysos*) swim in the background. Photo: G.P. Schmahl/NOAA

Since installation in 1981, a diverse array of fouling and encrusting organisms have colonized the underwater vertical and horizontal platform pilings. The platform is covered primarily with sponges, hydroids, macroalgae, bivalves, barnacles, tunicates, zoanthids, and a few stony coral species (Embesei et al. 2013). Orange cup coral (*Tubastraea* sp.), an exotic species, is the most abundant species of stony coral colonizing the platform (Figure 1.6).

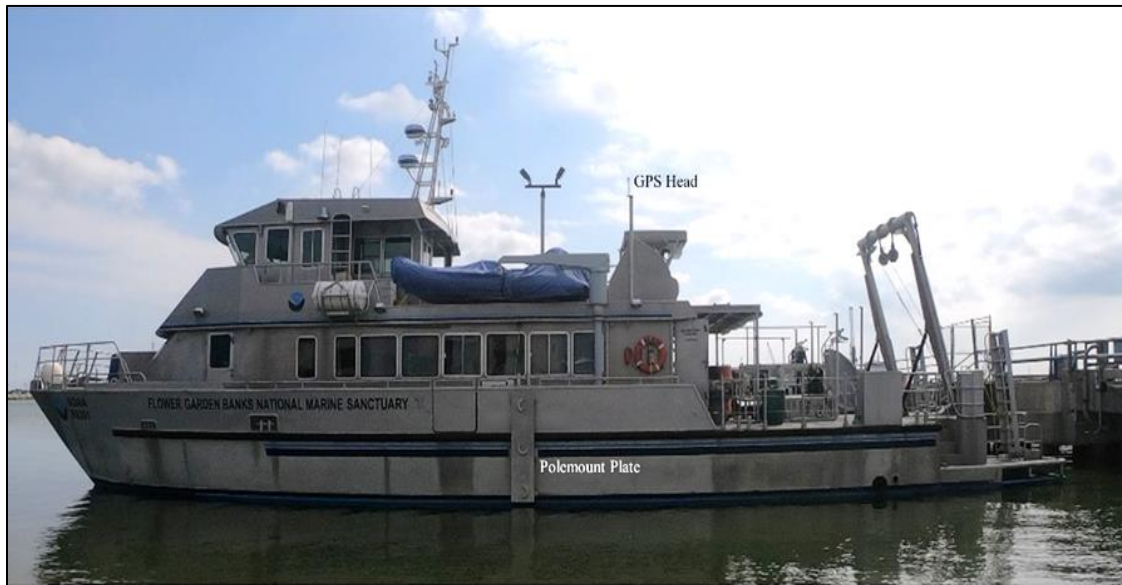
Figure 2.2. R/V *Manta* polemount and GPS antenna head location used for fishery acoustic surveys.
Photo: NOAA

Transducers were deployed over the side of the R/V *Manta* using an overboard pole secured to the starboard side of the vessel (Figure 2.2) to document fish densities in the water column surrounding the platform. The Simrad EK60 and EK80 split beam echosounder system operated at a frequency of 38 kHz (only pre-survey) and 120 kHz (pre- and post-survey). The transducers were oriented downward with a nominal beam geometry of 12° and 7°, resulting in a swath width across track of approximately 20% and 12% of the range, or 20 m and 12 m at 100 m depth, respectively (Figure 2.3). A survey of the R/V *Manta* was conducted for precise offset relative to the vessel's Furuno GP-32 GPS antenna and location of the pole mount, which resulted in accurate positioning and visualization of all water column targets, such as fish and the subsurface platform structure.

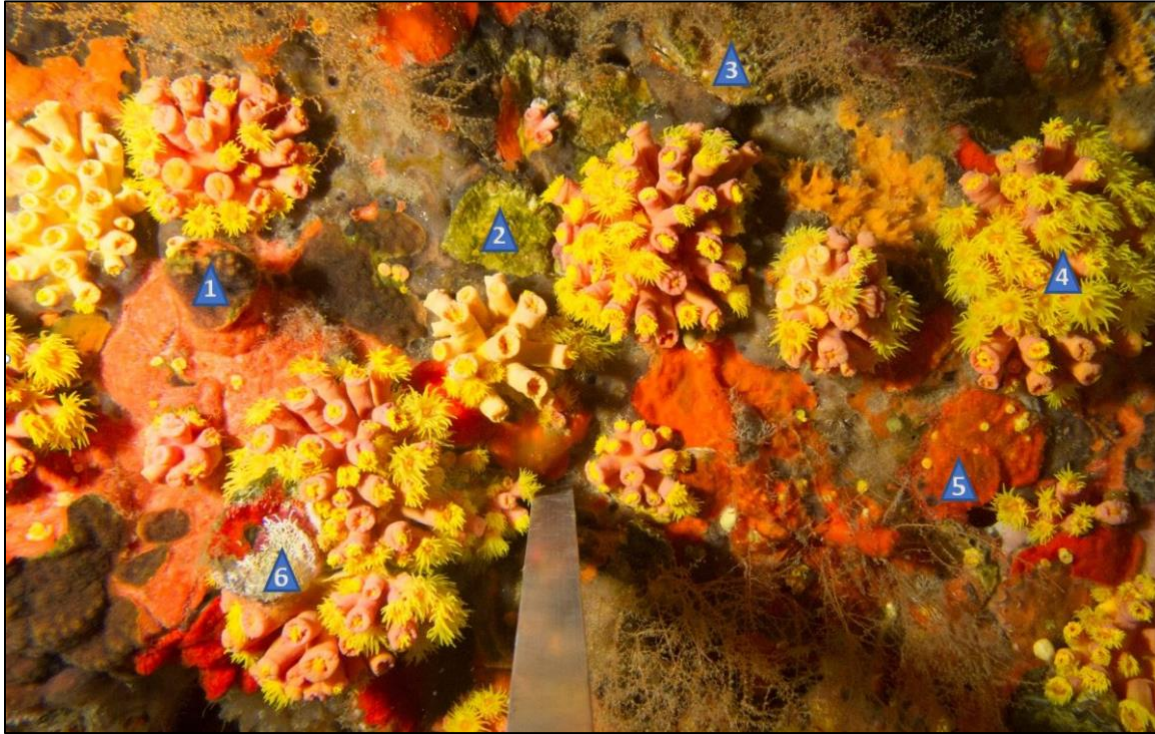
Figure 2.8. Benthic organisms in photo transect image used for CPCe analysis. Photo: John Embesi/CPC

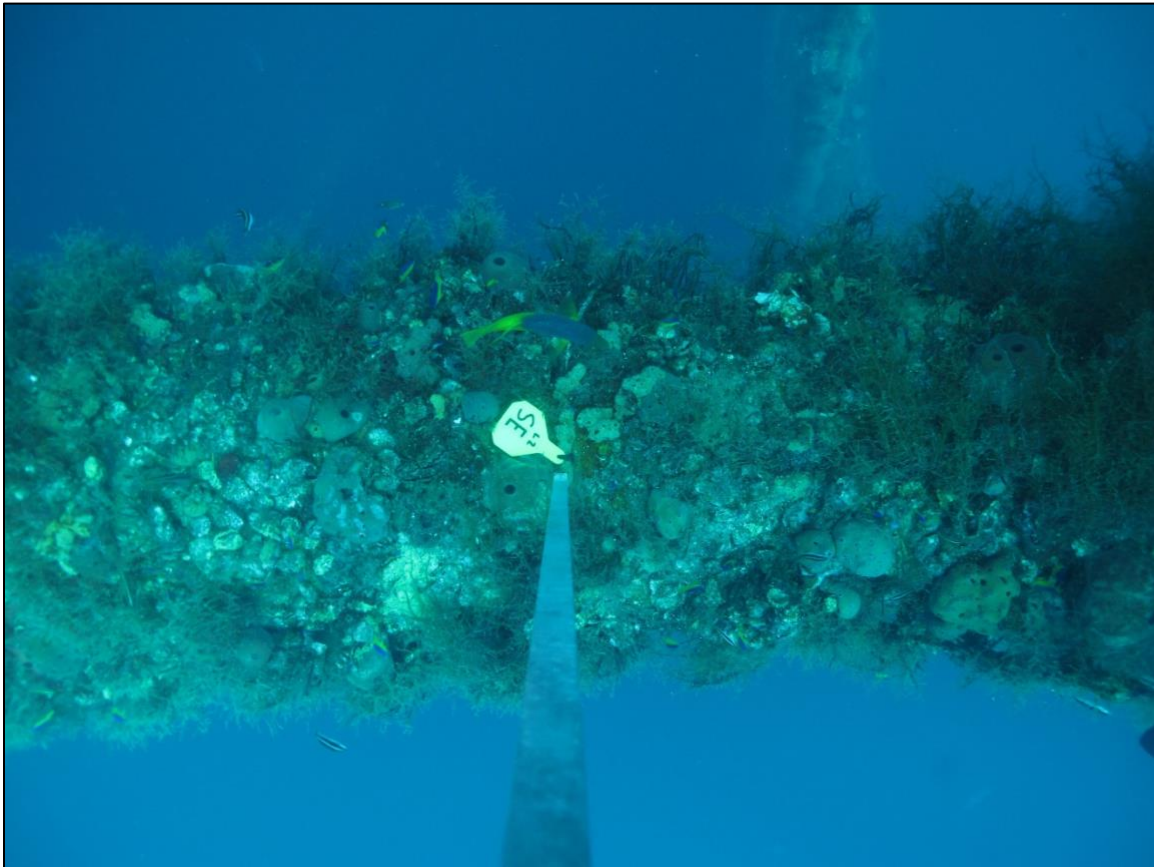
Figure 2.10. Repetitive photostation with camera mounted above aluminum t-frame. Photo: NOAA

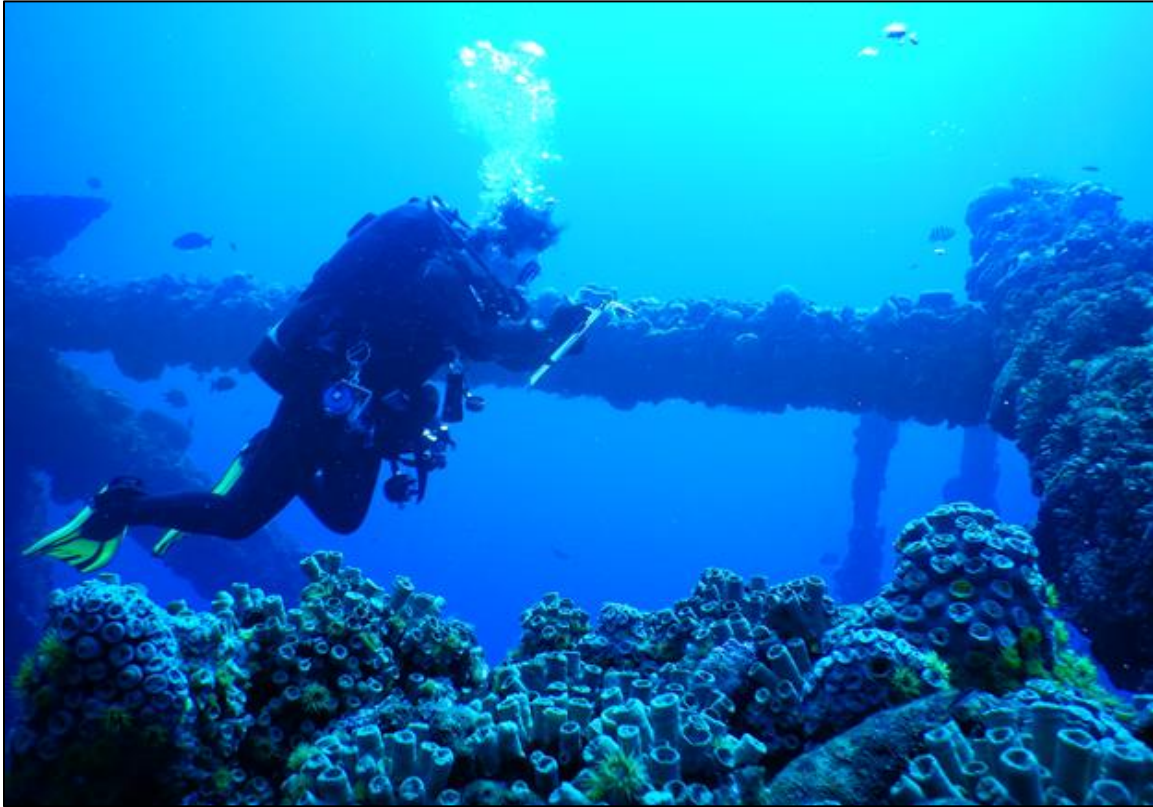
Figure 2.11. Diver conducting roving diver fish survey at HI-A-389-A. Photo: Marissa Nuttall/CPC

Roving diver surveys were conducted at each horizontal level and included a portion of horizontal supports (H), vertical supports (V), and diagonal supports (D). Surveys were patterned in a non-repeating fashion so that new areas were covered throughout the survey. The standard roving diver technique (RDT) (Schmitt and Sullivan 1996), where a diver swims freely throughout the dive area, recording every observed fish species and its approximate abundance (single, few 2-10, many 11-100, and abundant >100), was used with the following exceptions: divers stayed on the same level throughout the survey, and the ceiling limit for the survey was one meter below the next higher level (Figure 2.11). Fish observed on a horizontal cylinder structure and one meter below were counted. RDT surveys were standardized at 10 minutes in length. A total of 33 surveys conducted on H1, H2, and H3 were completed during the pre-removal scuba cruise, and a total of 18 were completed in the water column on H1, H2, and H3 during the post-removal scuba

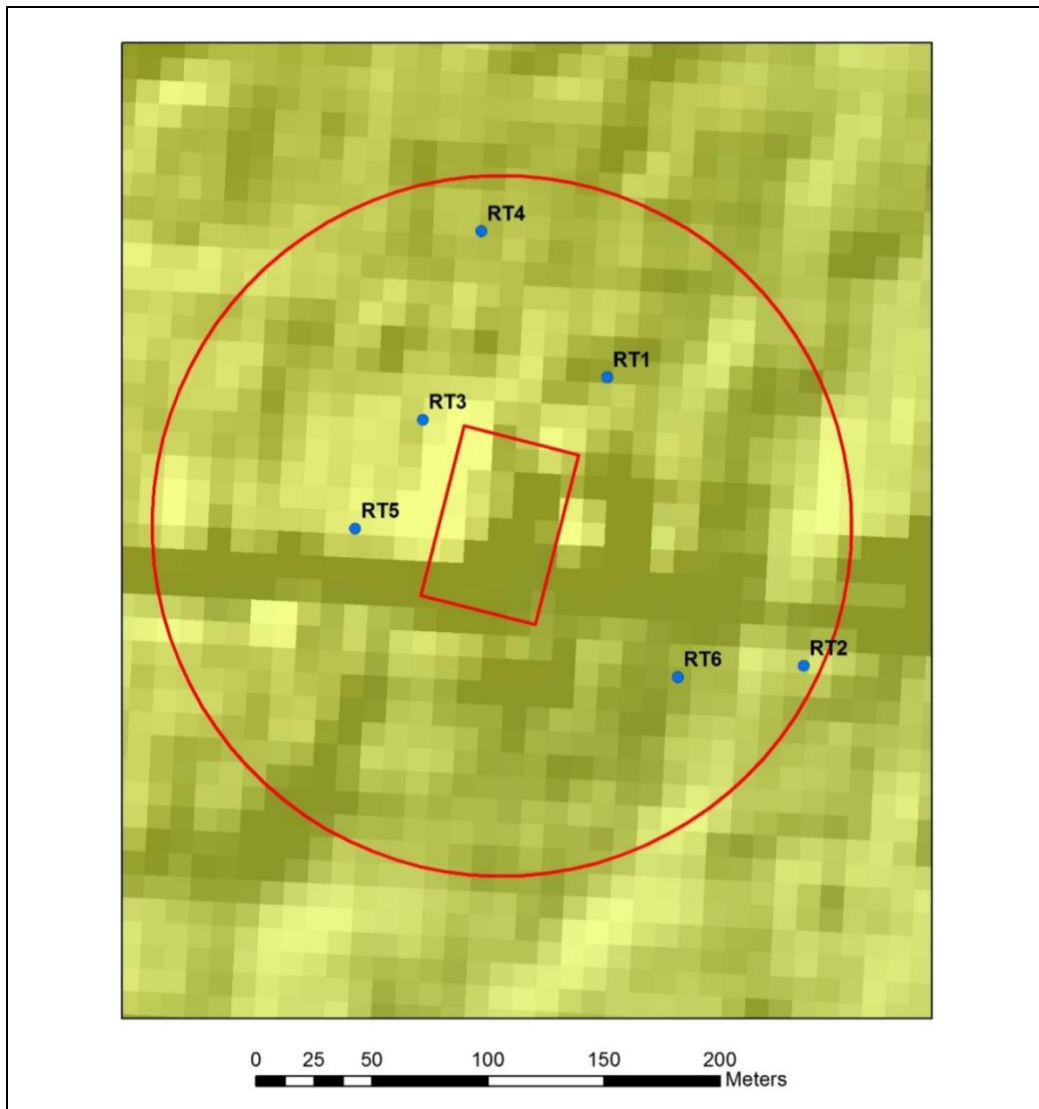
Figure 2.14. Locations of random photographic benthic transects (RT1-RT6) completed on the seafloor during the ROV pre-removal cruise at HI-A-389-A. The red square represents the base of the platform and the circle represents the 150 m survey radius. Image: John Embesi/CPC

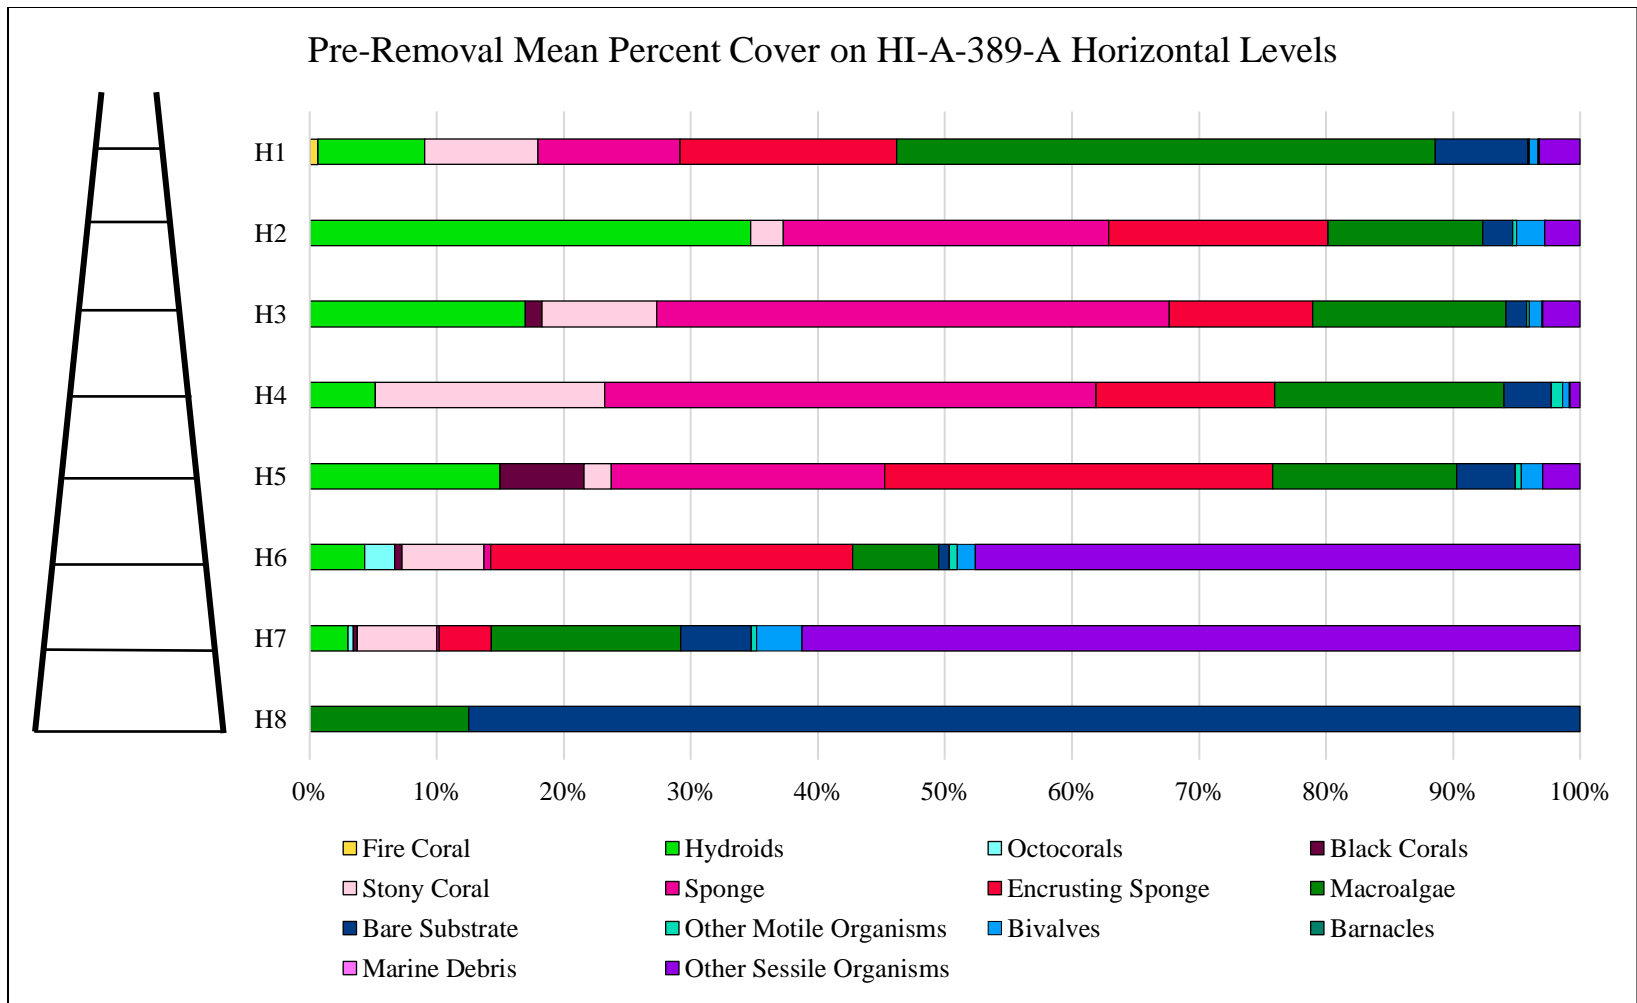
Figure 3.1. Percent composition of benthic cover groups per horizontal level (H1-H8) identified in CPCe pre-removal analysis. The outline of HI-A-389-A to the left of the stacked bar graph helps to visually represent the depth delineations of the horizontal beams below the surface: H1 (9 m), H2 (22 m), H3 (37 m), H4 (52 m), H5 (72 m), H6 (91 m), H7 (108 m), and H8 (125 m).

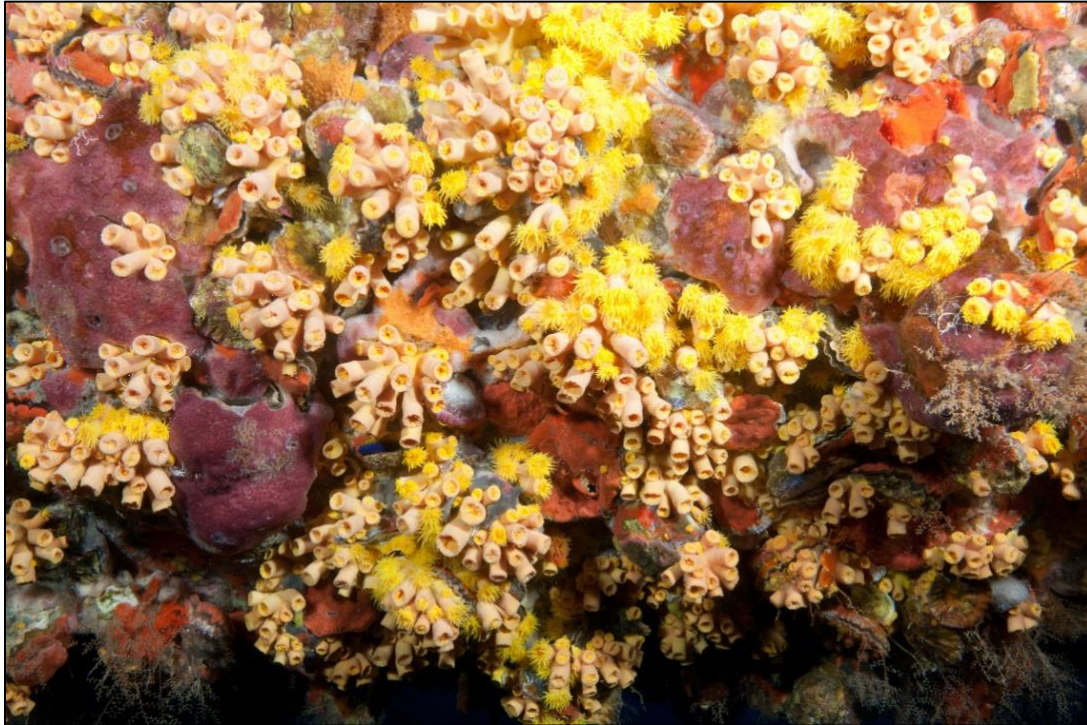
**Figure 3.2.** *Tubastraea* sp. on HI-A-389-A. Photo: G.P. Schmahl/NOAA

Stony corals (Scleractinia that build hard skeletons) were found on levels H1 to H7, but were most abundant on H4, due to the percent cover of orange cup coral (*Tubastraea* sp.) (17.98 \pm 3.77%) (Table 3.2). It is important to note that *Tubastraea* sp., an invasive ahermatypic cup coral native to the Indo Pacific, was the most abundant coral species observed from H1 to H5. Very few native coral species, such as ten-ray star coral (*Madracis decactis*) (found from H1 to H3) and symmetrical brain coral (*Pseudodiploria strigosa*) (H1 only), were detected on the structure (Table 3.4).

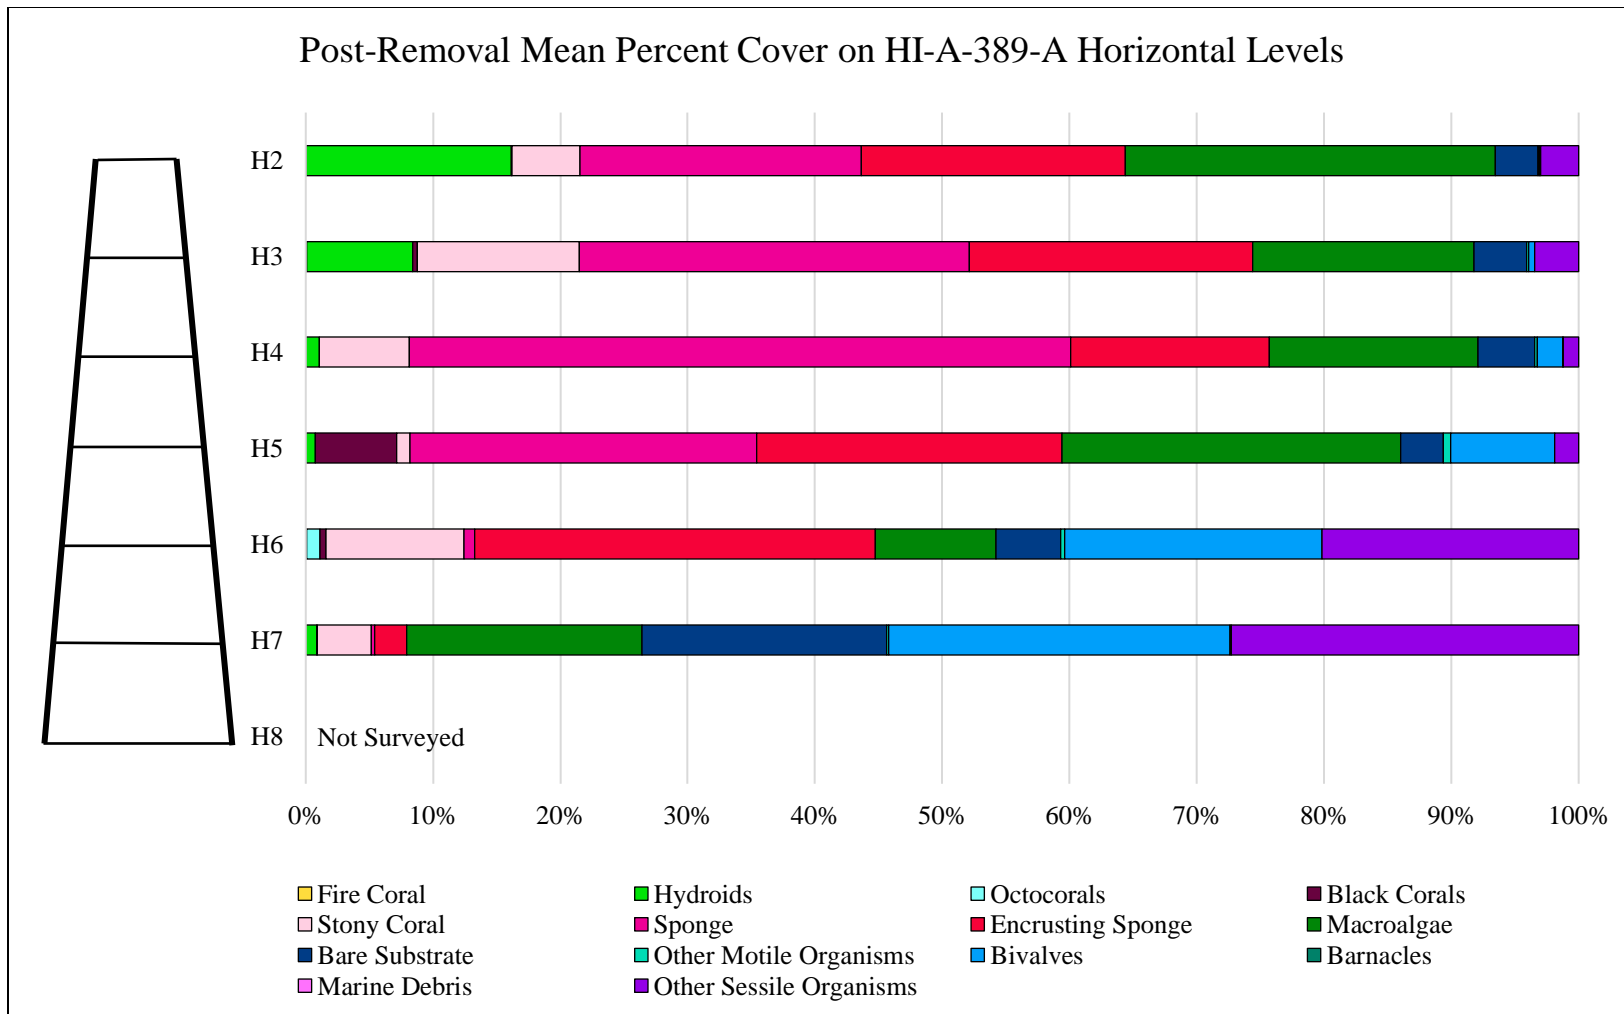
Figure 3.6. Percent composition of benthic cover groups per horizontal level (H2-H7) identified in CPCe post-removal analysis. The outline of HI-A-389-A to the left of the stacked bar graph helps to visually represent the depth delineations of the horizontal beams below the surface: H2 (22 m), H3 (37 m), H4 (52 m), H5 (72 m), H6 (91 m), H7 (108 m), and H8 (125 m). No surveys were conducted on H8.

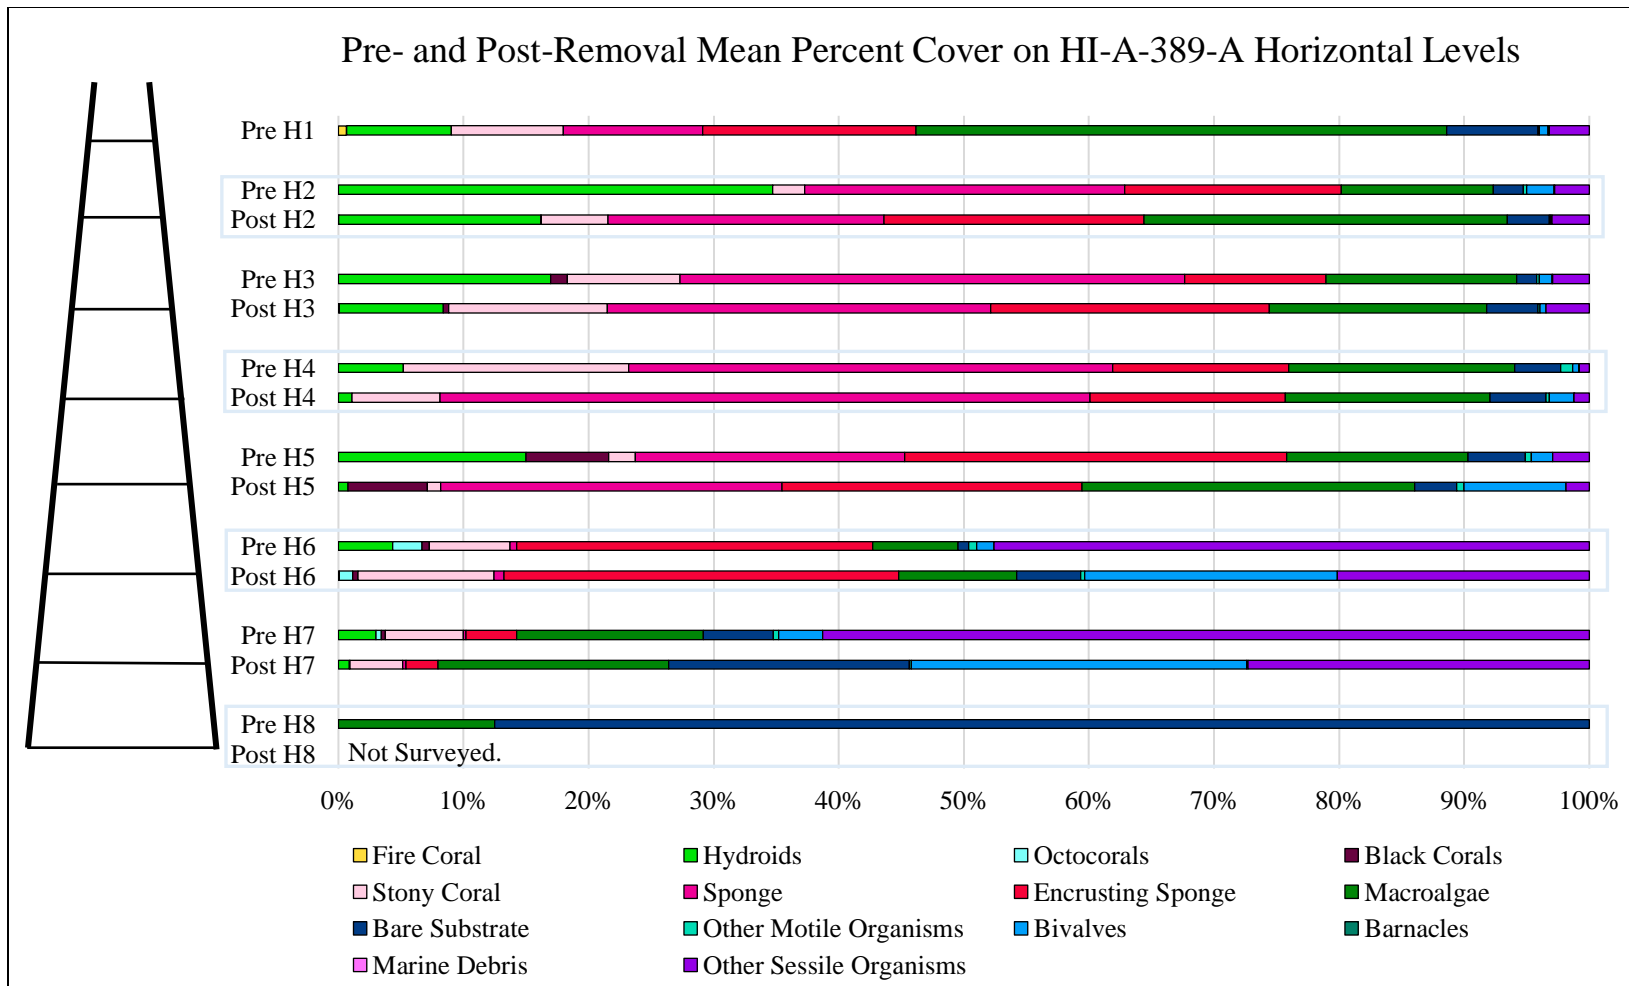
Figure 3.10. Percent composition of benthic cover groups per horizontal level (H1-H8) identified in CPCe pre-removal and post-removal analyses. Outline of HI-A-389-A to the left of the stacked bar graph helps to visually represent the depth delineations of the horizontal beams below the surface: H1 (9 m), H2 (22 m), H3 (37 m), H4 (52 m), H5 (72 m), H6 (91 m), H7 (108 m), and H8 (125 m). No post-removal surveys were conducted on H8. Light blue boxes aid in visually differentiating even and odd levels with coupled pre- and post-removal survey results.

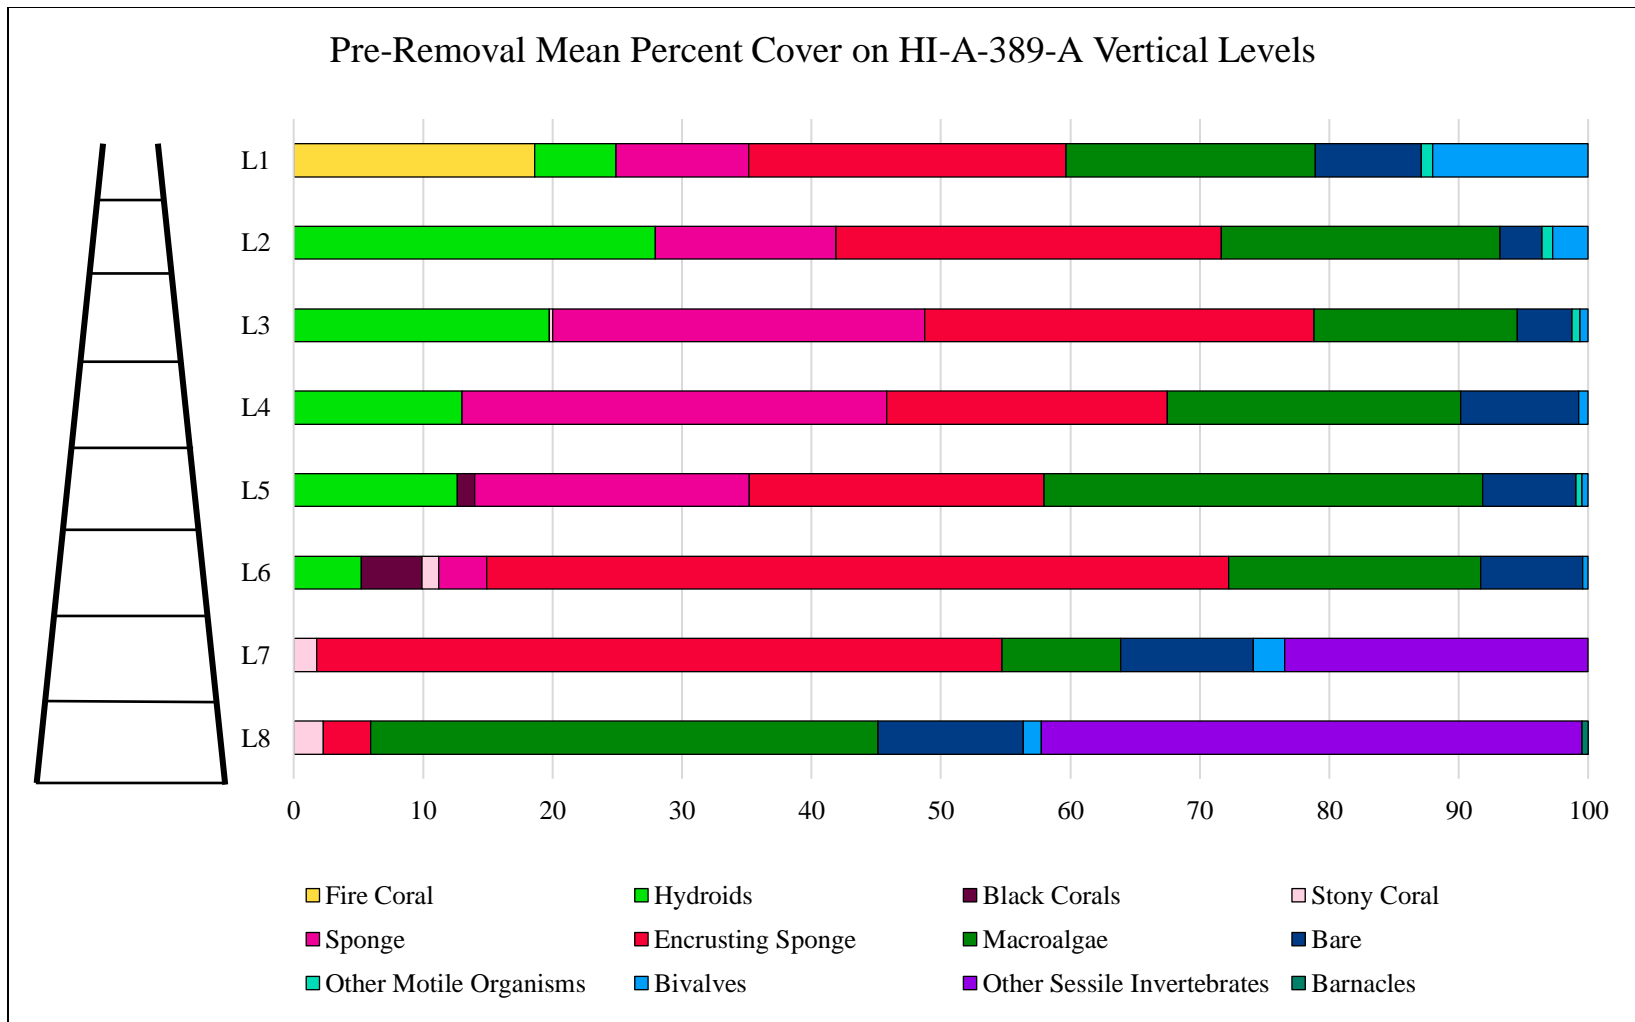
Figure 3.11. Percent composition of benthic cover groups at vertical levels (L1-L8) identified in CPCe pre-removal analysis. Outline of HI-A-389-A to the left of the stacked bar graph helps to visually represent the depth delineations of the level between horizontal beams below the surface.

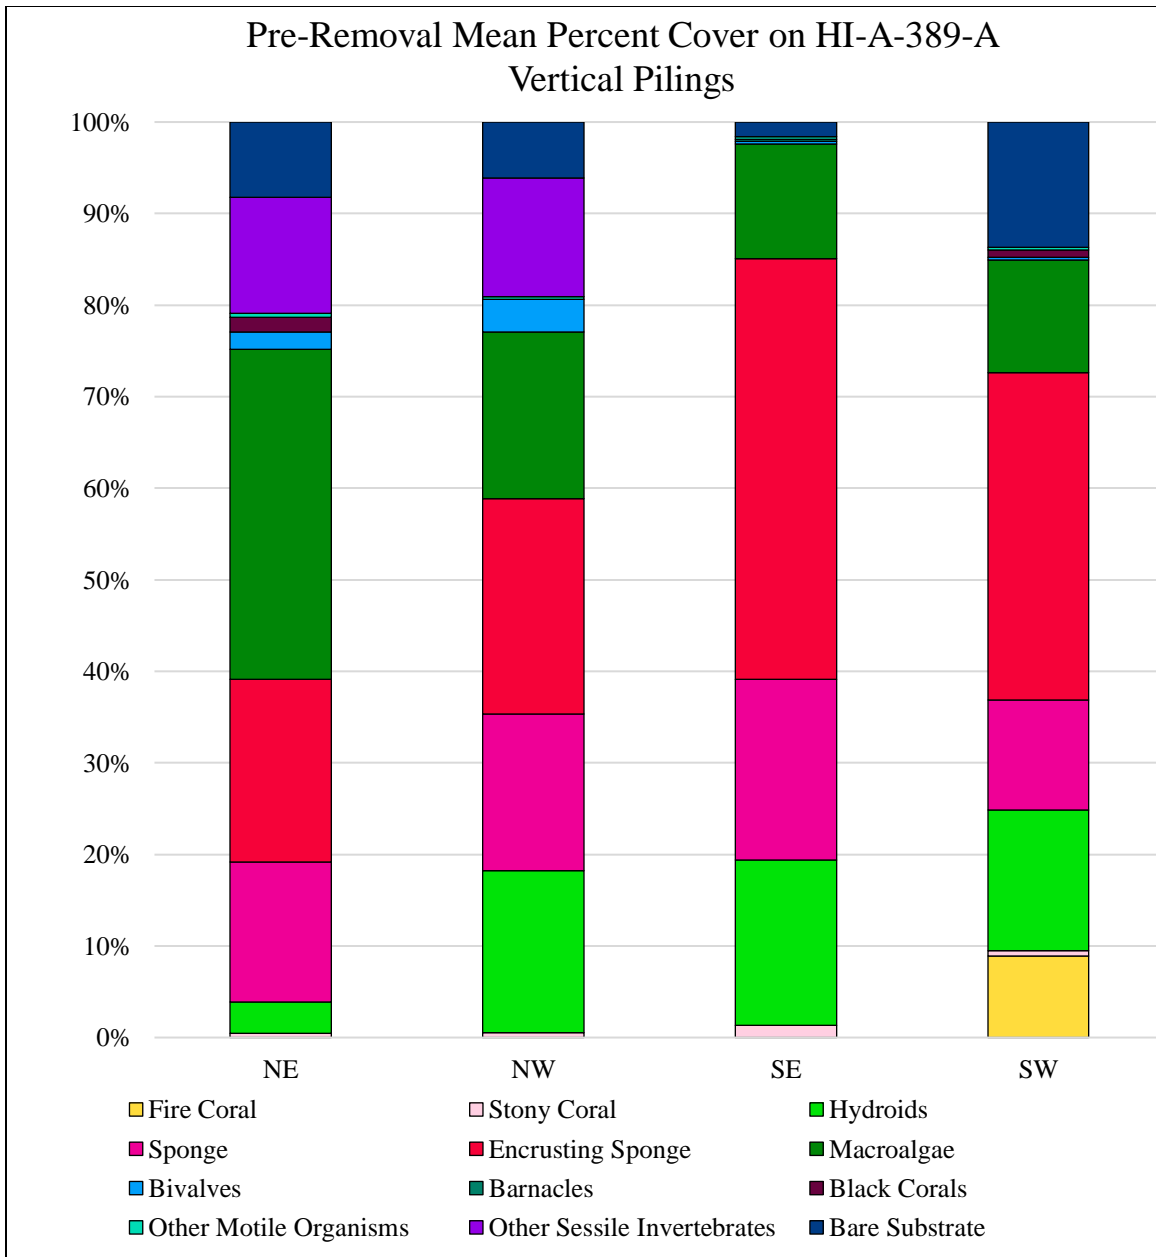
Figure 3.12. Percent composition of benthic cover groups on HI-A-389-A vertical pilings (northeast, northwest, southeast, and southwest) as identified in CPCe pre-removal analysis.

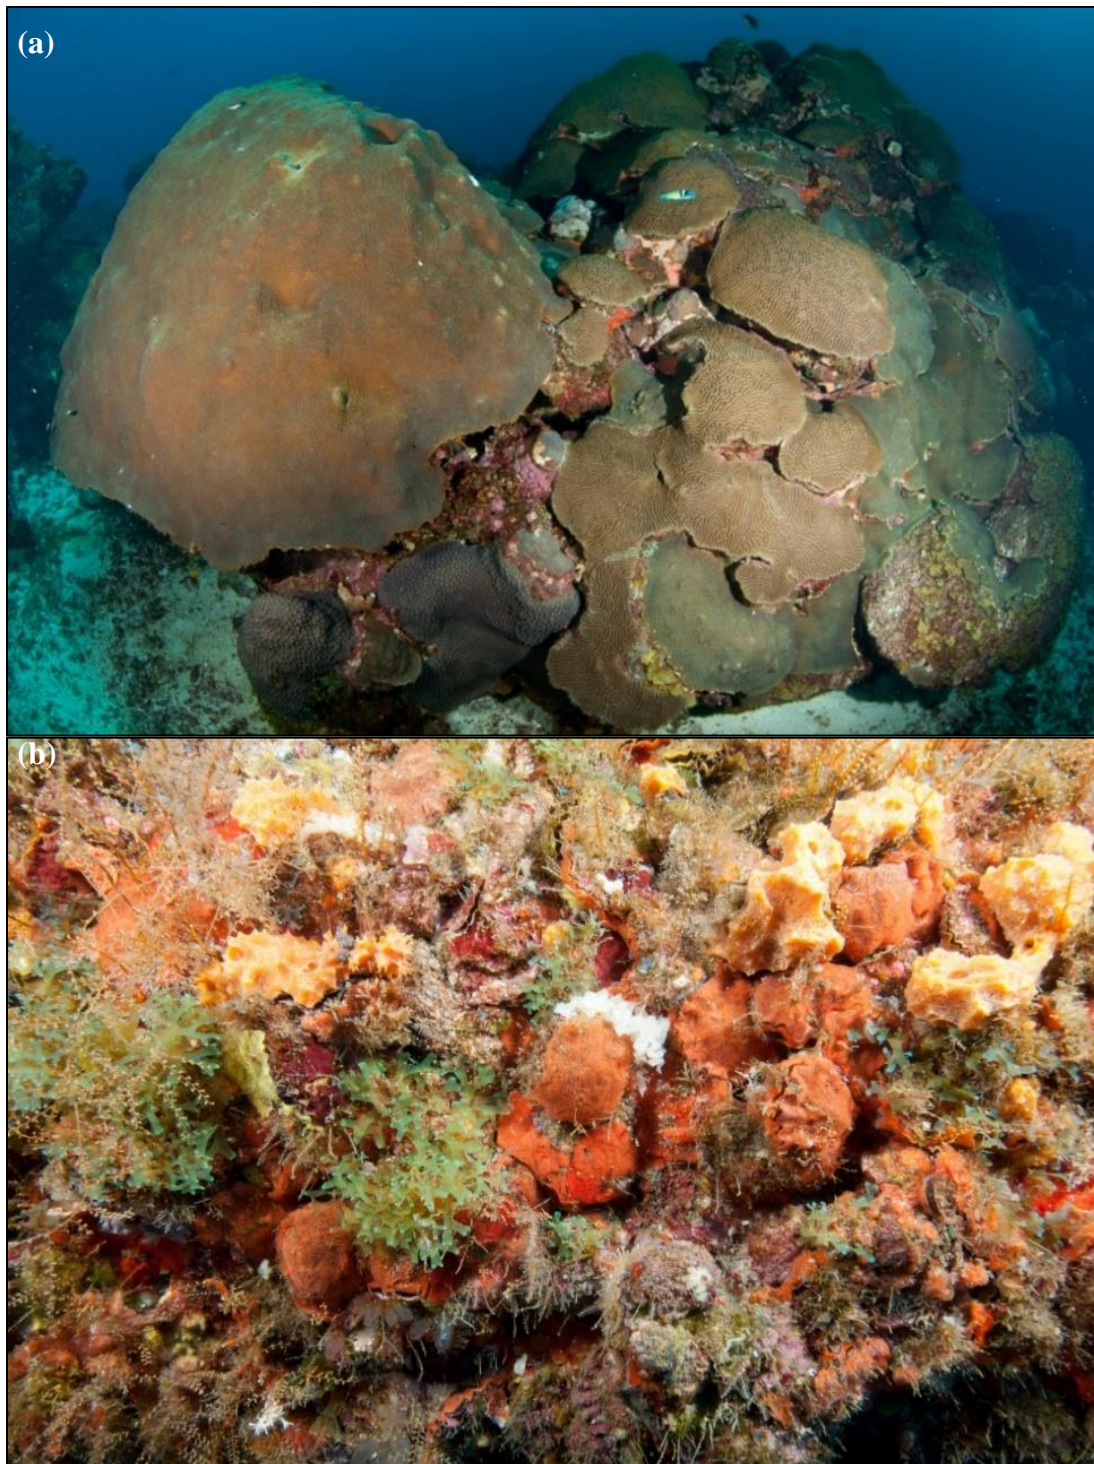
Figure 3.25. Typical benthic community at (a) EFGB, dominated by boulder star and brain corals, and at (b) HI-A-389-A, dominated by sponges, macroalgae, bivalves, and hydroids. HI-A-389-A is located 1.6 km southeast from the EFGB coral reef cap. Photos: G.P. Schmahl/NOAA

Considerable scientific debate has centered on the role oil and gas platforms play in the ecosystem of the Gulf of Mexico, and whether the communities on these structures are similar to natural coral reefs. Based on surveys conducted by FGBNMS scientists in 2012 on HI-A-389-A from a depth of 40 m to the surface (Embese et al. 2013) and the results of this study, the benthic community did not resemble the nearby coral reef at EFGB, even at comparable depths. Very few native coral colonies were observed on the platform, contrasting with EFGB benthic cover, which is comprised of living hermatypic corals (over 50% coral cover) in depths less than 40 m (Johnston et al. 2016, 2018). Benthic cover at HI-A-389-A from 20 m to 40 m was comprised of mostly sponges, encrusting bivalves, macroalgae, and hydroids (Embese et al. 2013), which are rarely observed on the nearby natural reef at these depths (Figure 3.25).

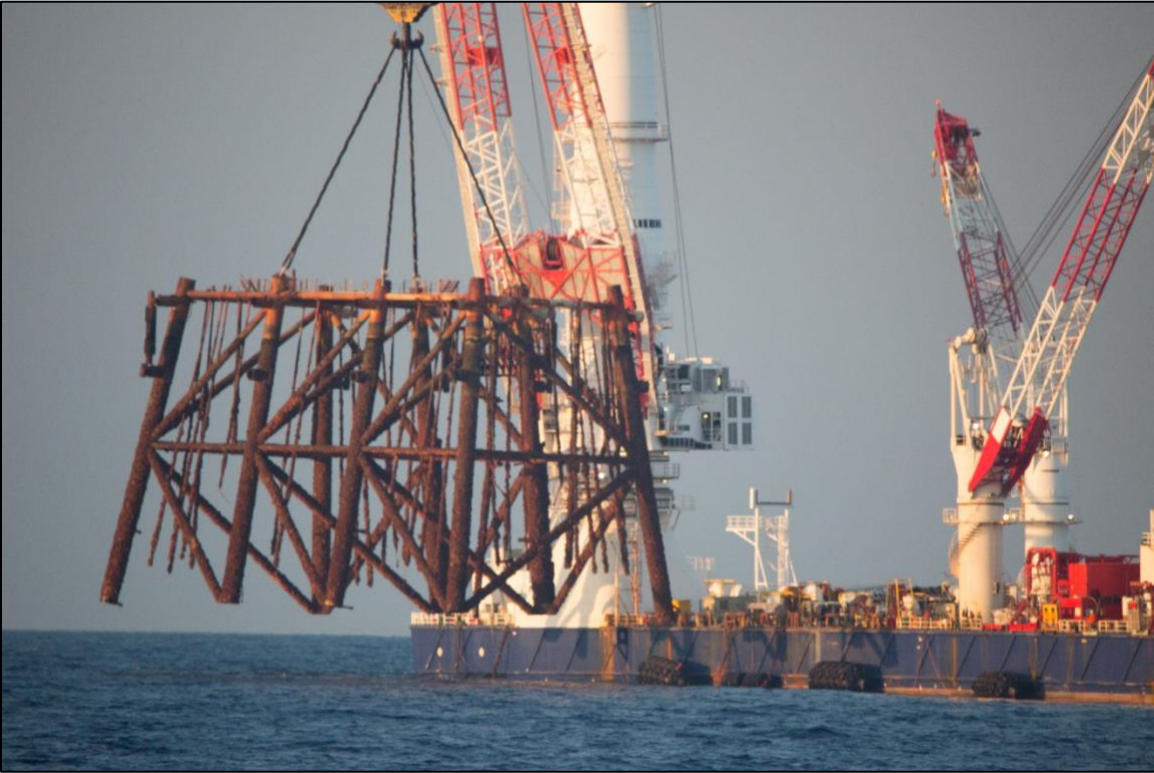
The top section of HI-A-389-A is lifted from the water in July 2018 by *Nor Goliath*. Photo: G.P. Schmah/NOAA
