*TRANSPORTATION RESEARCH RECORD 796*

# Highway Safety Appurtenances

*TRANSPORTATION RESEARCH BOARD*

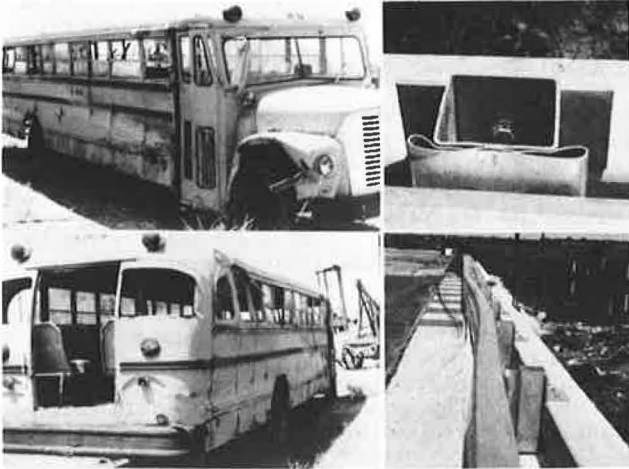
Figure 6. Vehicle and barrier damage, test RF-26.

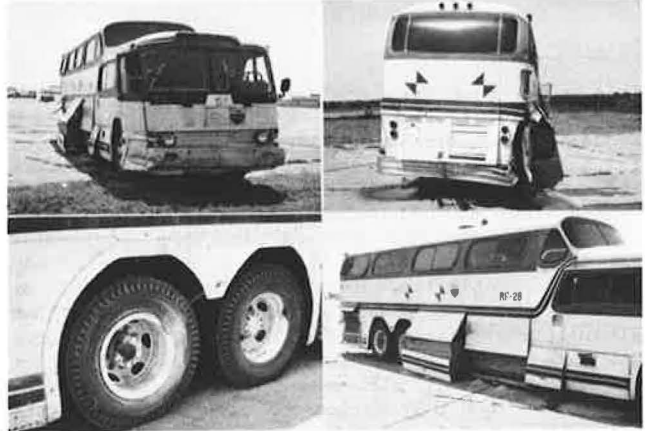
Figure 9. Vehicle damage, test RF-28.

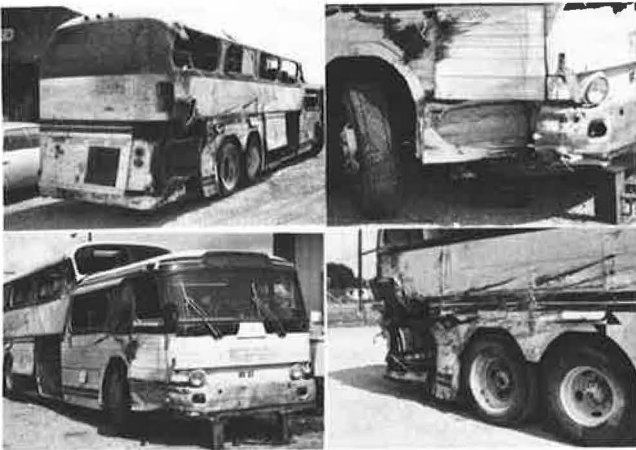
Figure 7. Vehicle damage, test RF-27.

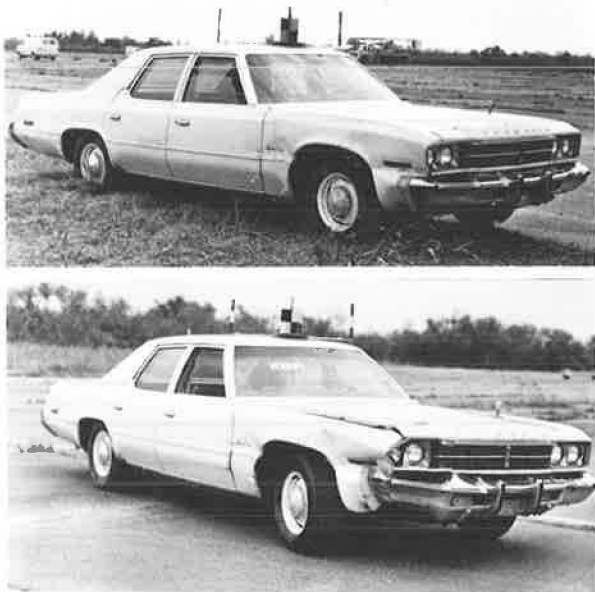
Figure 11. Vehicle before and after test 3825-2.

The barrier was pushed to its original position in 30 min by two men and a forklift. The extent of the permanent deformation was isolated to one 25-ft (7.63-m) rail segment between barrels 6 and 10 that had a 0.5-in (1.27-cm) permanent set. The damage to the rail segment was so slight that replacement was not considered necessary. Four barrels in the immediate area of impact were slightly deformed adjacent

to the wooden block. The barrels were not replaced because the deformations were not sufficient to affect performance.

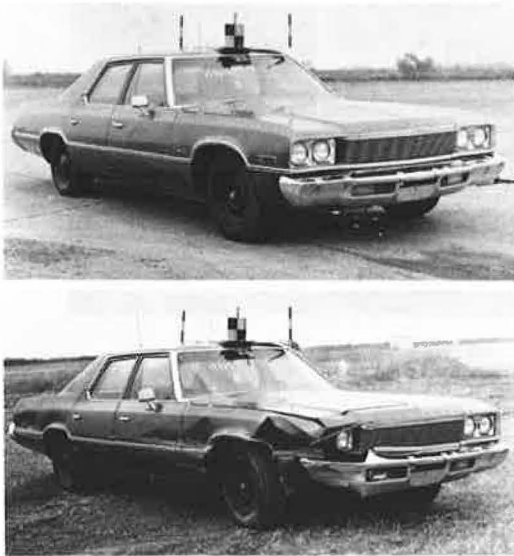
Figure 12. Vehicle before and after test 3825-3.

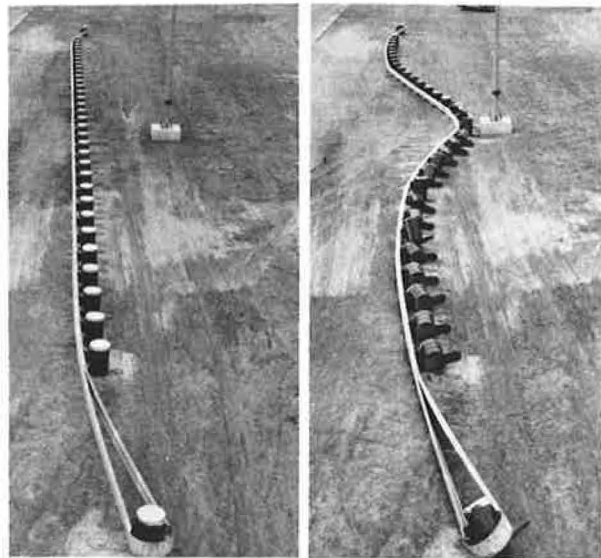
Figure 13. SBW3 installation before and after test 3825-3.

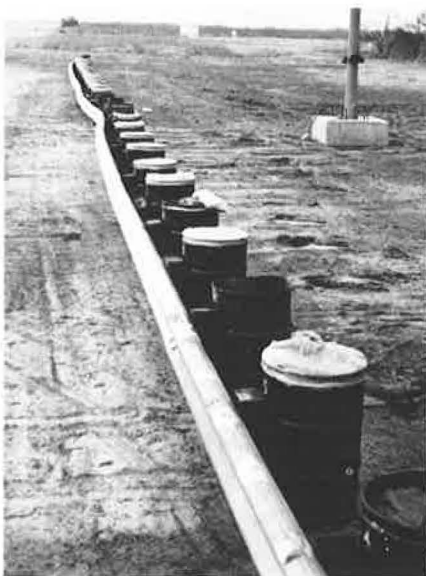
Figure 15. SBW3 installation restored after test 3825-3.

The barrier was returned to its original position by three men and two forklifts in 90 min. The extent of the permanent deformation after repositioning was between barrels 13-20. The maximum deformation, 5.7 in (0.15 m), occurred at barrel 16. The restored barrier is shown in Figure 15. The 25-ft rail section between barrels 13 and 17 was replaced. Barrels 14 through 18 were also replaced before testing continued.

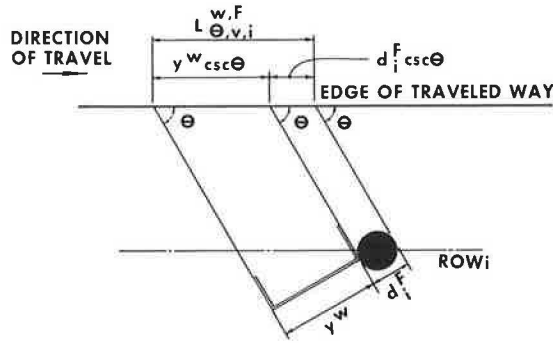
Figure 2. Length of roadway within which encroachment at angle  $\theta$  would intersect location of fixed object.

$d_i^F$  = DIAMETER OF FIXED OBJECT  
 $w$  = WIDTH OF VEHICLE  
 $\theta$  = ENCROACHMENT ANGLE

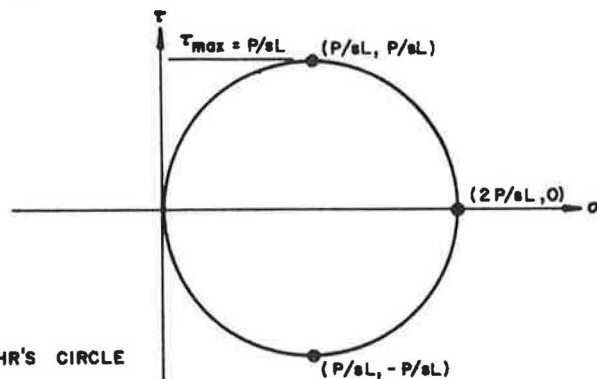
Figure 3. Simplified stress state hypothesized for fillet weld loaded as shown in Figure 2.

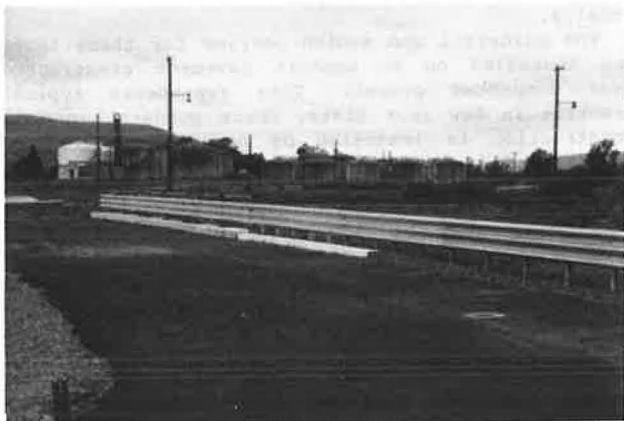
Figure 3. Bridge-rail upgrading (test 23A).

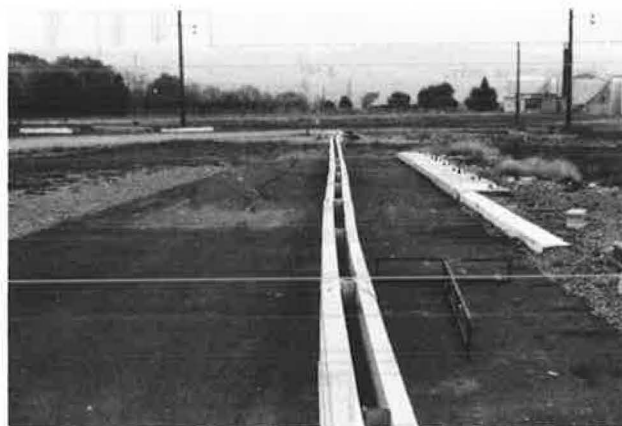
Figure 6. Median barrier that has 6-ft 3-in post spacing.

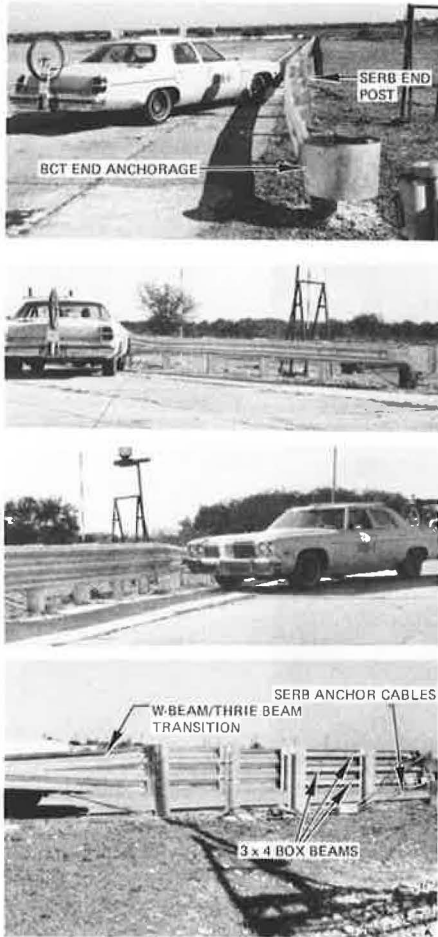
Figure 7. SERB end treatment.

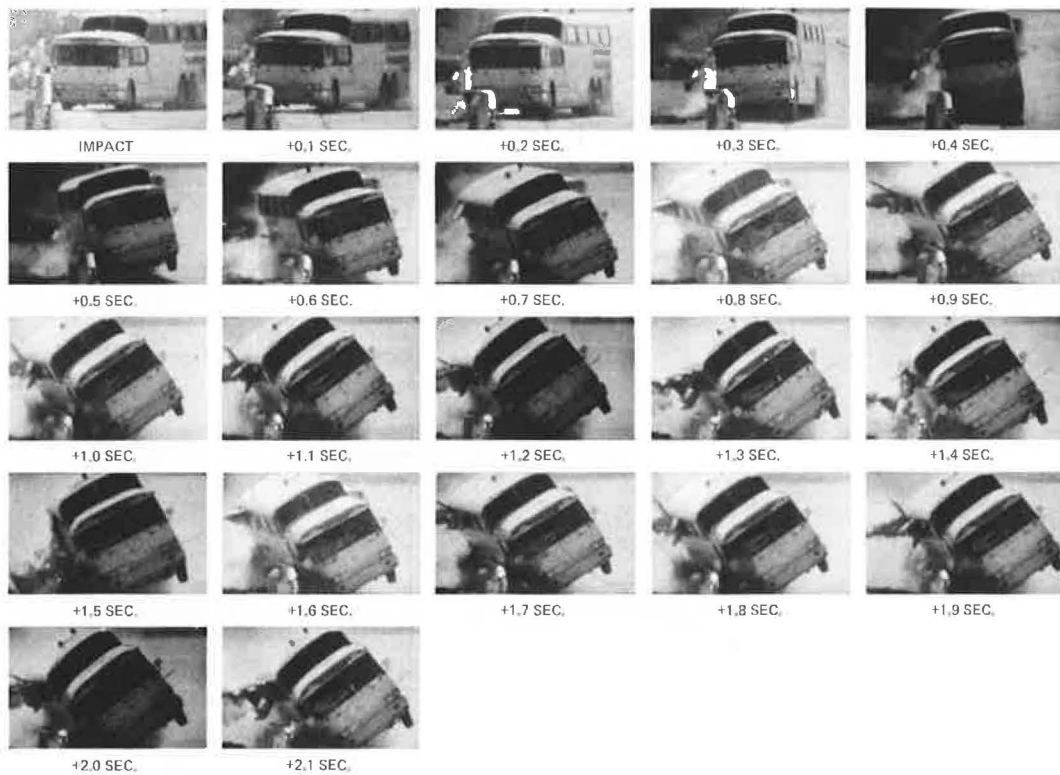
Figure 9. Test SRB-7.

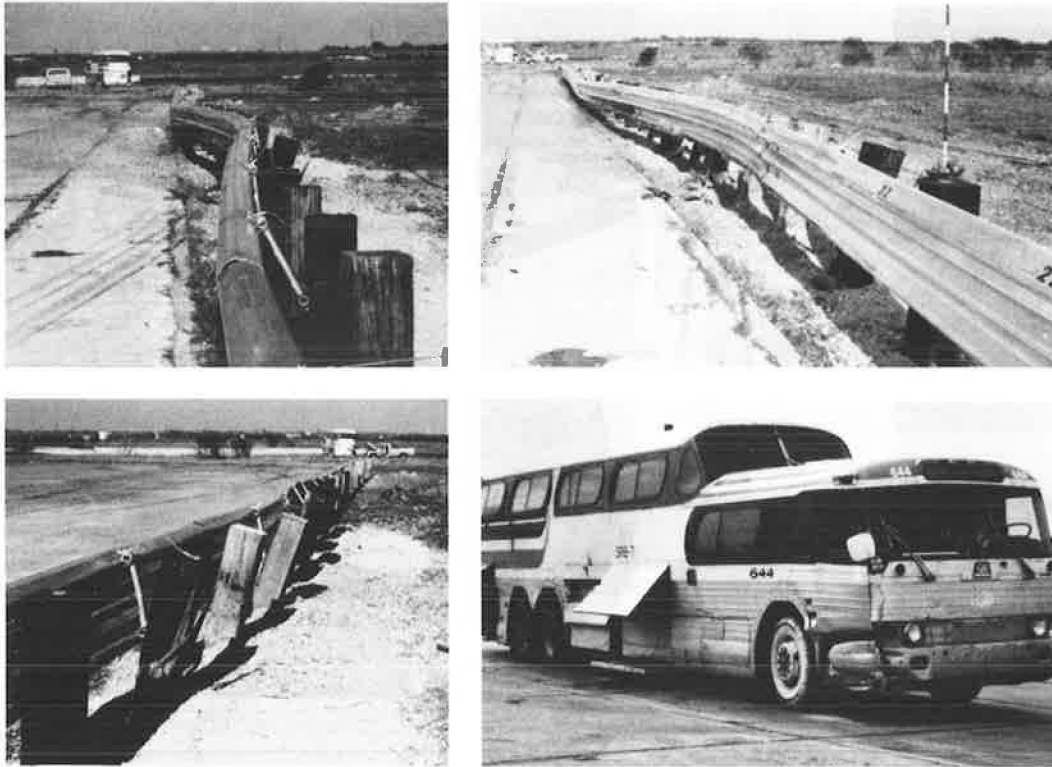
Figure 10. Results of test SRB-7.
