Summary report

Planned object: Mechanical Mine clearance device

Model: 910 MCV

Task: Establishment of mine test lanes in two distinctly different types of soil and execution of clearance trials.

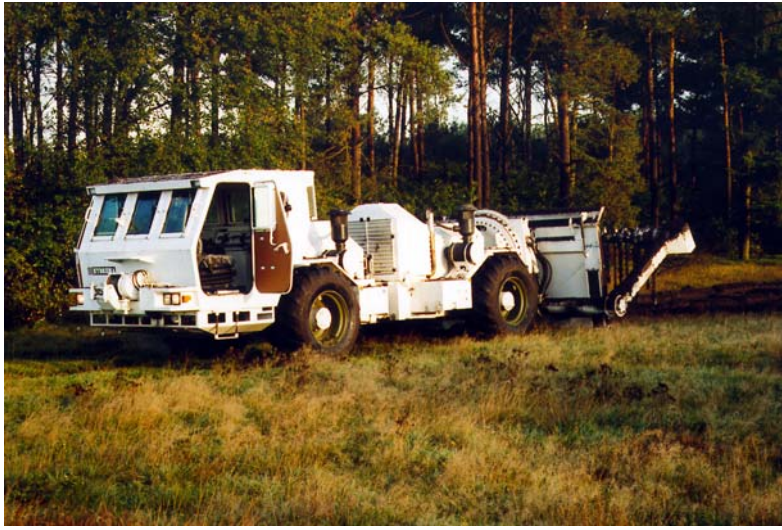
Picture 1 910 MCV working position overall view, front left

The MCV 910, designed for clearing surfaces is a mobile mine clearance device accredited also for the public road traffic. On the rear part it presents a special rotating

clearance device, hydraulically operated. The clearance takes place through the rotation movement of the flail, which should, through this action, detonate the mines. When working, the vehicle moves in the opposite direction to road movement and it can be either operated through a computerized automatic pilot steering system or manually using a joystick.

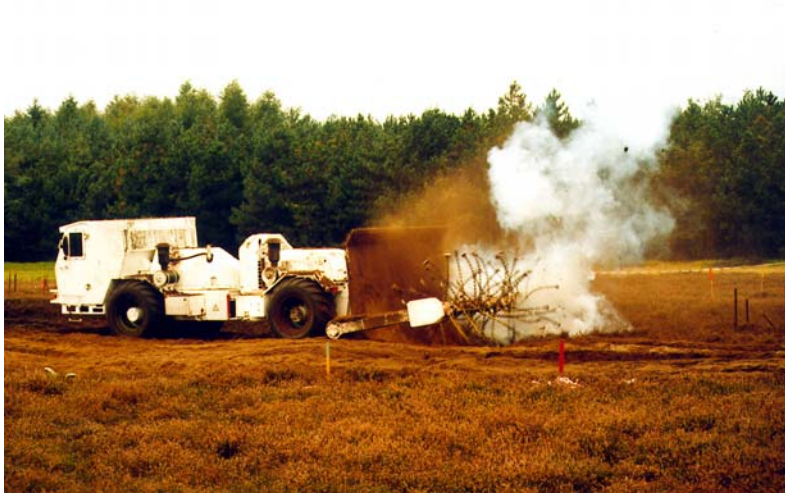
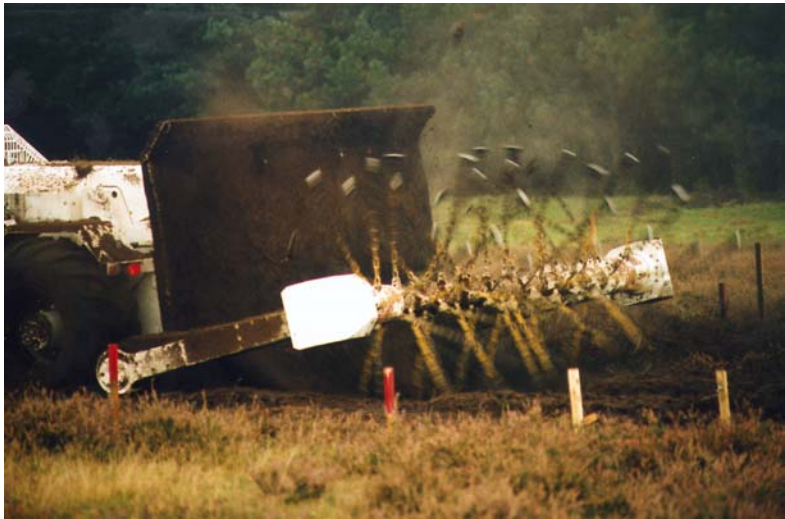
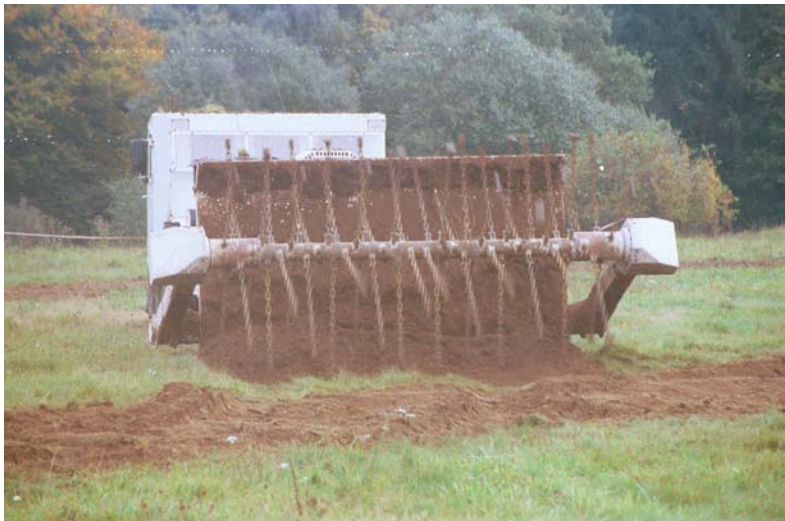
Picture 4 910 MCV during the clearance process

Picture 5 910 MCV during the clearance process

Picture 6 910 MCV during the clearance process

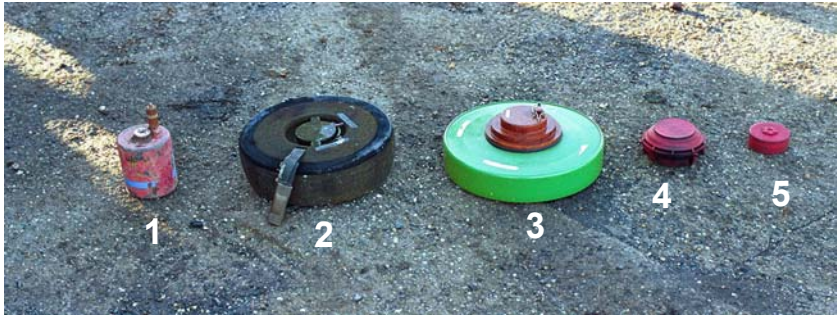
<p data-bbox="212 659 649 814"> 1 DM 31 Splitterspringmine 2 DM 21 Panzerabwehrmine 3 TM 62P3 Panzerabwehrmine 4 PPM-2 Schützenabwehrmine 5 DM 18 Schützenabwehrmine </p>		<p data-bbox="1140 302 1289 331">Picture 13</p> <p data-bbox="1140 369 1302 399">Used mines</p>

[See Annex 15 picture 13 and 14](#)

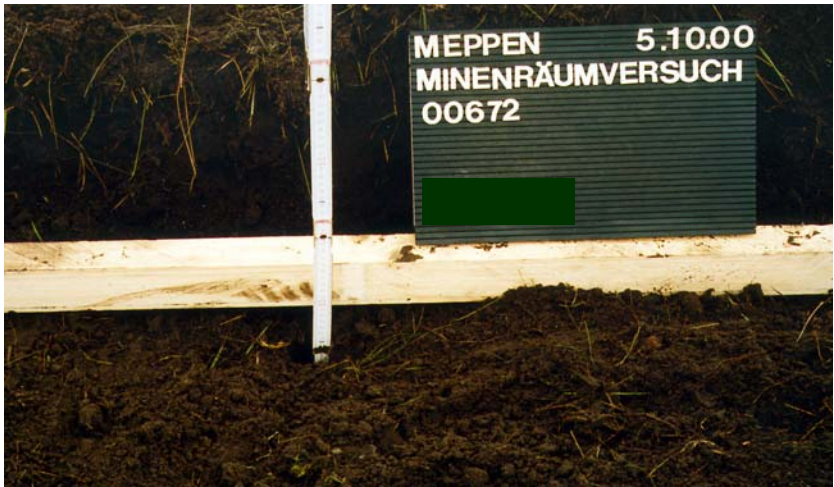
<p data-bbox="1140 1407 1289 1436">Picture 15</p> <p data-bbox="1140 1474 1364 1537">Clearance depth measurements</p>

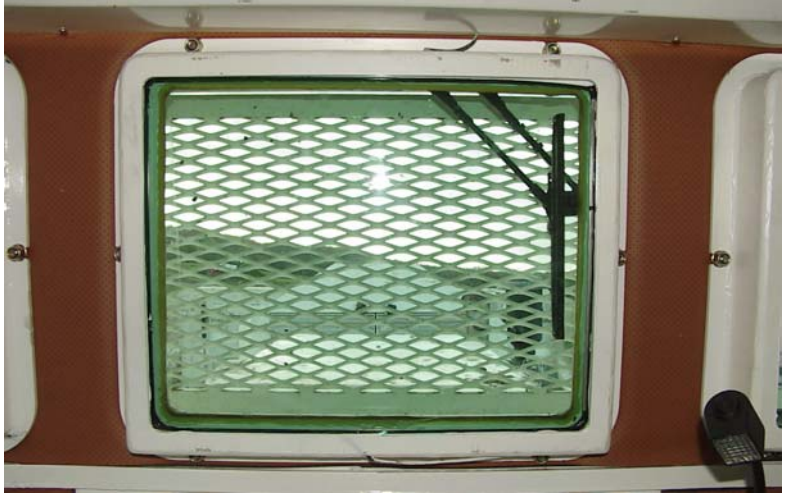
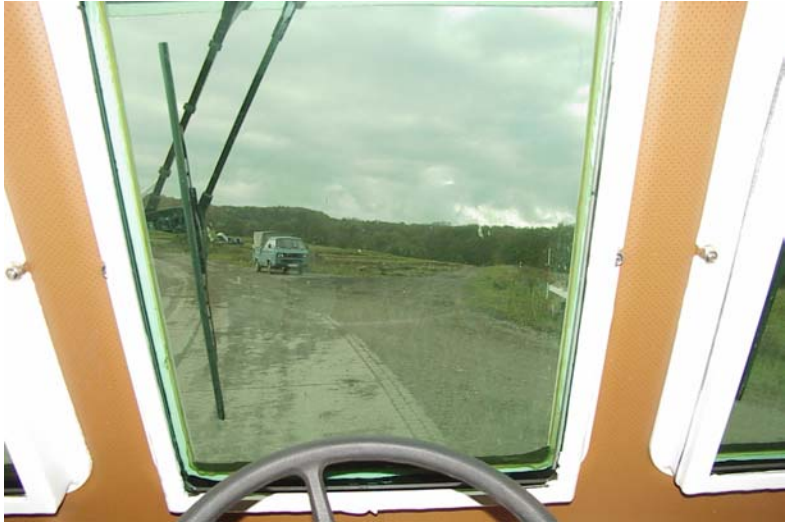
Picture 16 910 MCV Window alignment during the clearance process

Picture 17 910 MCV View during the clearance process

Picture 18 910 MCV View during front drive

Operation: The operating of the machine from the driver cabin created no problems, notwithstanding the view conditions ([see Annex 15 picture 16 to 18](#)) being very limited due to the protection blade. The programming of the soil characteristics in the on-board computer requires however much experience.

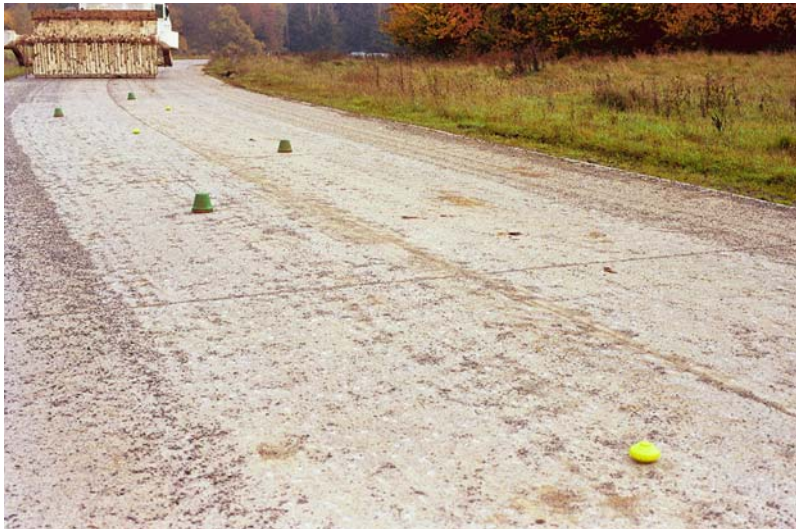
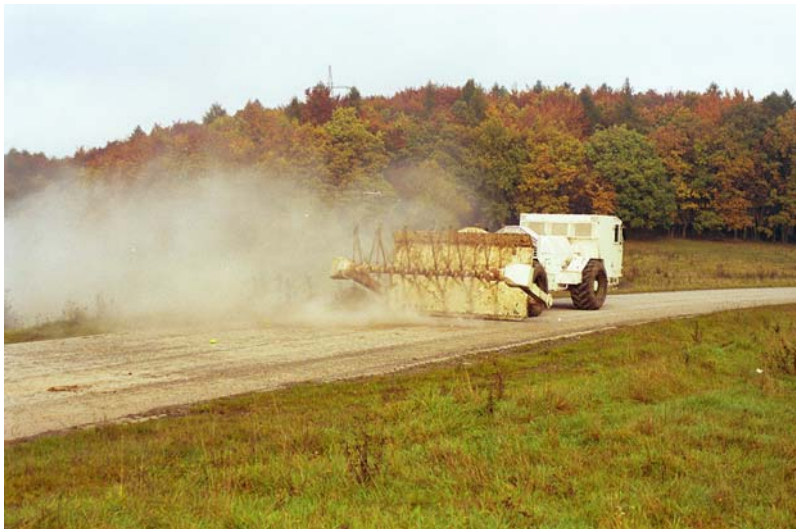
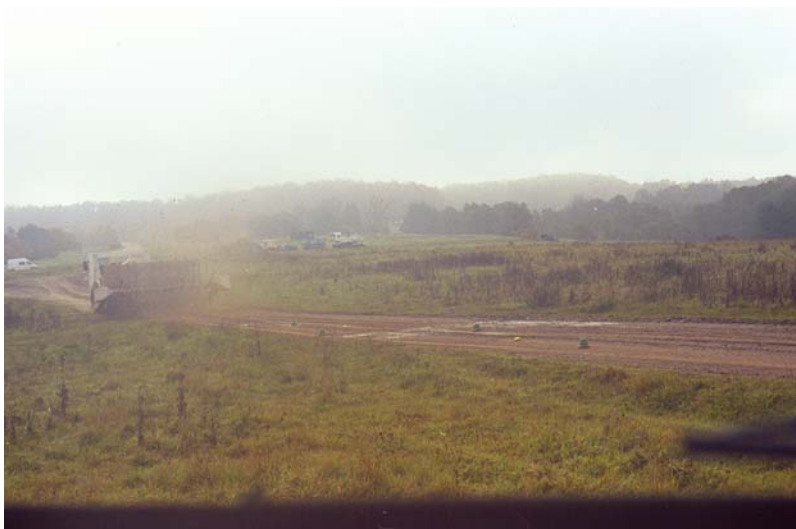
Picture 19 910 MCV Dummy mines distributed on paved roads

Picture 20 910 MCV Clearance of mines on a paved road

Picture 21 910 MCV Clearance of mines on a paved road

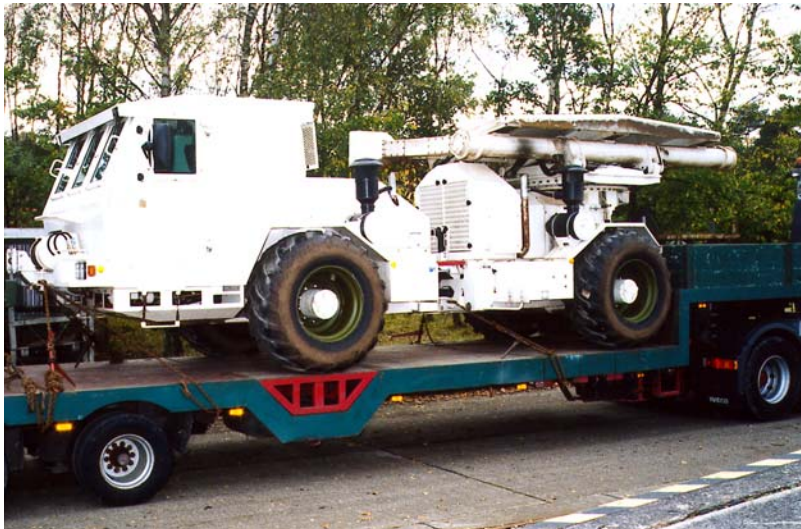
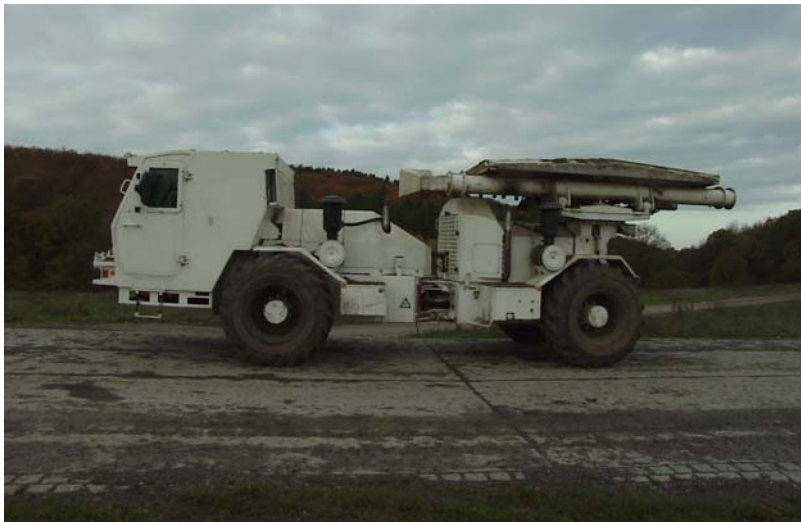
Picture 22 910 MCV Mounted on a trailer

Picture 23 910 MCV Road transport position

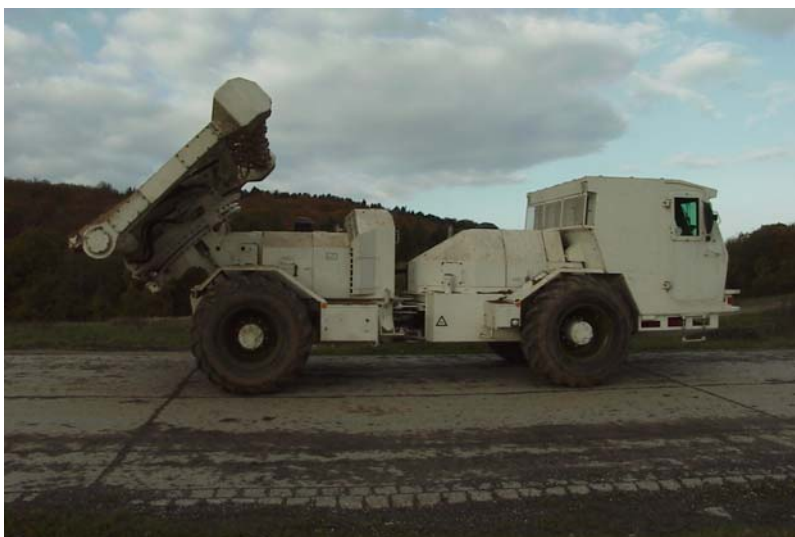
<p>Picture 26</p> <p>910 MCV Rotation of 90° of the flail pushing frame and blade</p>

<p>Picture 27</p> <p>910 MCV Flail pushing frame and blade flapped to the stop position</p>

2. Loose the fuse of the rotating assembly on the vehicle's tail ([see Annex 15 picture 24](#)).
3. Loose the screw fuse on the rear handle bar ([see Annex 15 picture 25](#)).
4. Rotate flail pushing frame and blade of 90° ([see Annex 15 picture 26](#)).
5. Flap flail pushing frame and blade to the stop position ([see Annex 15 picture 27](#)).
6. Lower flail pushing frame to the clearance position – starting position is reached - ([see Annex 15 picture 28 and 29](#)).
7. For road clearance the blade will be lowered until the rollers touch the ground.
For terrain clearance the rollers have to be dismantled first.

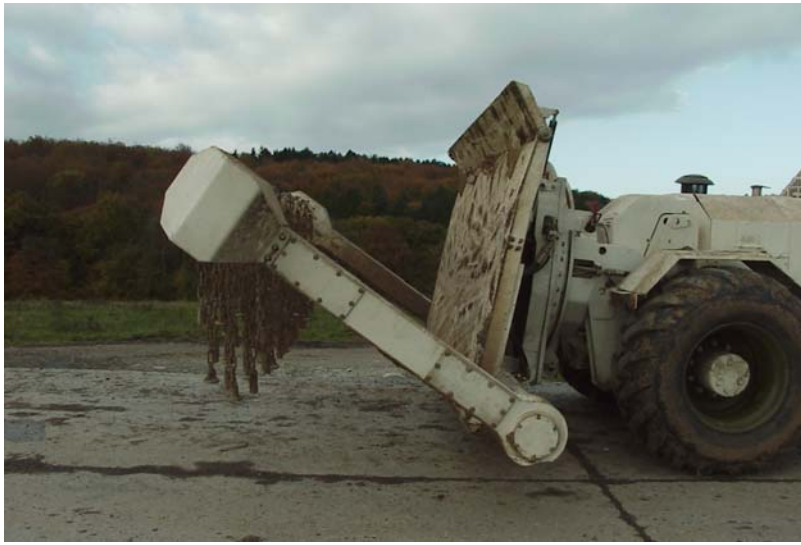
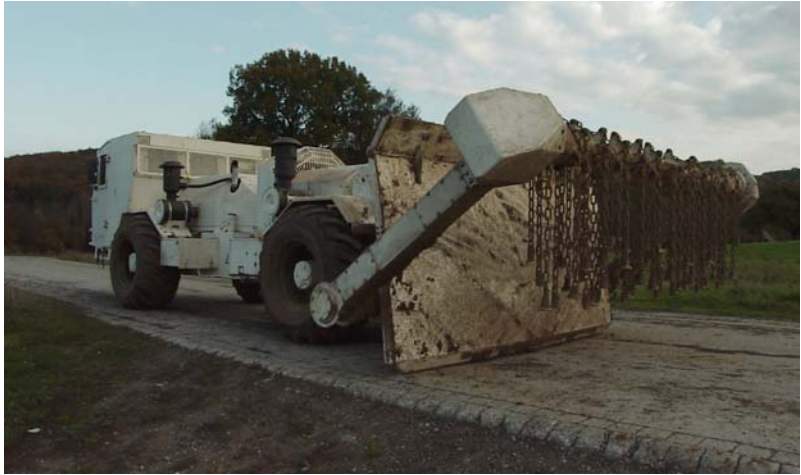
<p>Picture 28</p> <p>910 MCV Flail pushing frame lowered to the clearance position</p>

<p>Picture 29</p> <p>910 MCV Clearance position</p>

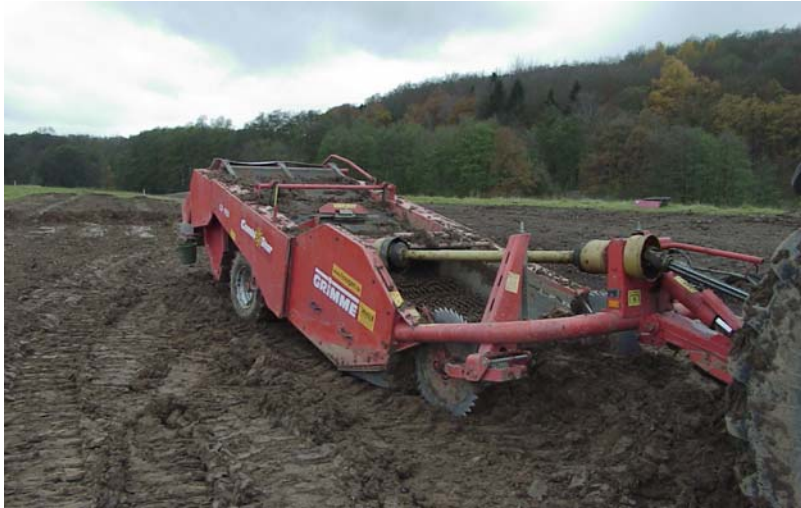
<p>Picture 30</p> <p>Searching for remaining mine fragments with the rock collector</p>

Picture 31 Searching for remaining mine fragments with the rock collector
