GEOTECHNICAL ASPECTS AND OBSERVATIONS OF A QUARRY RECLAMATION

Hermann Schad, Geoffrey Gay

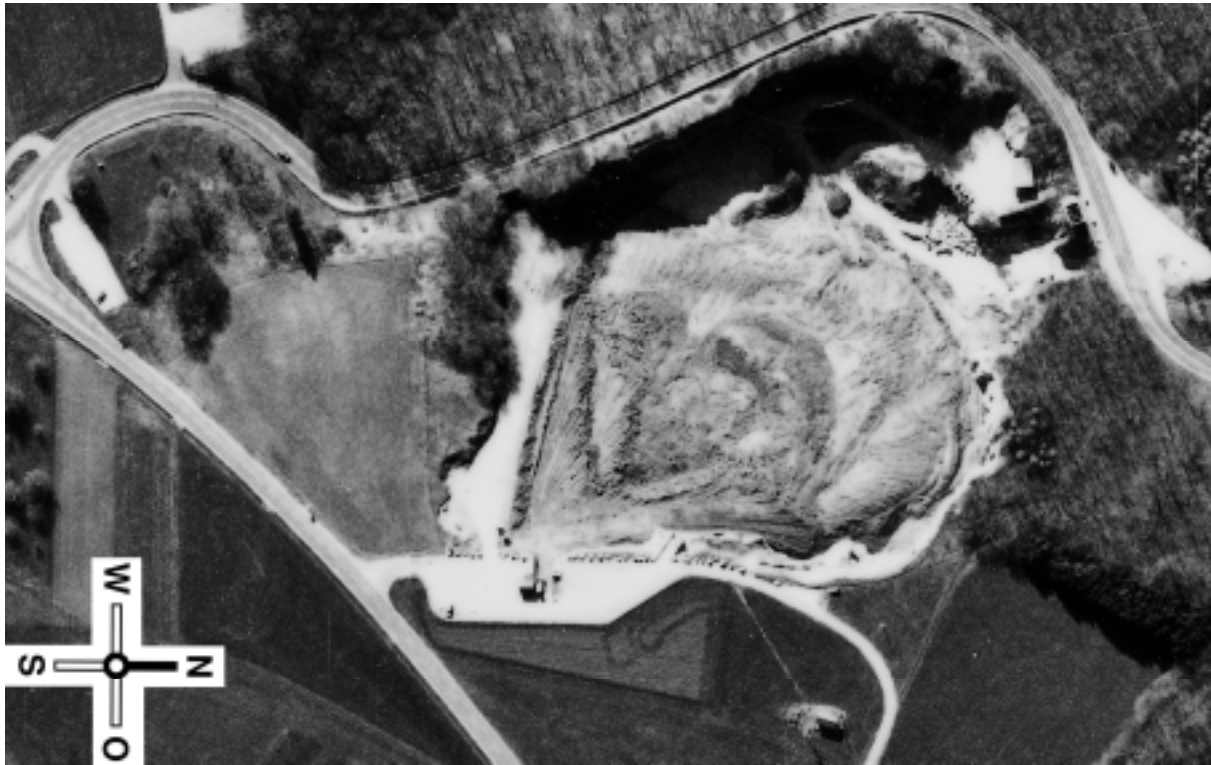
In 1985 it was decided to refill and recultivate part of a limestone quarry in the south west of Germany near Neuffen in the state of Baden-Württemberg. The quarry had been used for the production of crushed limestone mainly for the use in road construction. An aerial photograph of this stage of the refilling is shown in fig. 1.

Fig. 1: Aerial photograph of first stage of refilling 24.4.1988

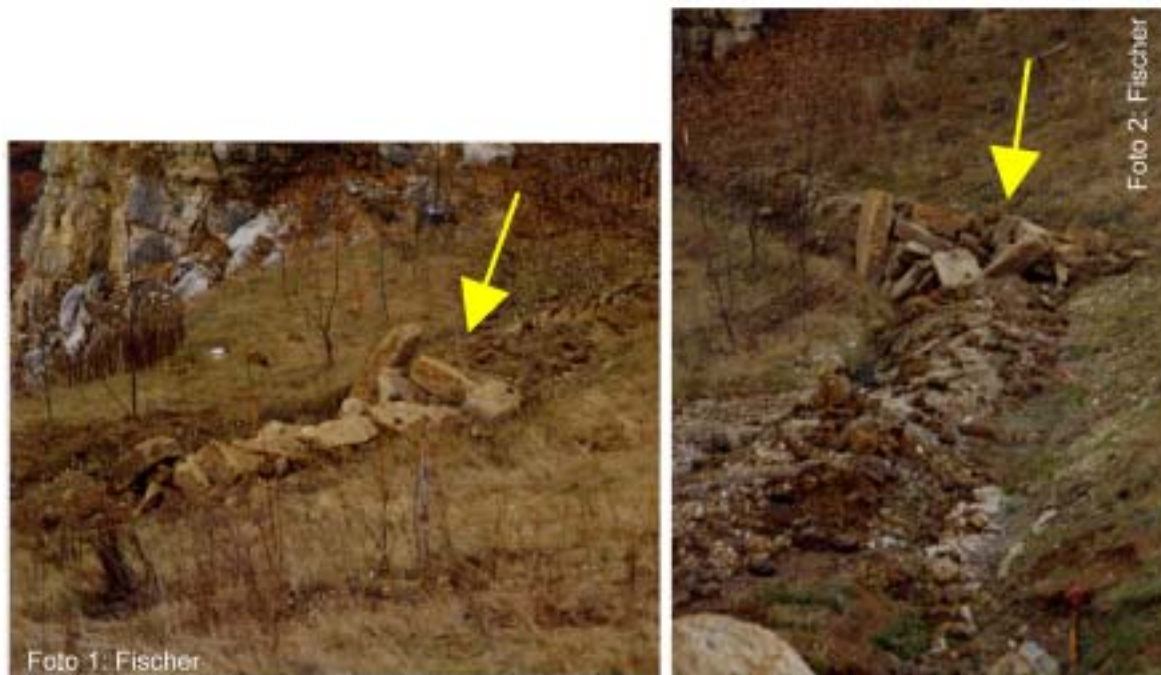
In November 1997 it was noticed that relatively large slip movements must have taken place because a natural stone wall surrounding a manhole had been deformed considerably. (see fig. 3). The refilling was not complete at this time.

Fig. 3: Deformed natural stone wall

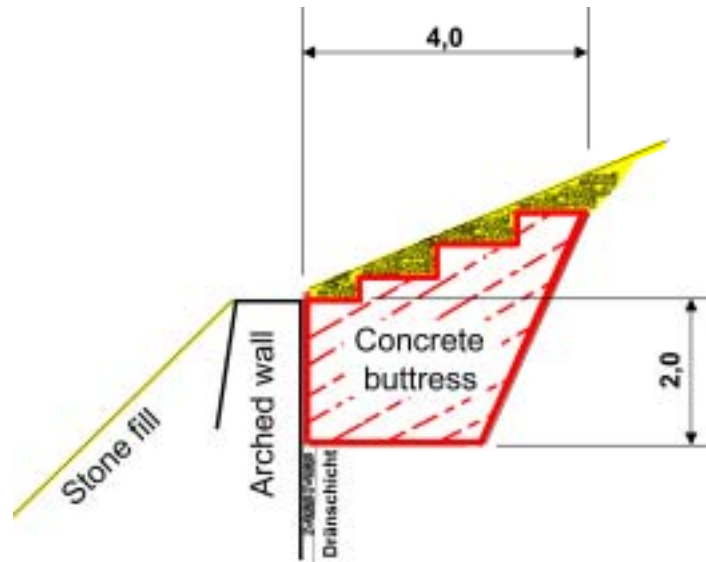
The first measurement took place in November 1997. After the first two measurements with a weeks difference between them it appeared that the deformation rate was slowing down. It had reduced from 9mm/d to 5mm/d. In the third week however the speed increased to 20mm/d so it was decided to increase the factor of safety by stabilising the foot of the slope using concrete buttresses with crushed rock between them as shown in figs. 5 and 6.

Fig. 5: Section through concrete buttress

The concrete buttresses were used as a supporting element and the crushed rock as a drainage. Grid point measurements on the 23.12.97 showed a further increase in the deformation rate (37mm/d). It was therefore decided to fill the volume between the concrete buttresses with a well graded crushed rock instead of the coarse crushed rock as planned. The deformation rate slowed down considerably (see Section 3). At first it was not clear whether this was due to a frost period between 21.1.98 and 4.2.98.

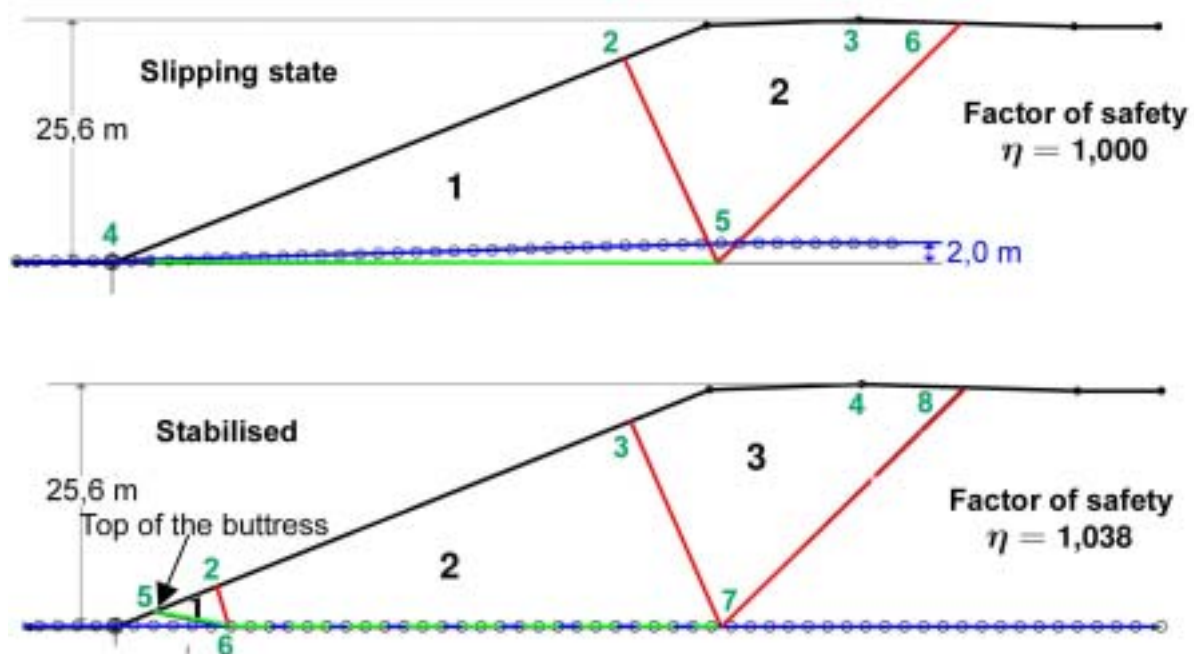
A slope stability calculation showed that for a factor of safety of 1.0 the shear parameters in the horizontal direction have to be $\phi = 10.21^\circ$ and $c = 0$ kN/m² and in the vertical direction $\phi = 20^\circ$ and $c = 0$ kN/m² (see fig. 7).

Fig. 7: Elements for slope stability calculations

Calculations with the Kinematical Elements Methods (Gussmann et al. 2002) for the stabilised state showed that the increase in stability factor due to the concrete buttresses and the lowering of the water table by 2m was relatively small (0.04). In the long term however an increase in the shear strength due to consolidation and “age hardening” is to be reckoned with. Under the phenomena “age hardening” is understood that when a cohesive soil is placed, especially in wet weather, there is a relative large amount of water between the soil aggregates and the soil is very soft or even “liquid”. In the course of time this

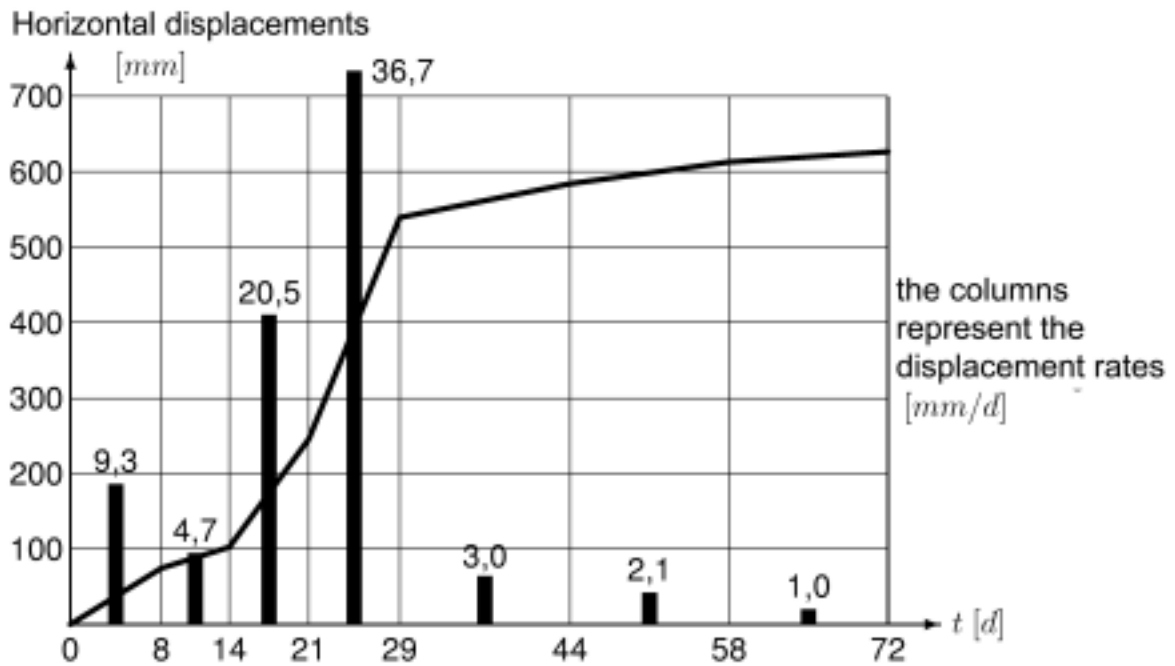
The displacement rates of the points 16 and 17 (fig. 4) are characteristic for the lower part of the slope. The average deformations and the resulting deformation rates are shown in the following diagram.

Fig. 9: Displacements of the lower part during the first 72 days

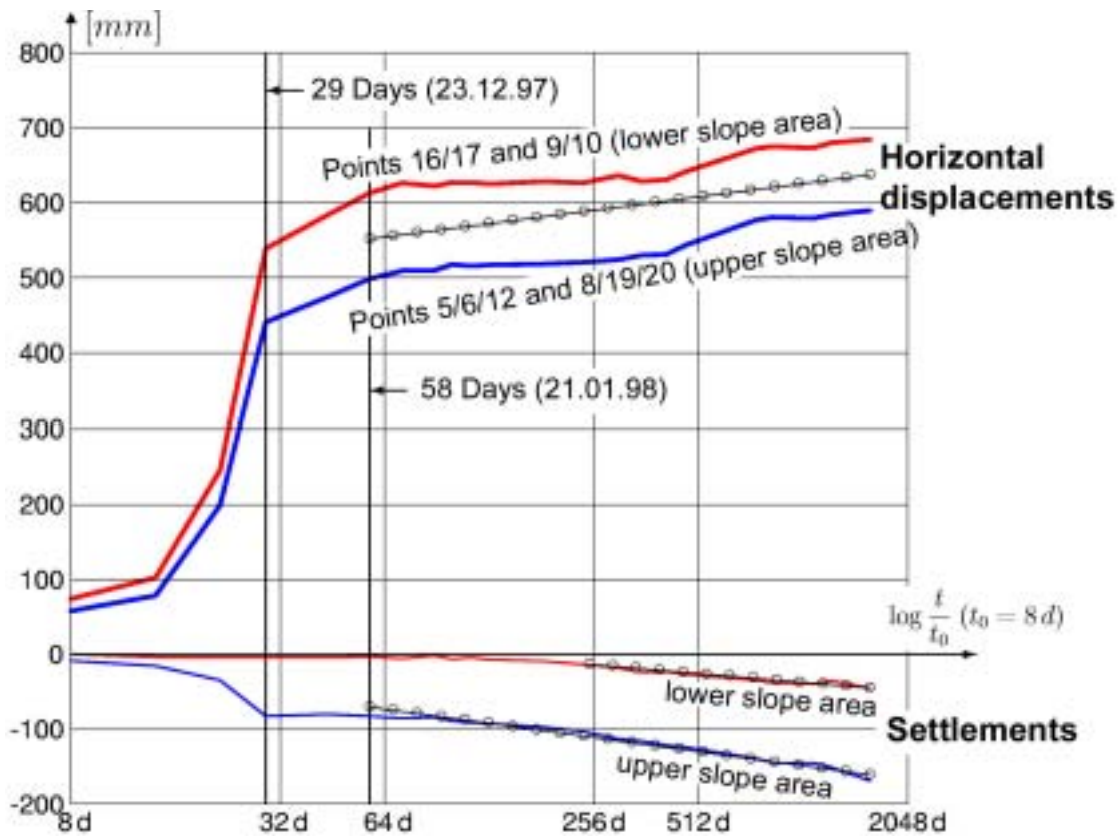
In the following diagram (fig. 11) the average time deformation curves with the time on a logarithmic scale are plotted. It can be seen that up to 68 days after the start of the measurements slipping took place. After that the creep phase started.

Fig. 11: Displacements as function of time

In the semi-logarithmic plot the creep phases approximate to straight lines which can be represented to a good approximation by the black lines with circles as points. Using logarithms to the base 10 the following relationships are obtained. This logarithmic creep is often observed in soil but a lot of other rheological models could be used (e. g. Schad/Breinlinger 1991).

Horizontal displacement: $v = \alpha_h \log \frac{t_2}{t_1} = 59 \log \frac{t_2}{t_1} \quad [mm]$

Settlements in the upper area of the slope: $s_u = \alpha_{s,M} \log \frac{t_2}{t_1} = 63 \log \frac{t_2}{t_1} \quad [mm]$

Settlements in the lower area of the slope: $s_l = \alpha_{s,F} \log \frac{t_2}{t_1} = 40 \log \frac{t_2}{t_1} \quad [mm]$
