Control Panel Message Document (CPMD)

HP Color LaserJet Enterprise M855, flow MFP M880

This document provides error-code troubleshooting information

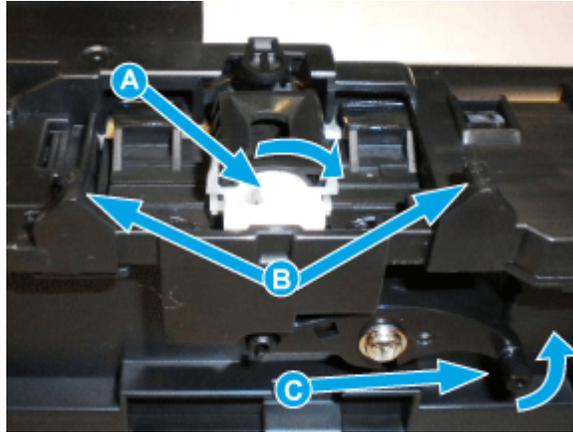
Toner cartridge components

- f. Verify that the plastic pins (callout B) on the toner cartridges are not broken. If either one of the pins is broken, replace the toner cartridge.

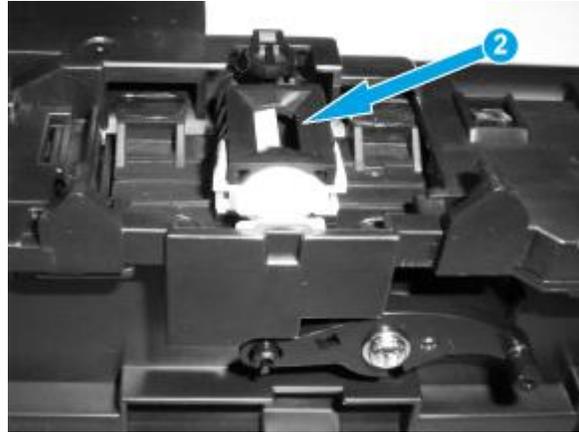
Toner gate partially open (callout 2)

3. Check the imaging drum cartridge gates. If any of the toner gates are partially or completely open, then perform the following steps:
 - a. Push up and hold the black lever (callout C) to release the white gear.
 - b. Rotate the white gear (callout A) clockwise until the toner gate is completely closed.
 - c. Release the black lever.

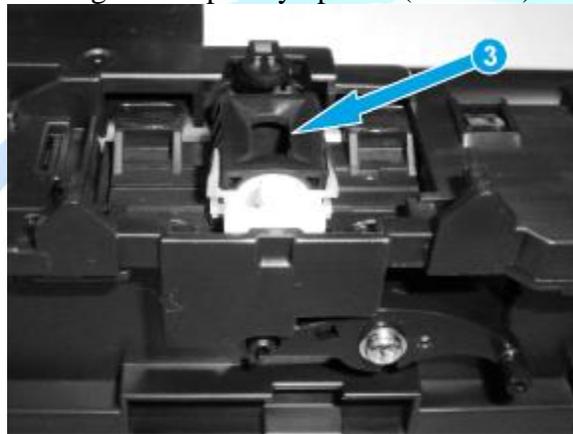
Toner gate completely opened (callout 3)

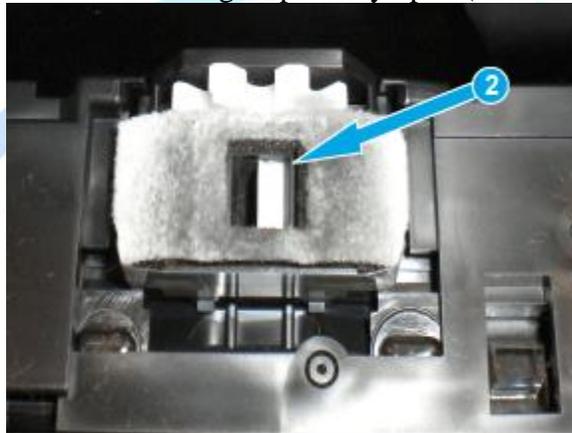
Drum unit toner gate partially open (callout 2)

4. If any of the toner gates are partially or completely open, then perform the following steps to close the gates.

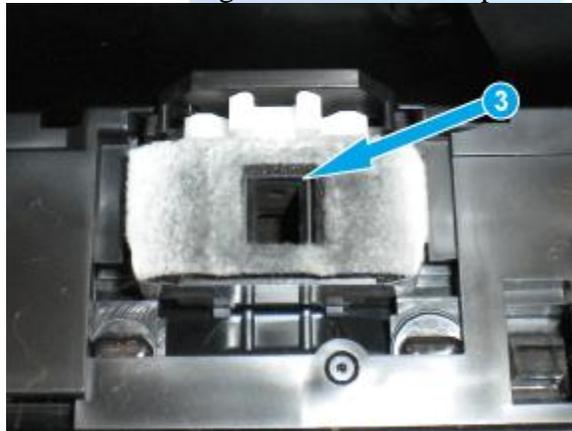
Drum unit toner gate in the incorrect position open (callout 3)

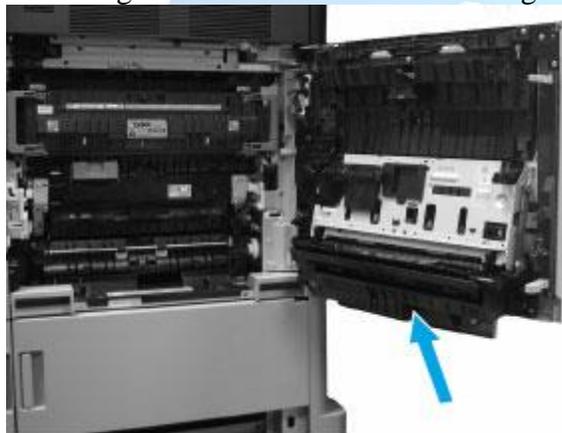
Lower right door area to check for damage

- b. Check all of the lower right door ribs for damage, cracks, or cuts.

- c. If this damage is seen on the ribs, replace the MP paper pickup assembly that contains the affected rib or ribs.

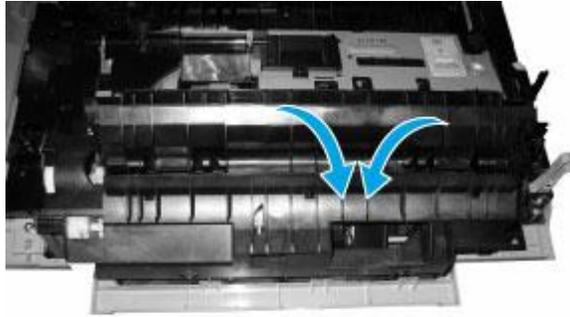
Example of the small ribs

Make sure to check all of the ribs and not only those shown in the call-outs. Small cuts, cracks, or nicks due to heavier than normal paper being constantly fed from the optional input trays can cause the paper to jam.

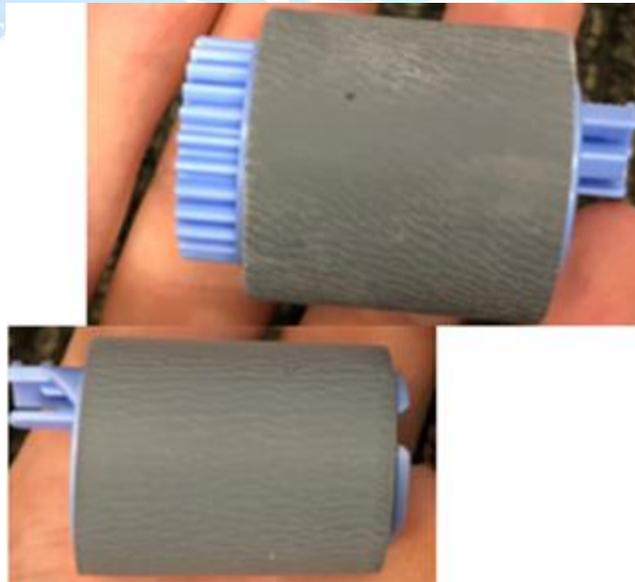
Incorrect rollers

Make sure to use the correct rollers.

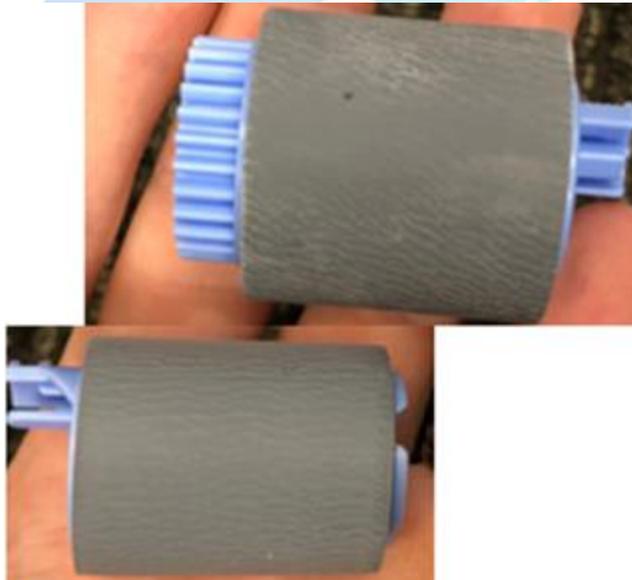
Incorrect rollers

Make sure to use the correct rollers.

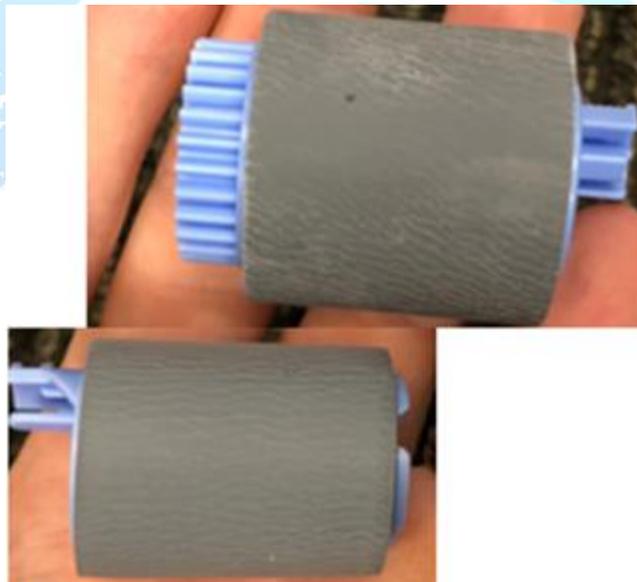
Incorrect rollers

Make sure to use the correct rollers.

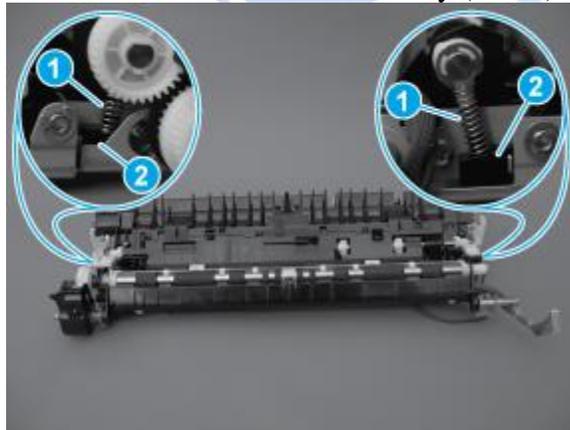
Reinstall the 2nd transfer assembly (1 of 2)

If the springs are out of position, this can cause an obstruction for the shutter (de-skew gate) and prevent it from moving freely. This delays the paper from arriving at the registration roller located at the ITB in the designated amount of time.

- b. Make sure the spring mounting blocks (callout 2) are in the correct position (the springs should be straight and not bent or curved as shown above).

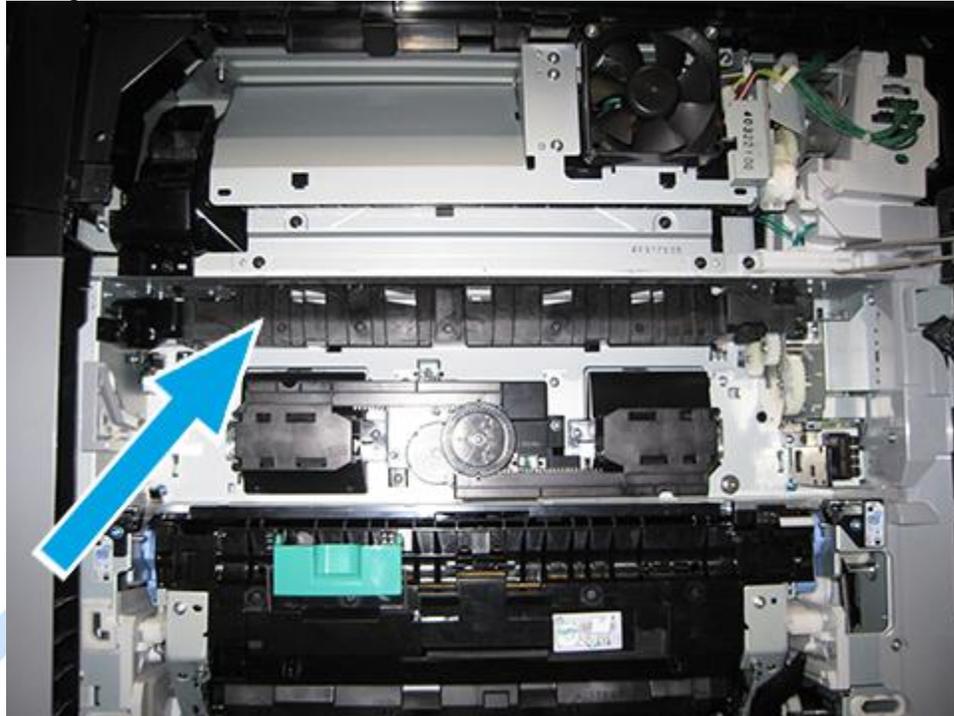
Exit guide

- d. If the exit guide is excessively loose, hanging crooked, moves around, or is otherwise not installed correctly, then remove the guide and check the retaining tabs for damage.

7. Ensure that the fuser exit flag is functioning correctly and engages the fuser sensor correctly on the right door assembly.
8. If the flag on the fuser is broken or damaged, check the event log for the 10.23.70 code and replace the fuser.
 - If a 10.23.70 error is listed, the supply is past very low. Inform the customer that they must order and pay for the replacement.
 - If an active low warning is not listed, replace the part under warranty.

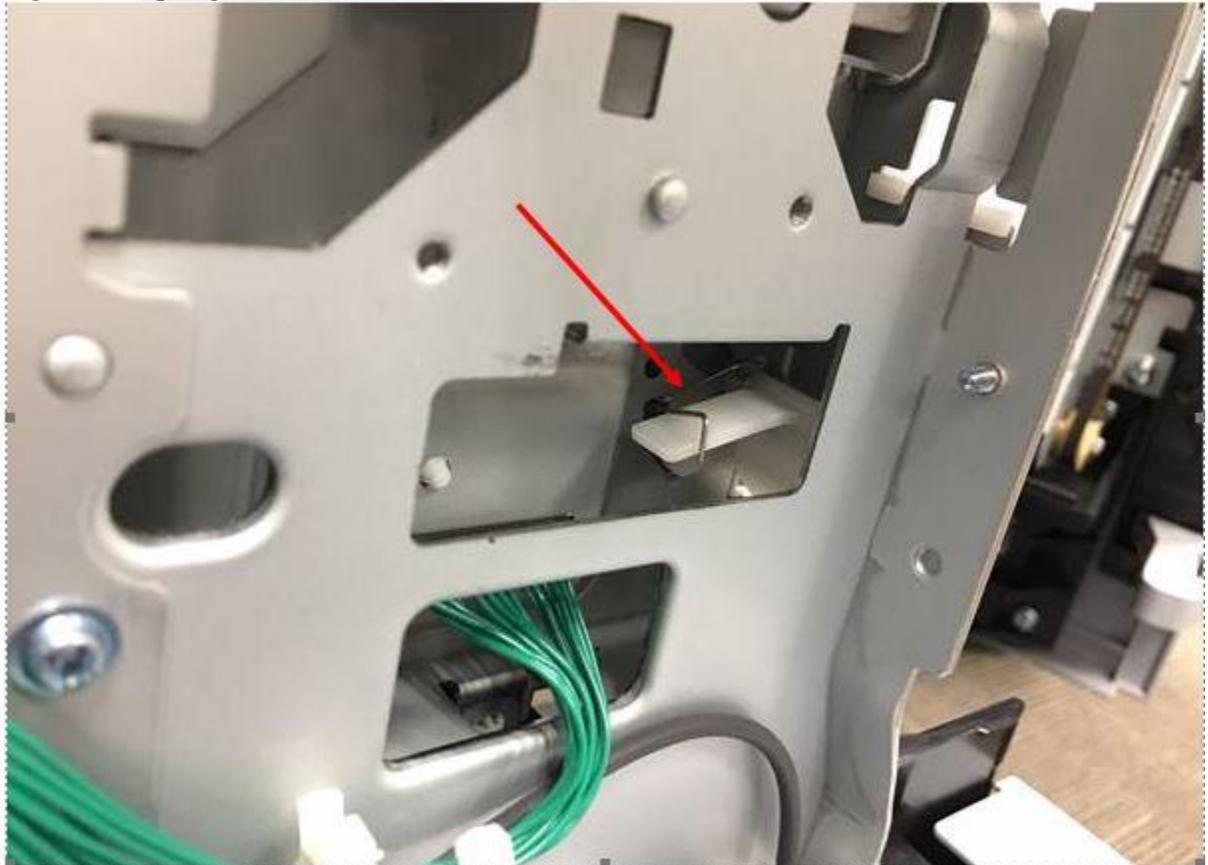
Right door spring

4. Turn the power on with the fuser out and allow the device to prompt to install the fuser.
5. If the error persists (without a previous jam code), test the sensors.
 - . Open the following menus:
 - Administration
 - Troubleshooting
 - Diagnostic Tests
 - Manual Sensor Test
 - a. Select each of the following sensors (one at a time), and then manually move the sensor to ensure that it moves freely and responds correctly to the sensor test.
 - SR302, SR304, SR35, and SR45
 - SR24
 - SR2501
 - SR29, SR37, or SR38
 - b. If the sensor fails to change state, clean the sensor of paper dust or toner, and then test again.
 - c. If SR304 is intermittent check for a loose spring, see the following image.

- d. If the sensor test still fails, the sensor might be defective. Replace the sensor or the assembly containing the sensor.

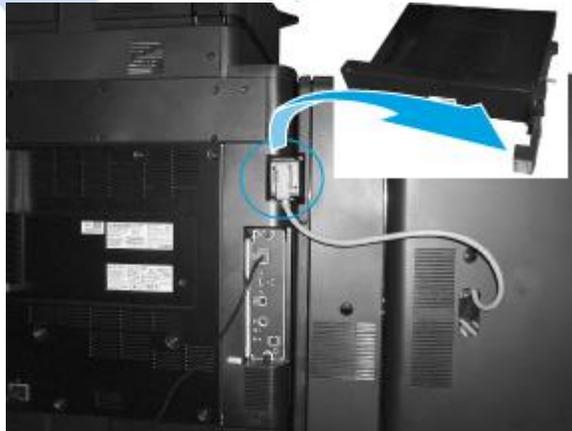
IPTU unit connector

1. Ensure that the high output accessory initializes correctly. If it initializes, skip to the next step. If not, perform the following steps to check the IPTU connector:
 - a. Check the connector from the IPTU to the output device and ensure that it is connected correctly.

- d. Check the cables on the IPTU controller to make sure that they are seated correctly and not damaged.
- e. If the lock assembly or connector is damaged, replace the finisher lock assembly/ITPU.

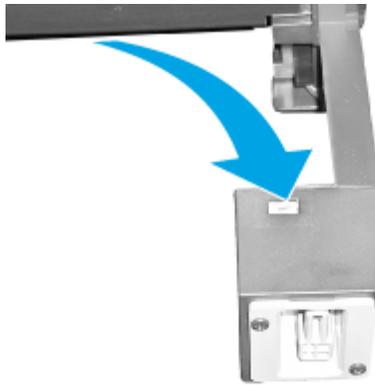
Opening IPTU connector

- c. Ensure that the connector is not loose or disconnected.

With the cover off from the connector housing, check that the interior cables are seated correctly and not damaged.

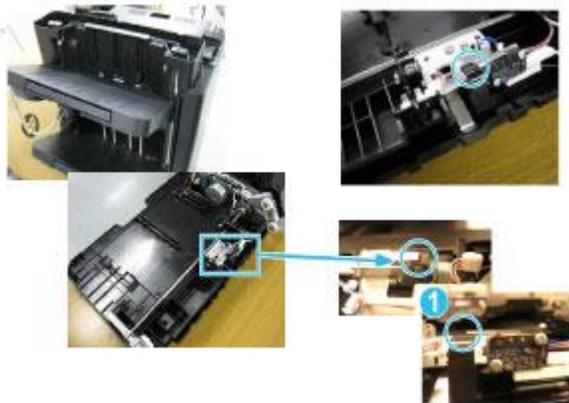
Incorrect position

Switch MSW103 (output bin 1 close detection switch) actuator is unable to actuate due to a mounting issue. The actuator arm is not in the correct position for the switch to actuate.

Callout 1 shows the switch lever in the incorrect position, which is above the holder.

1. Verify that the switch MSW103 is not aligned correctly. If the switch is not aligned correctly, continue to the next step.
2. Remove the upper and lower stepped cover, rear cover, front door cover and the inner cover.

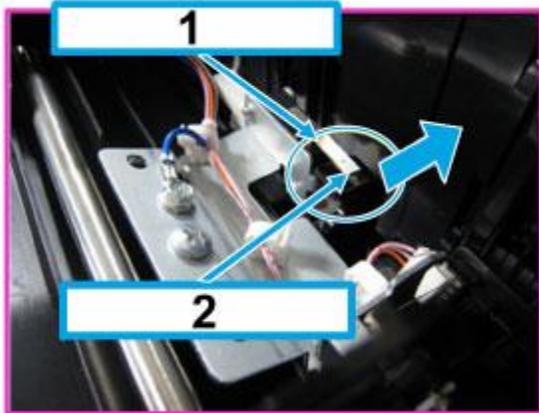
Tray-guide switch-lever in the wrong position

- 1 - Safety switch metal plate.
 - 2 - Lever of the tray guide shown off of the metal plate (notice that the metal plate is on top of the lever).
10. Move the lever for the tray guide back into the correct position. While making the tray guide bend in the direction of the blue arrow in the first image, cover the safety switch metal plate by the lever.

9. Move the lever for the tray guide back into the correct position.

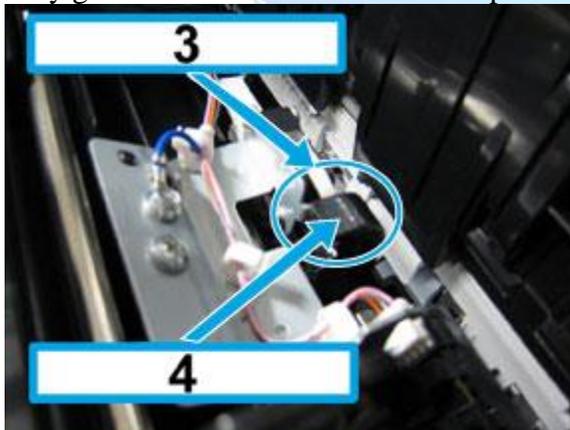
Tray guide switch lever in the correct position

- Callout 3 - Safety switch metal plate.
 - Callout 4 - Tray-guide lever in the **correct** position, which is pushed onto the metal plate.
11. Reverse the previous steps to reassemble the parts.

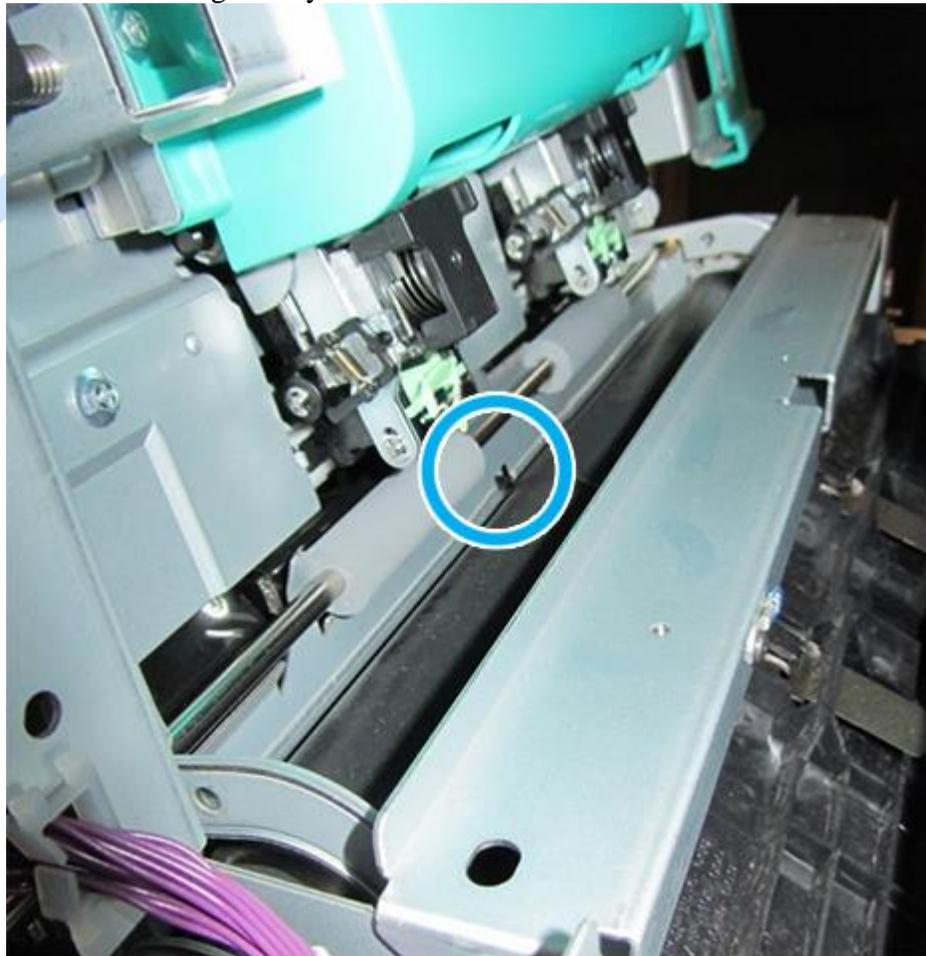
Black sensor flag clearly visible in cutout.

- d. If the sensor is **not** in the correct position, remove the output device back cover and check the following section in the lower center of the output device.

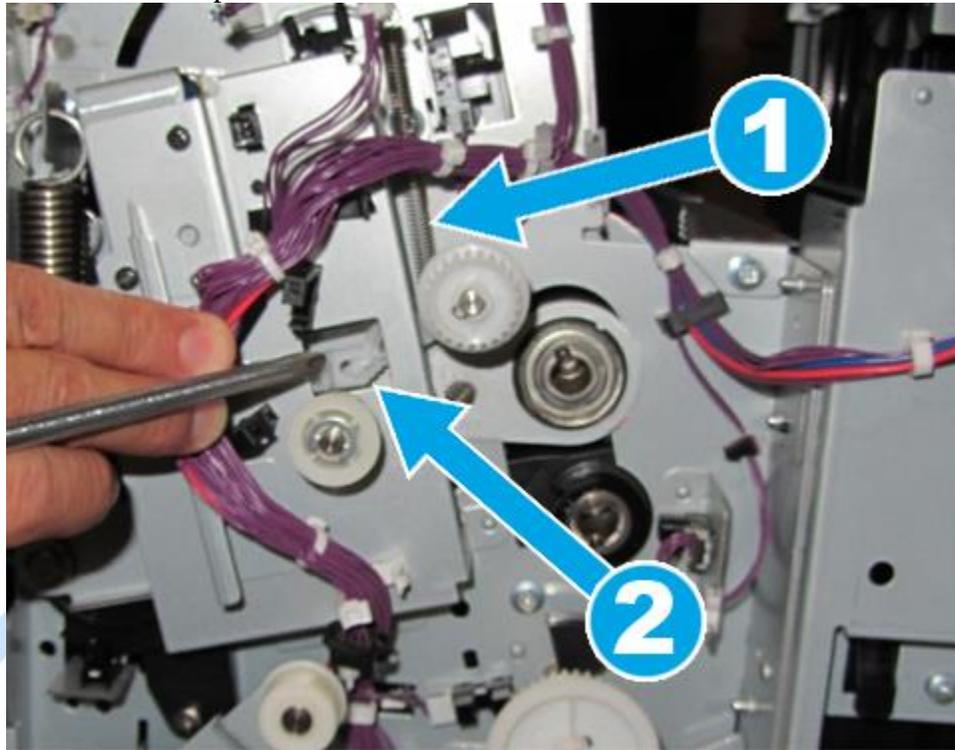
Back side of output device

Callout 1: Tension spring installed correctly.

Callout 2: White plastic engagement arm pin and fork holder.

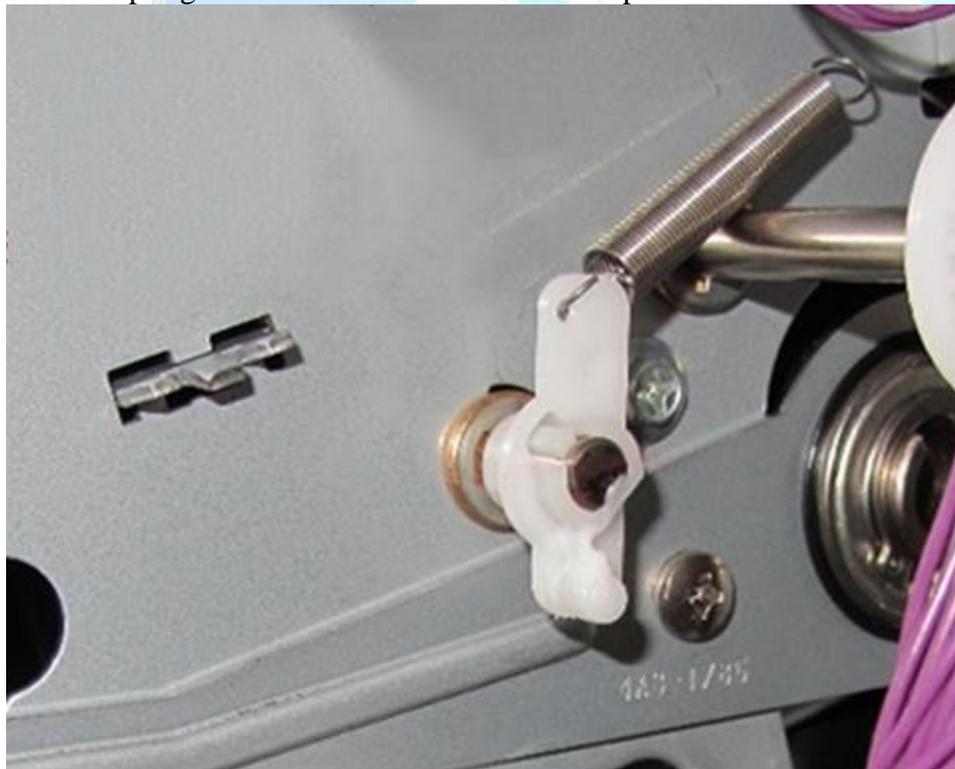
Tension spring loose and white arm in incorrect position

- f. If the pin is not in the correct position, rotate the arm clockwise so that the arm pin is between the plastic fork, then reattach the tension spring.

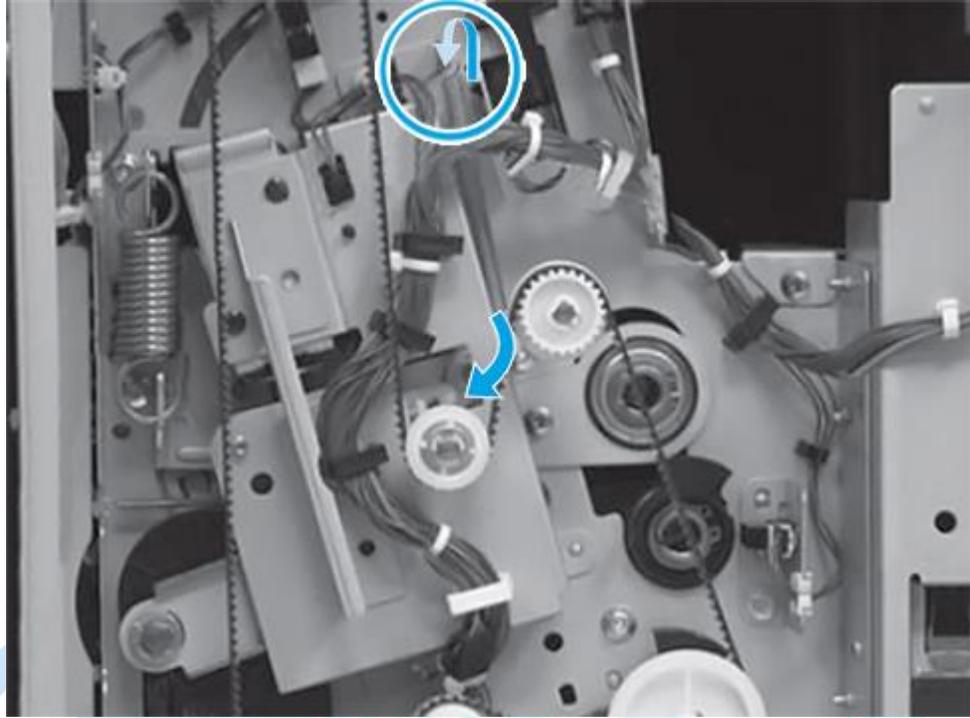
The white arm should be in a horizontal position with the pin held between the plastic fork.

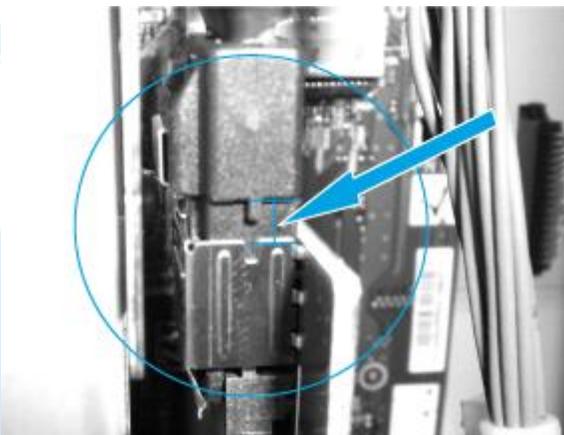
USB not connected correctly

6. Make sure the USB connectors on each end of the cable are plugged in and seated correctly.

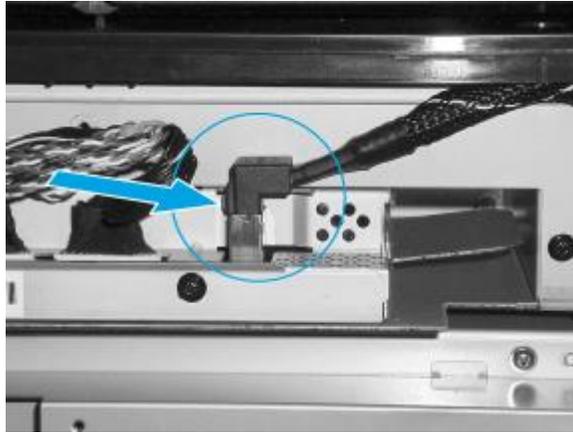
SCB USB connected correctly

8. Check the USB connection on the engine and the SCB (a loose or poorly seated connection can cause this error).

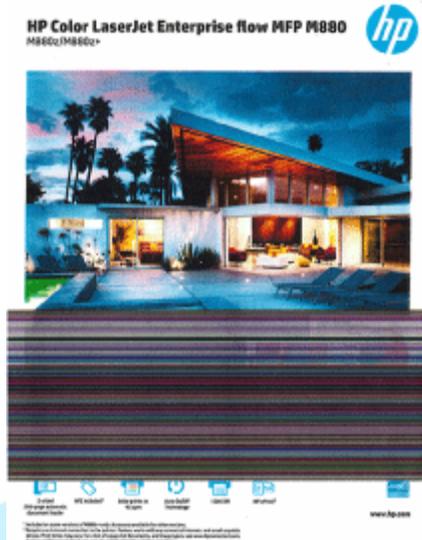
Flatbed image defect

3. Upgrade the firmware.
4. Check the connectors from the SCB to the printer engine for correct seating and secure connection.

5. If the error persists, replace the image scanner assembly.

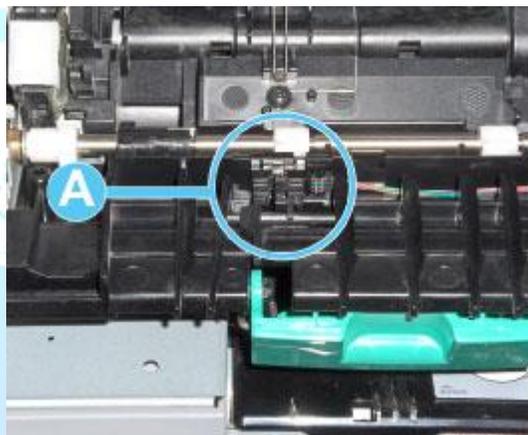
Width sensor seated correctly

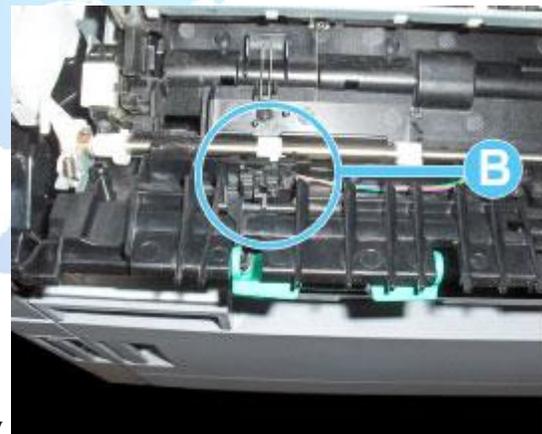
Width sensor not seated correctly

- f. When replacing the sensor cover, make sure that the tabs are placed correctly before locking the retaining tabs.

9. If the paper width sensors are not functioning correctly, check the event log for the 10.22.70 code and replace the secondary transfer unit.

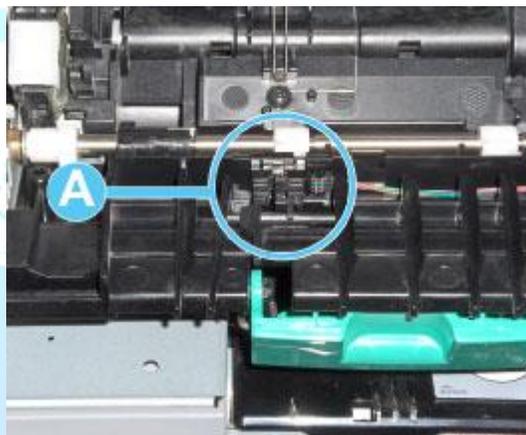
Width sensor seated correctly

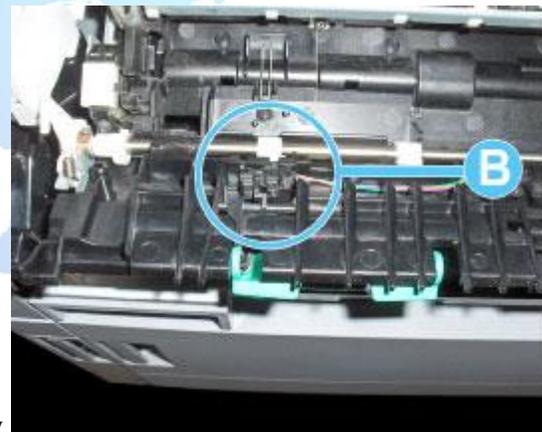
Width sensor not seated correctly

- f. When replacing the sensor cover, make sure that the tabs are positioned correctly before locking the retaining tabs.

9. If the paper width sensors are not functioning correctly, check the event log for the 10.22.70 code and replace the secondary transfer unit.
 - If a 10.22.70 error is listed, the supply is past very low. Inform the customer that they must order and pay for the replacement. HP recommends that the customer order and install a maintenance kit at this time.
 - If an active low warning is not listed, replace the part under warranty.

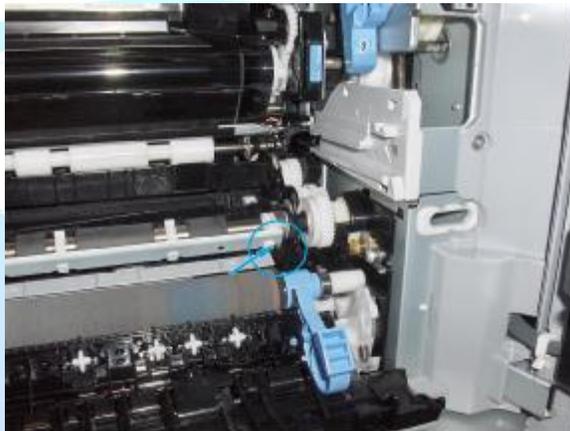
Spring positioned correctly

The arrow points to the spring clip positioned correctly in the deskew shutter

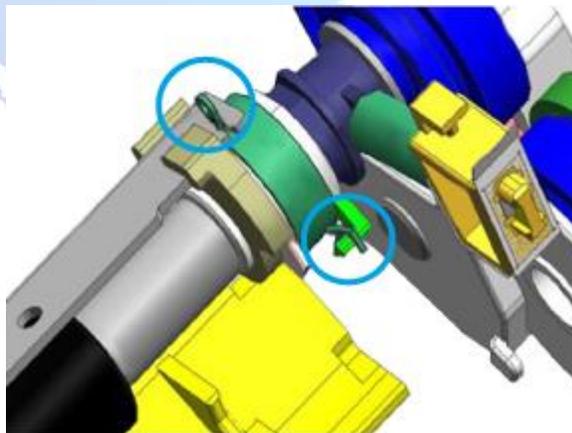
Spring installed correctly

The circles show the correct spring position. If the spring is out of position, try to put it into place, and then check the results.

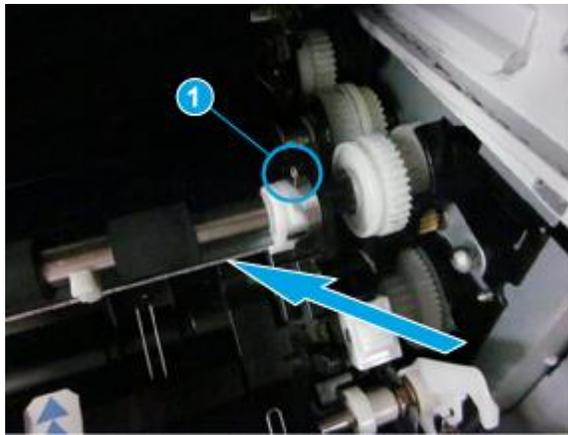
Spring out of position

Call-out 1 - Spring is not clipped into the deskew shutter. The arrow points to the deskew shutter in lowered position.

- a. Rotate the deskew shutter up.

- b. While holding the shutter up in place, rotate the spring into position and place it into cutout in the deskew shutter.

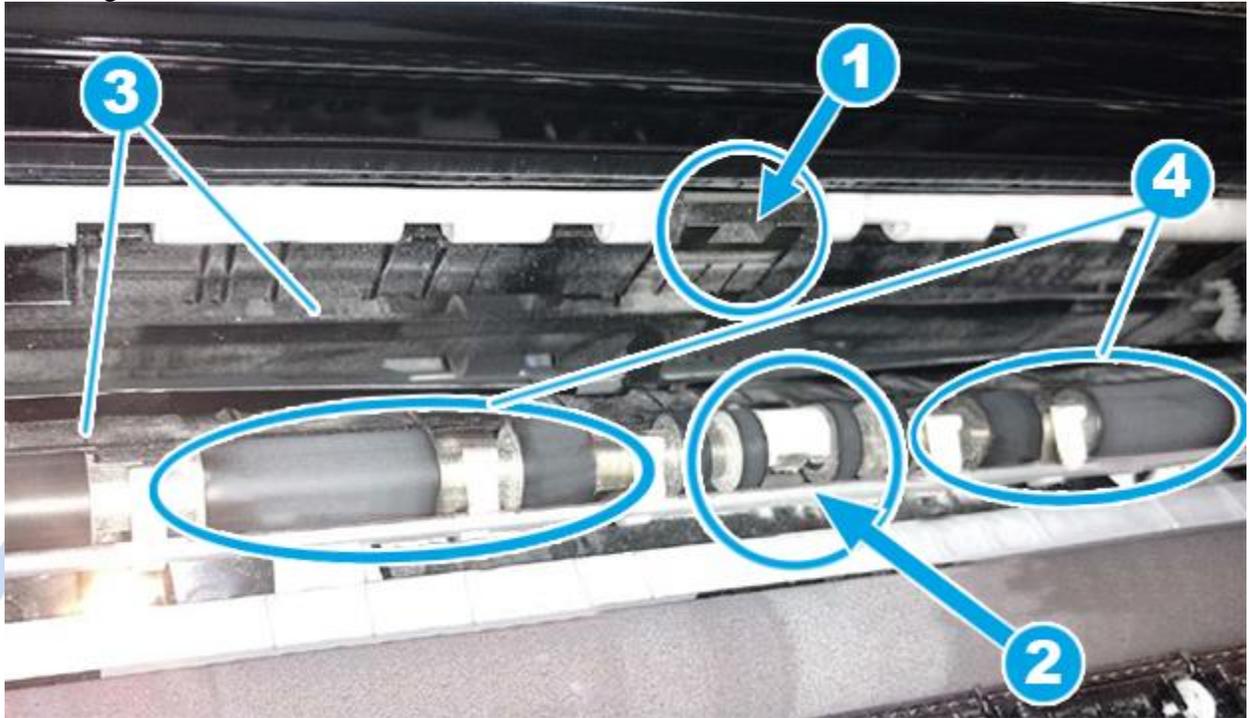
Cleaning locations

Callout 1: SR2501

Callout 2: Location of media sensor (Note the dust on the shaft).

Callout 4: Registration rollers are not clean.

3. Check the event log for 54.XX errors that might indicate the media sensor is not calibrating correctly. If the error is present, make sure the CPR sensor is not contaminated with toner or paper dust.
4. Clean the sensor with compressed air and a soft brush.

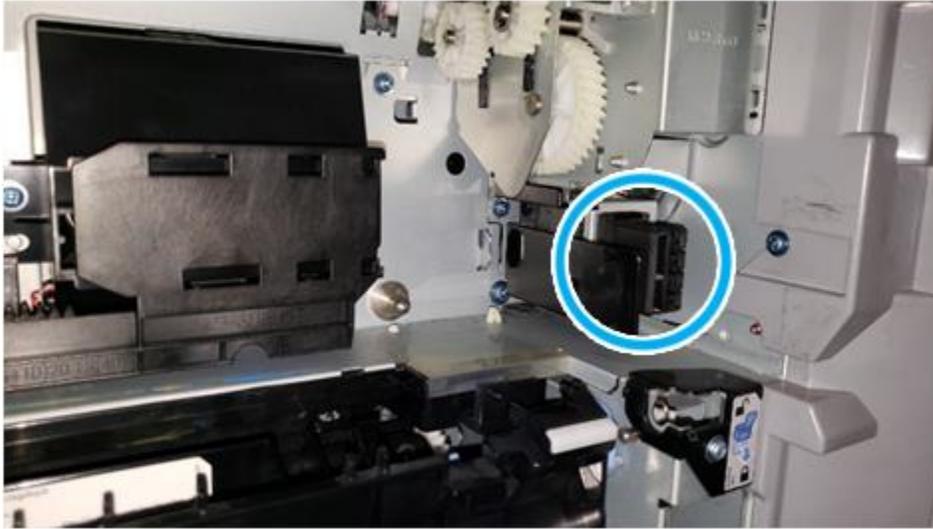
4. Check the connector (J1901) between the fuser and printer. If the connector is damaged, replace the fuser drive assembly.

Part number: RM1-9606-000CN

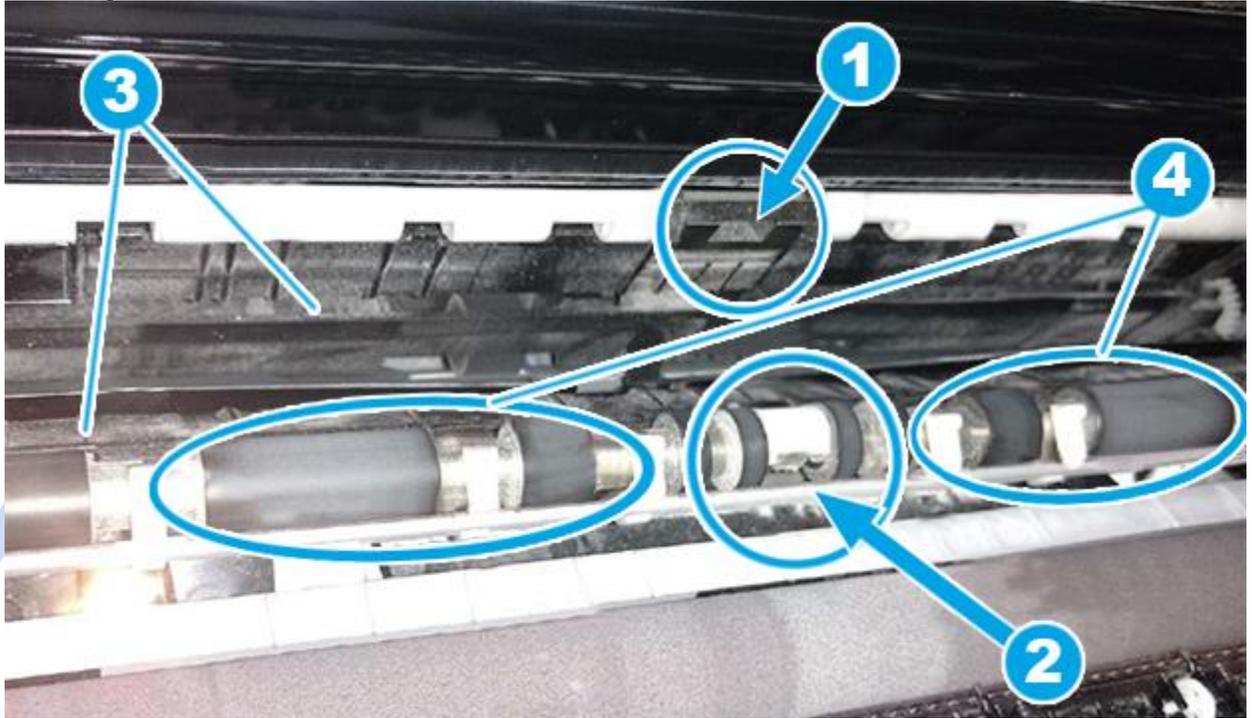
Cleaning locations

1. Check the supplies status page to make sure the toner cartridges are not past their useful life.
2. Remove and check the ITB for damage.
3. Make sure the CPR sensor is not contaminated with toner or paper dust, and clean the sensor and area with compressed air, soft brush, or a lint-free cloth.

Callout 1: SR2501

Callout 2: Location of media sensor (note the dust on the shaft)

Callout 4: Registration rollers are not clean

4. Turn the printer off, and then on.
5. Check the following connectors:
 - (J1904) between the ITB and the printer
 - (J119, J118 and J116) on the DC controller PCA
 - (J1824 and J1931) on the CPR/density sensor assembly
6. If the error persists, replace the CPR/density sensor.

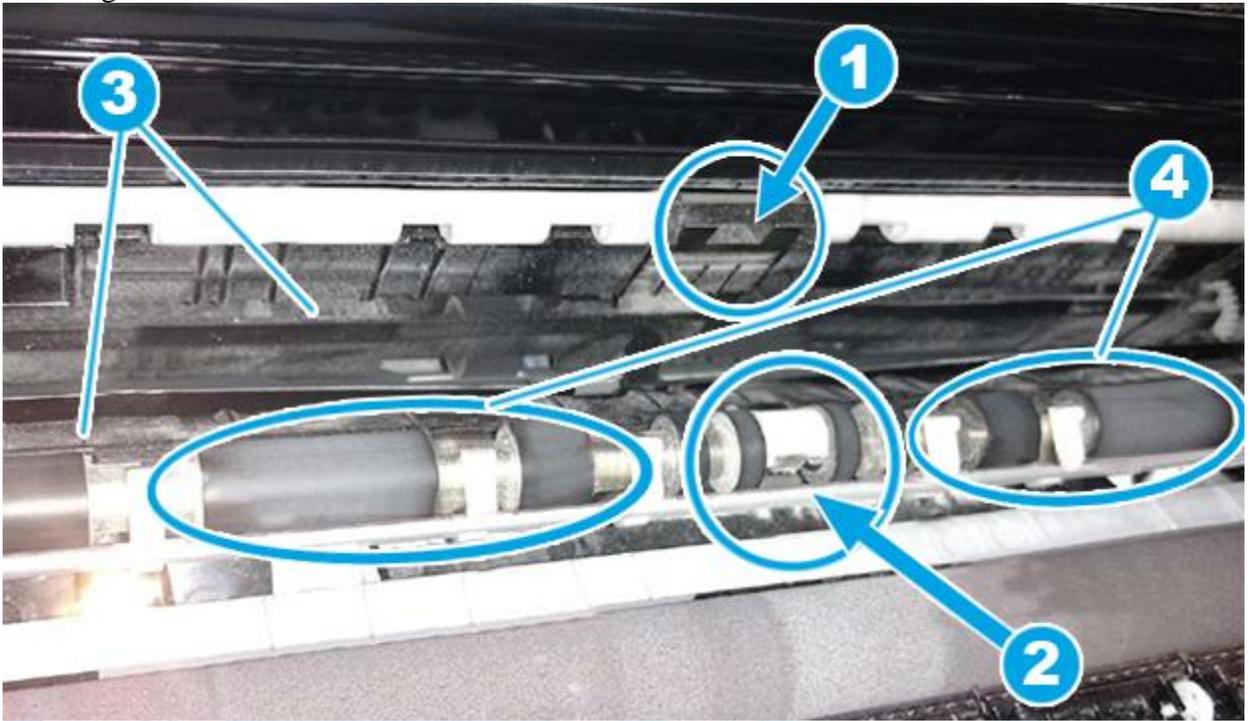
Cleaning locations

1. Check the supplies status page to make sure the toner cartridges are not past their useful life.
2. Remove and check the ITB for damage.
3. Make sure the CPR sensor is not contaminated with toner or paper dust, and clean the sensor and area with compressed air, soft brush, or a lint-free cloth.

Callout 1: SR2501

Callout 2: Location of media sensor (note the dust on the shaft)

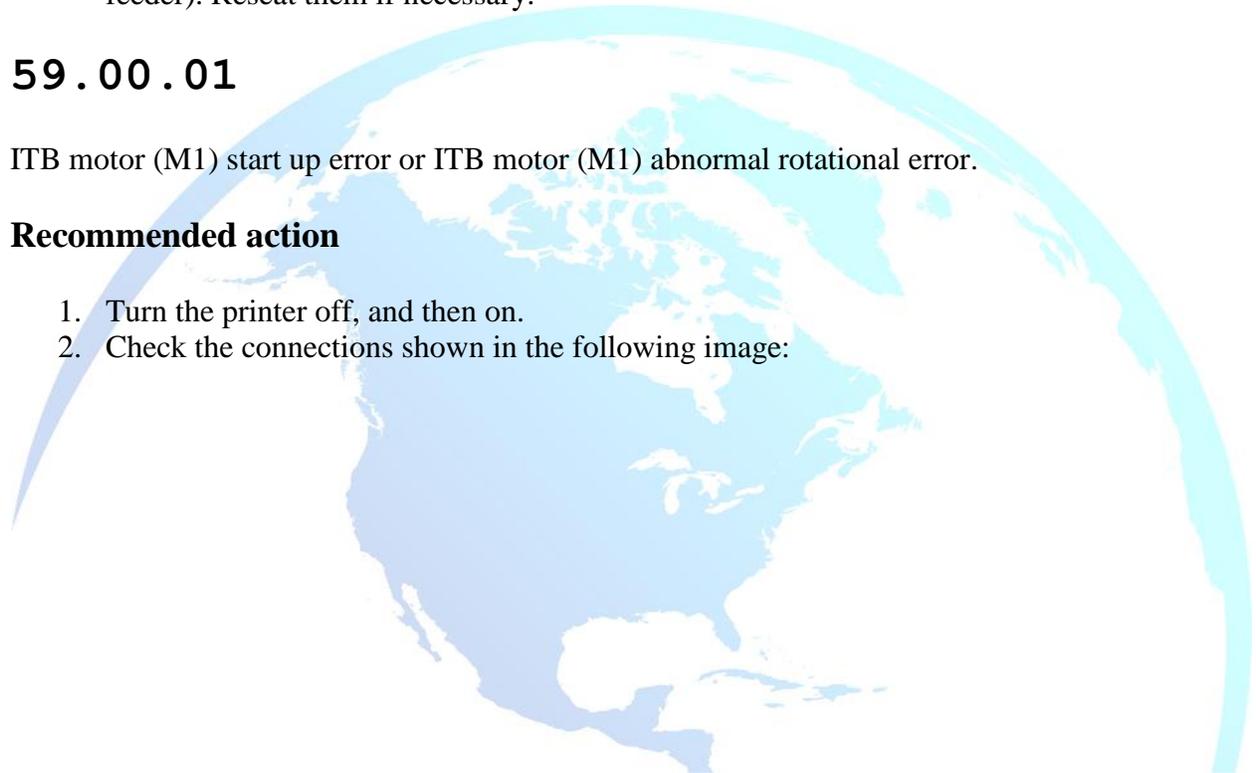
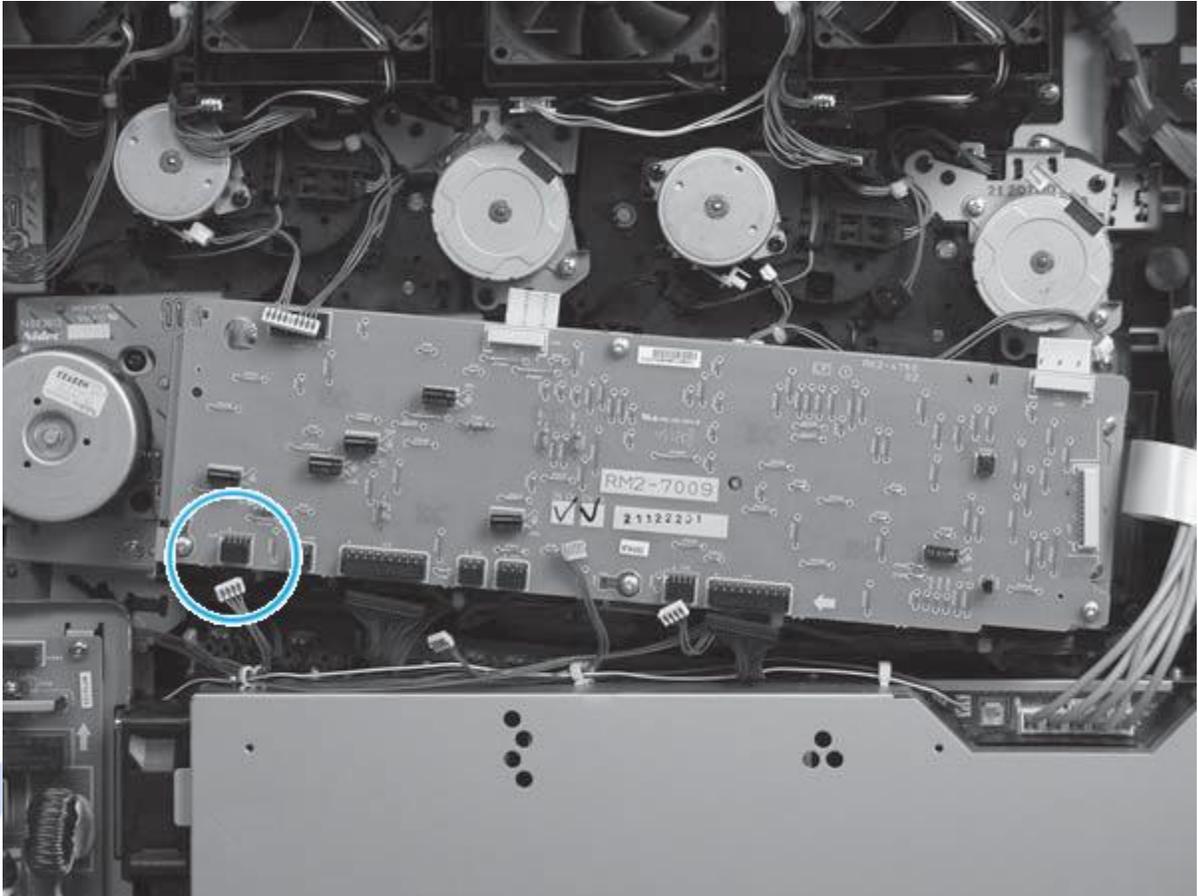
1. Turn the printer off, and then on.
2. Check the connections shown in the following image:

3. Remove the back cover, check the connector (J424) at the memory tag PCA, make sure there are no broken or bent pins, and that the connector is seated correctly.
4. If the error persists, replace the following assemblies:
 - Shutter gear holder assembly (contains the M17 motor that moves the shutters) part number: RM1-9857-000CN
 - Memory tag PCA (controls and contains the (J424) connector) part number: RM2-7009-000CN
