FA-TR-75087

A GEARLESS SAFE AND ARMING DEVICE FOR ARTILLERY FIRING
(PROGRAM SUMMARY AND MATHEMATICAL ANALYSIS)

September 1975

MUNITIONS DEVELOPMENT AND ENGINEERING DIRECTORATE

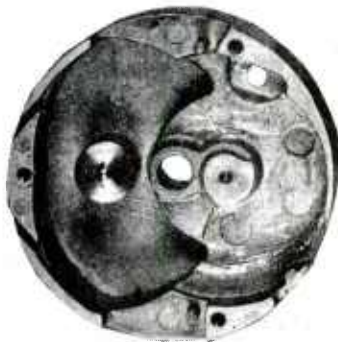
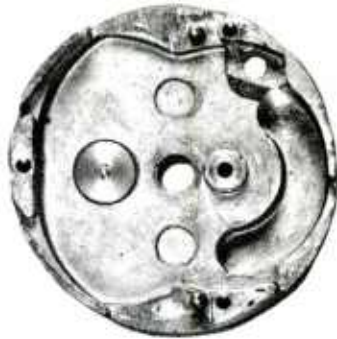
Figure 24. Spacer/Body Assembly

POST PRESS FIT
INTO LOWER PLATE

POST/BLOCK PRESS FIT
BETWEEN SPACER WALLS
AND DOWELED INTO LOWER PLATE

POST PRESS FIT
INTO SOLID BODY
